# National road cliff protection analysis in Malibau Anai after Anai River flood, West Sumatra

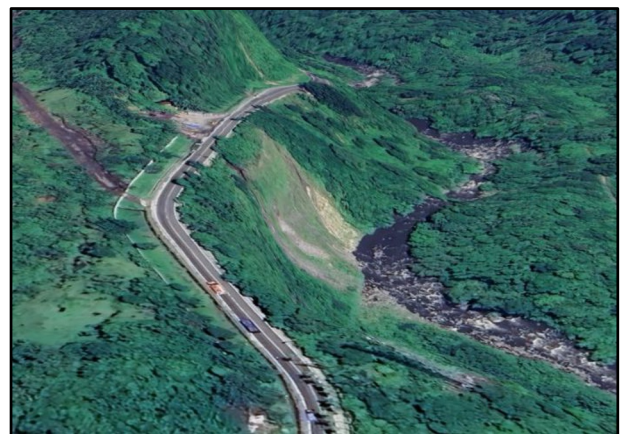
**Fig. 1.** Cliff condition before the landslide (source: google earth, february 23, 2024)

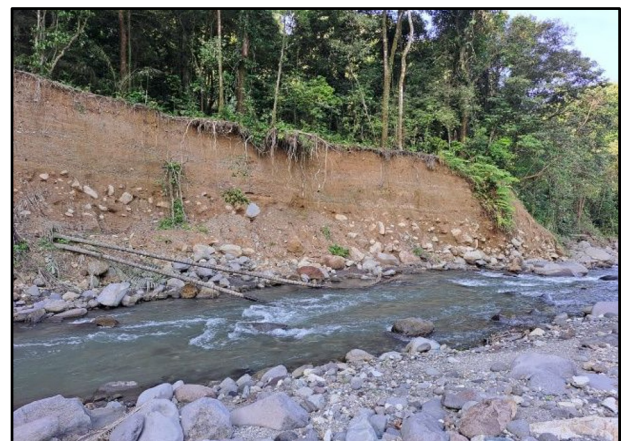
Floods in the region significantly impact riverbed erosion and weaken cliff foundations. Flooding accelerates lateral erosion, eroding the cliff's base and reducing overall slope stability. These impacts are exacerbated by unpredictable river discharge changes, increasing hydraulic stress on the cliff structure. The condition of the Anai River is illustrated in Fig. 3.

**Fig. 3.** The condition of one of the points in the Anai River

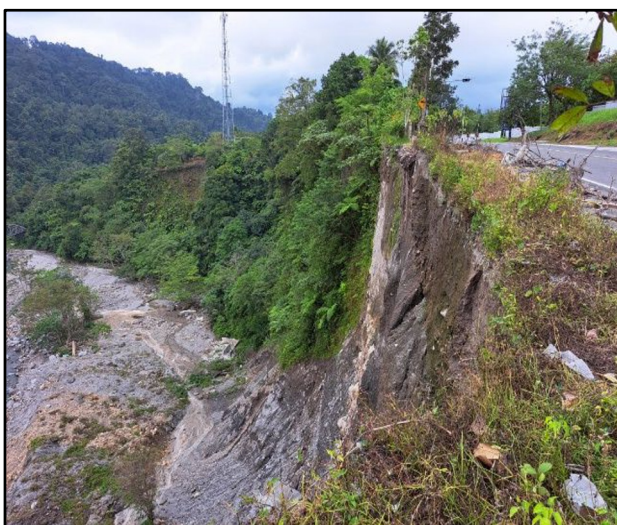
**Fig. 5.** Cliff condition after flash flood (may 11, 2024)

The results of the field survey conducted after the flood in the Anai River showed significant morphological changes to the cliff, located at 0°29'36"S 100°20'20"E along the Padang–Bukittinggi national road. The flood caused severe erosion at the base of the cliff, leading to the loss of soil and rock material. This erosion resulted in slope instability which was further exacerbated by the extremely steep slope of the cliff (Fig. 5).

After the flood, several new cracks were observed in the middle to upper section of the cliff, indicating an increased risk for landslides. These cracks resulted from the pressure of water entering the soil through its pores during the flood, which increased pore water pressure and reduce the soil's shear strength [2, 11, 12]. In addition, the cliff section adjacent to the river flow experienced a reduction in height due to the lateral erosion process, which further weakened the cliff foundation. Meanwhile, the road cliff collapse at the Malibau Anai location still needs to be repaired.

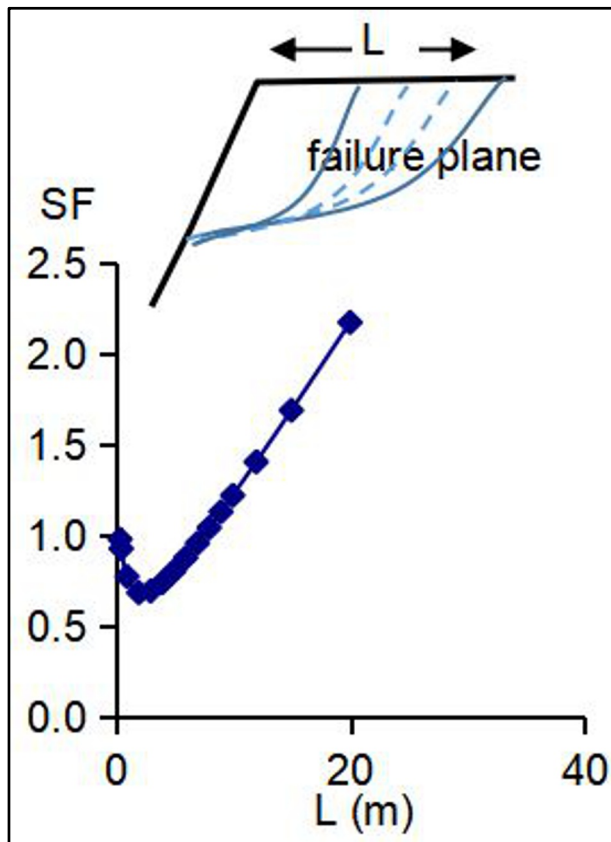
The slope stability of the cliff then was analyzed using the test result. The stability analysis in the terms of factor of safety with the results in Fig. 7. The cliff has safety factor (SF) less than 1 for the distance about 8 m from the edge of the cliff.

**Fig. 7.** The reduced stability of the cliff increases the risk of landslides.

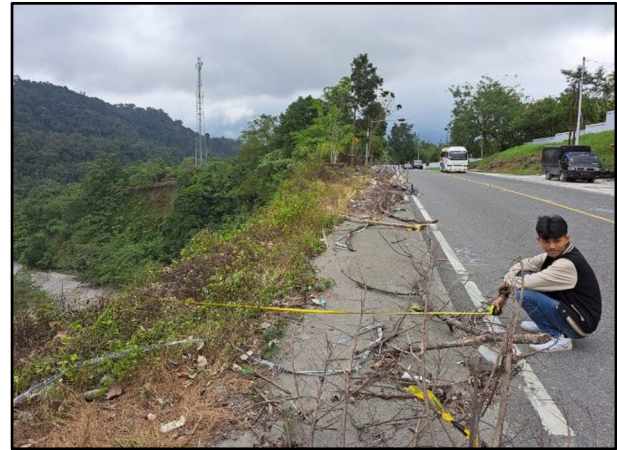
Changes in the cliff's morphology after the flood have directly impacted the national road, located only 3 meters from the cliff (Fig. 8). The reduced stability of the cliff increases the risk of landslides (Fig. 7), potentially damaging this vital transportation route due to river water erosion. Minor deformation had been observed on the road surface in some areas, indicating potential soil movement beneath the asphalt layer.

**Fig. 8.** Cliff Condition with road shoulder 3 meters away.

The installation of guardrails along the road shoulder would be an effective temporary solution to prevent motorists from getting too close to the cliff and to safeguard vehicles from falling off the edge.

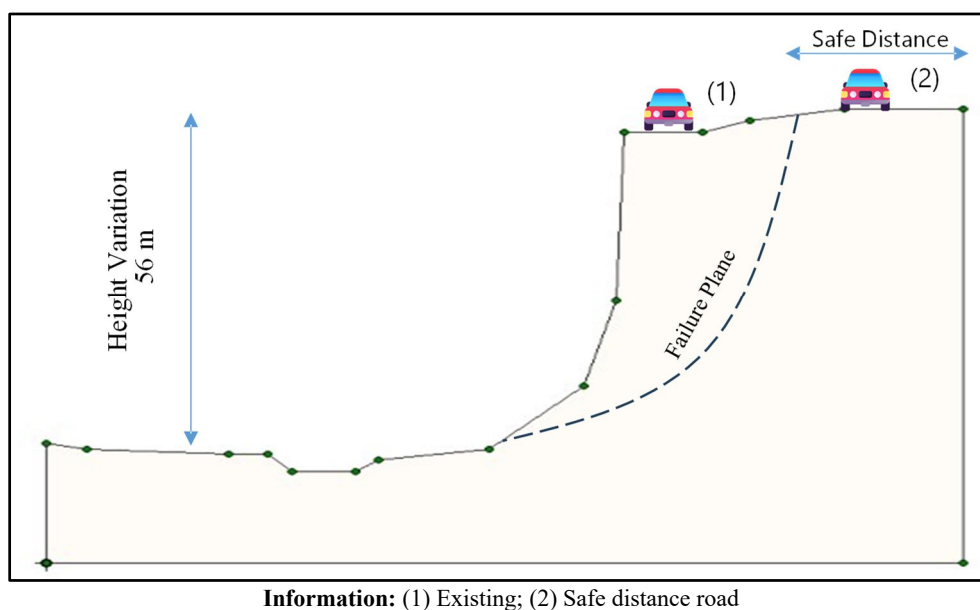
**Fig. 10.** Illustration of the condition of the cliff with the shoulder of the road

In the medium term, the road which currently has a width of 2 x 3.60 meters, should be realigned to move it away from the landslide prone area (Fig. 10).
