## Evaluation of Imminent Fire Hazards of Inheritance Ancestral Temple and Mansion in Georgetown, Penang

**Abstract.** Fire hazards of the inheritance buildings are often been neglected, causing fire to take place. Most of the heritage buildings are of large scale, flammable priceless contents and large numbers of visitors, however, the existing structures are weak in fire resistance. There are a few factors that contribute to the fire in these unique yet vulnerable structures. Therefore, fire risk assessment plays an important role as many historic buildings in Penang are significant in their architectural value and historically important and their destructions by fire are great irreplaceable losses. Thus, this study is intended to identify the current fire emergency plan of heritage temples and mansions in Penang which includes 4 buildings such as Khoo Kongsi, Cheah Kongsi, Hock Teik Chen Shin Temple and Teochew Temple. The possible fire risks of these heritage buildings will be identified and evaluated comprehensively. The previous fire cases will be considered as well in order to discover the common factors contributing to the fire cases at heritage buildings. Time and again,

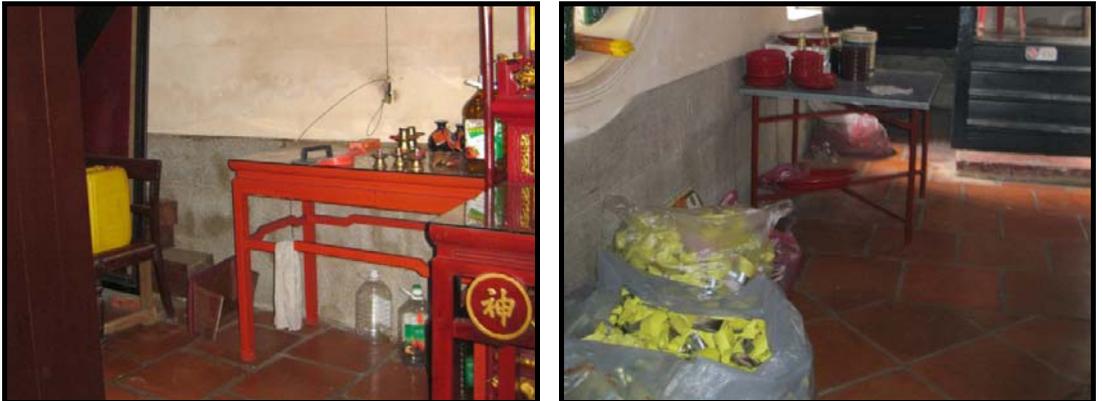
After the fire risks assessments were carried out, it is found that the fire risk of the temples is mainly from the joss stick used to worship the ancestral. Besides, the fire hazards are more likely to come from the oil lamps where the posterities light up the oil lamps as to pray for good fortune. The storage management for combustible materials vary in each temples. Khoo Kongsi makes a good example in keeping them whereas Hock Teik Cheng Sin Temple are less aware of this issue. The combustible materials are not well kept as shown in Fig. 2. There should be a store to keep all the flammable materials in the temples.

**Figure 2:** Oil for lamps and joss stick not well kept (left) and materials to worship not properly kept (right)

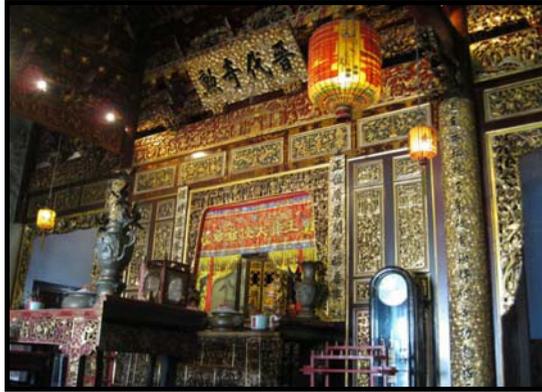
Fig. 3 shows a typical worship hall of these ancestral temples in Khoo Kongsi. It is clear that the area is made up almost 70% by timber. Timber is a highly flammable building material. Thus, the fire risks increased proportionally with the types of building materials. Nobody actually staying in four of the temples nowadays, thus there is no open flame and fire hazard from the kitchen as compared to old times. The main electrical installation and equipment are inspected occasionally, depending on situation of each temple. In preventing electrical fire, there is however, no testing procedure been carried out.

**Figure 3:** A typical worship hall of the ancestral temple at Khoo Kongsi

Discussing about the fire protection in the entire studied ancestral temples, the most important element that can be recommended is the compartmentalization. The spread of fire within a building can be restrained by sub-dividing it into compartments separated from one another by walls and/or floors of fire-resisting construction [11]. This method helps to prevent rapid fire spread which could trap occupants of the ancestral temples and to reduce the chance of fires becoming large, on the basis that large fires are more dangerous, not only to occupants but to people in the vicinity of the building. The construction of such compartments and all their components is a matter of systems within systems, which use bounding to achieve fire-resistance ratings, all interdependent, forming part of an

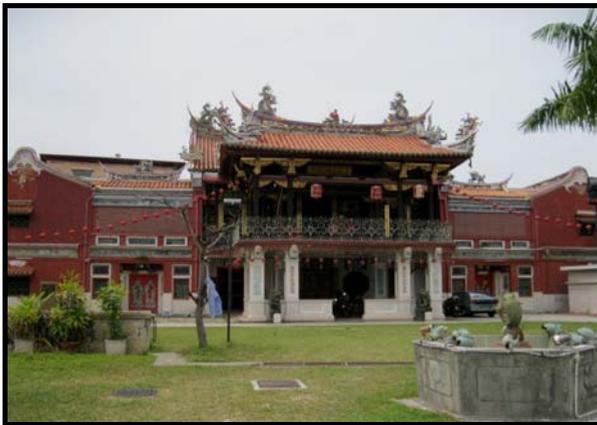
Under UBBL clause 166, it states that every floor space shall be provided with at least two exits on the basis that if one exit is inoperable, the other exit can serve the function [13]. Every ancestral temple fulfilled this aspect because all of the temples have more than one excess to upper floor. It meets the requirement of to provide with at least two exits on the basis that if one exit is inoperable, the other exit can serve the function. However, the exits routes in these temples are not provided with conspicuous exit sign such as the “Green Running Man” on a white background. However, it is quite easy to escape from these temples as the points of exits from the building clear of obstructions. All floor surface and stairs on escape routes are free from tripping and slipping hazards [14]. However, the door used in all the ancestral temples are not fire rated door. This puts people in dilemma because when efforts are made to protect the heritage art and culture of the elements of these temples, we need to compromise a little with these art values. Lighting wise, it can be considered as satisfactory as all lighting (normal and where provided emergency) on escape routes are fully operational. However, to the needs of the disable, all the four temples have not provides mean of escape adequately for them. The escape routes of these ancestral buildings are by far satisfactory and they all leads in different direction to places of safety, as shown in Fig. 4, the open space in Cheah Kongsi.

**Figure 4:** Large open space outside of Cheah Kongsi for mean of escape during fire outbreak.
