Stability evaluation of modernized bank protections in a culvert construction

Abstract. The paper presents stability evaluation of the banks of the Wilga River on a chosen stretch in Koźmice Wielkie, Małopolska Province. The examined stretch included the river bed upstream from the culvert on a district road. The culvert construction, built over four decades ago, was disassembled in 2014. The former construction, two pipes that were 1.4 m in diameter, was entirely removed. The investor decided to build a new construction in the form of insitu poured reinforced concrete with a 4 x 2 m cross section. Change of geometry and different location in relation to the river current caused increase in the flow velocity and, as a consequence, erosion of both protected and natural banks. Groundwater conditions were determined based on the geotechnical tests that were carried out on soil samples taken from the banks and the river bed. Stability calculations of natural slopes of the Wilga River and the ones protected with riprap indicate mistakes in the design project concerning construction of the river banks. The purpose of the study was to determine the stability of the Wilga River banks on a

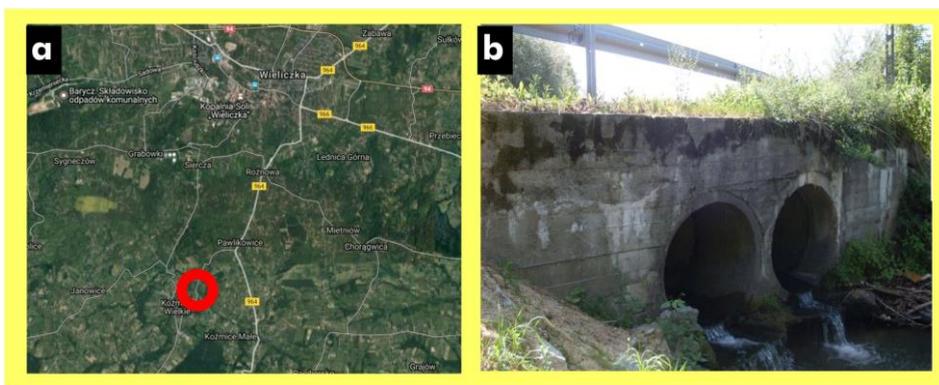
The culvert was built in 1970s for lightweight horse and vehicle traffic. At that time the road was rather quiet and unpaved. In the following years the road was paved using metallurgical slag, later an asphalt surface was placed (Fig. 2a). Two reinforced concrete pipes with an internal diameter of 1.4 m were used as elements carrying water. The length of each pipeline was 10.3 m (Fig. 2b). The culvert was built without any design project since it was not necessary at the abovementioned economic conditions.

Fig. 2. a) Localization of the culvert b) condition of the construction before rebuilding

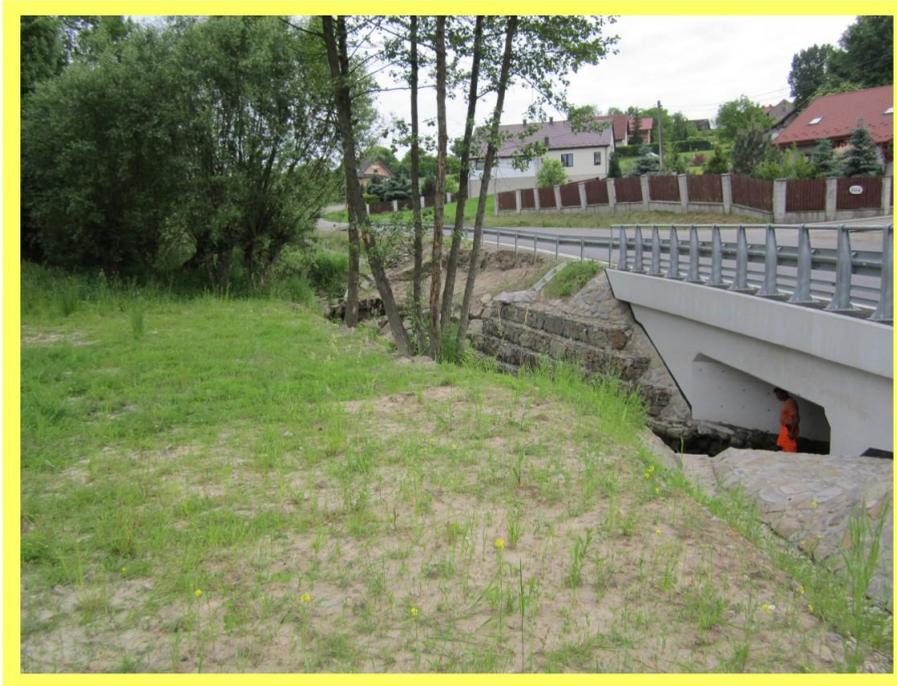
Former culvert pipe was entirely disassembled. On the ground level where geotechnical parameters were appropriate the base of a new culvert was built. It is a reinforced concrete culvert poured on site; it is a closed frame based directly on solid clayey soils. The front walls are situated parallel to the road axis. The total length of the construction is 11.74 m. The horizontal diameter is 4.00 m, the vertical 2.00 m (Fig. 3) and the total carriageway is 10.34 m wide.

Fig. 3. Culvert on the upstream side and the view of damages

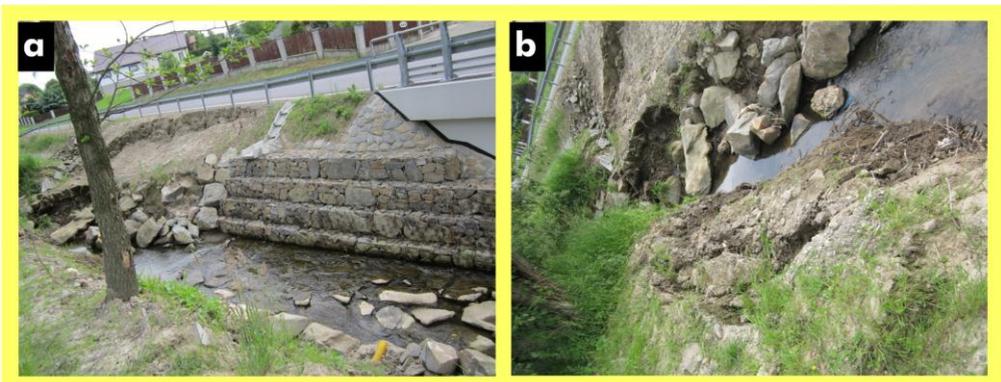
In the first year (2015) after the construction was finished the bank protection on the right side formed from riprap slid along with the soil from the slope fig. below.

Fig. 4. The view of damages that occurred after the first year of exploitation a) from the downstream side and b) upstream side

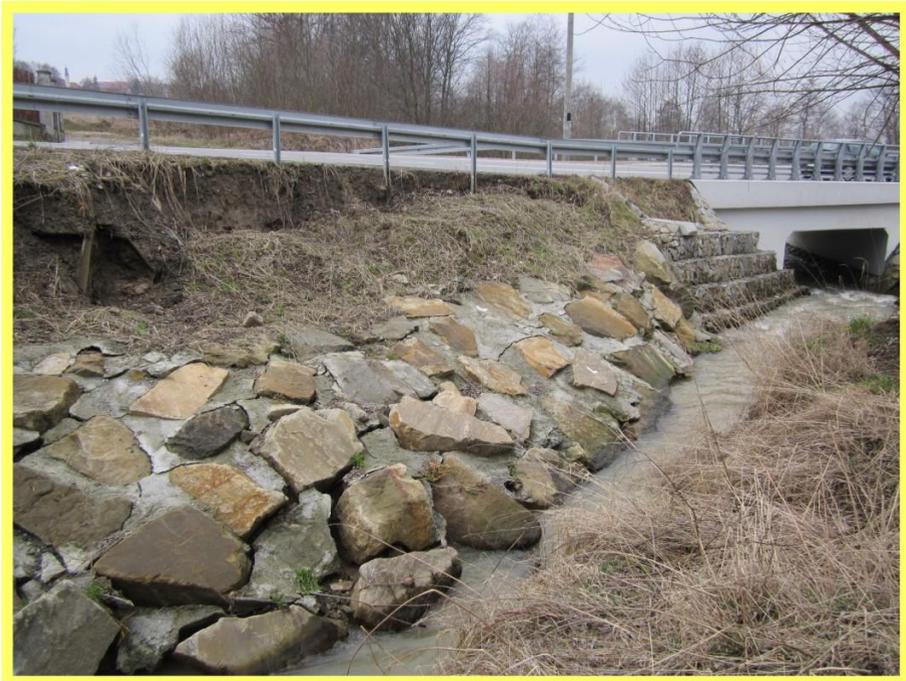
In the following year (2016) the improved protection was also gradually destroyed. Progressive failure of the bank is presented in fig. below.

Fig. 5 The view of damages that occurred after the second year of exploitation from the upstream side

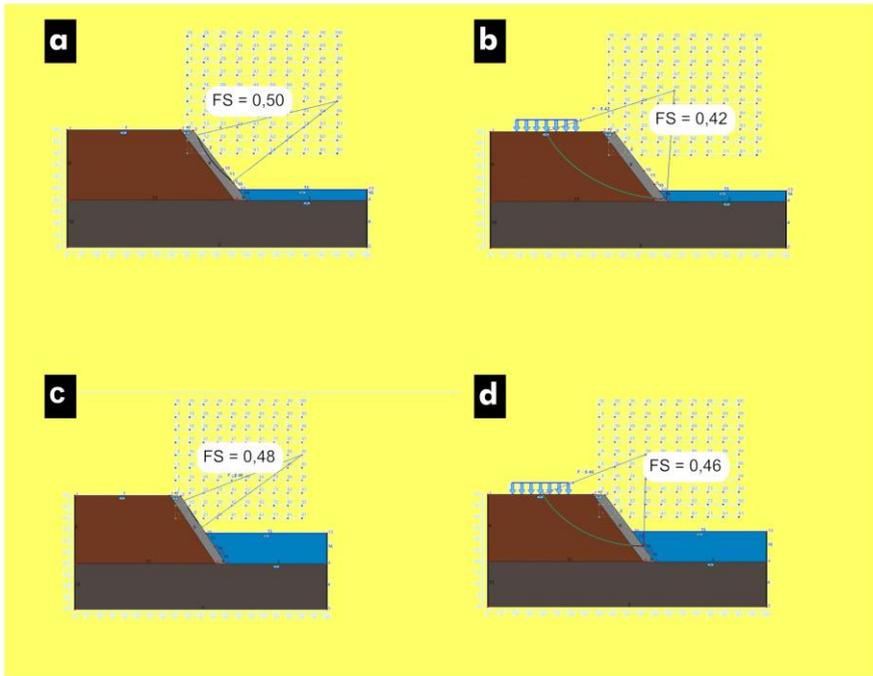
Fig. 6 Calculation scheme for the first model – at low water level a) without any load, b) vertical load of 1000 kN. Calculation scheme for the second model – at high water level c) without any load, d) vertical load of 1000 kN

Scheme presented in Fig. 6a shows the results of calculations at low water level – parameters of the soil (Tab. 1) and geometry of the slope resulted in the value of the global stability factor of safety at 0.50.

Apart from total saturation of the slope, the scheme in Fig. 6b assumes that there is a heavy transport vehicle on the top of the road, which was presented on the scheme as vertical load of 1000 kN. The factor of safety is 0.42. Failure surface goes deeply into the road.

When the water level is high (Fig. 6 c,d) the values of the factor of safety do not differ significantly from the first model. Adequately it was 0.48 for the road without any load and 0.46 when there is a surface load of 1000 kN.

All obtained results of the factor of safety are below the limit value of 1.0 (Tab. 2). When the water level is low it undermines the base of the slope and at the same time the water filtrates through the ground from the opposite side of the road embankment. During the low and medium flow, in the hole scour, the average values of velocity at measurement points were in range from $V = 0,210$ m/s to $V = 0,333$ m/s. The maximum values at vertical measurements points were equal from $V = 0,223$ m/s to $V = 0,370$ m/s. Then, the values measured above the river bed were in range from $V = 0,060$ m/s to $V = 0,32$ m/s. The river bed is a natural drainage element for the adjacent area, so water supply to the river banks has to be taken into consideration [8, 9, 10]. When the water level is high the hydraulic pressure is compensated by the water pressure. Although another unfavourable phenomenon connected with water uplift pressure occurs (decrease in the value of density in the calculation scheme) [11, 12, 13]. It should also be noticed that high current velocity washes out and lifts the soil material.
