Vertical Displacement of the Surface Area over the Leakage to the Transverse salt Mine in 1992–2012

Tomasz Lipecki^{1,*}

¹ AGH University Science and Technology, Faculty of Mining Surveying and Environmental Engineering, A. Mickiewicza Av. 30, 30-059 Krakow, Poland

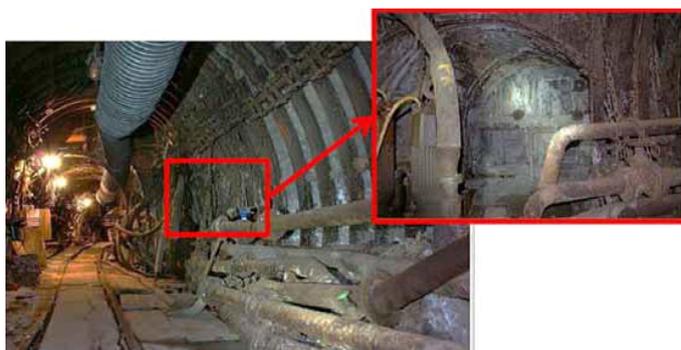
Fig. 2. Place of transverse leakage

Immediately, after the inflow was revealed, protective work was started, which was based not only on the execution of the dam but also on the drilling of wells [3, 5]. Observation wells and subsequent ones forming the so-anti-filter and injection barrier [4]. Due to the unsatisfactory effectiveness of these activities in 1993, the drainage holes of the dam were made and the rock injections were started by drilling around the transverse in the so-called. "Range". In total, 102 injection holes were drilled, including almost 2000 m³ of mortar ore. By the year 2000, the outflow stabilized at around 120 l/min, similarly saturated NaCl to about 3 g/l and insoluble (from 240 g/l to 10 g/l).

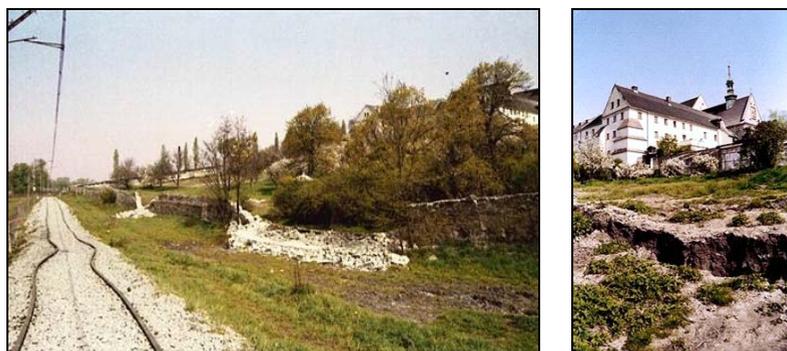
Fig. 3 Deformation of the track and destruction of the wall and cracking of the soil in the monastery's garden [4]

practically destroying level IX, which was eventually liquidated by flooding. Water flooding the mine also threatened the city located above the mine. As a result of the disaster, significant deformations occurred on the northern front of the mine, and after a spill in 1992, a subsidence of a 0.3 m drop was observed, which deepened at an extremely fast rate from day to day. The trough covered by its impact railways and threatened the buildings of the nearby monastery, eventually causing the wall to collapse. (Fig. 3). These spots are located north of the transverse front, which indicates the size of the area covered by the water inflow. Figure 4 shows the surface deformation in relation to the transverse run that is visible at the bottom of the picture.

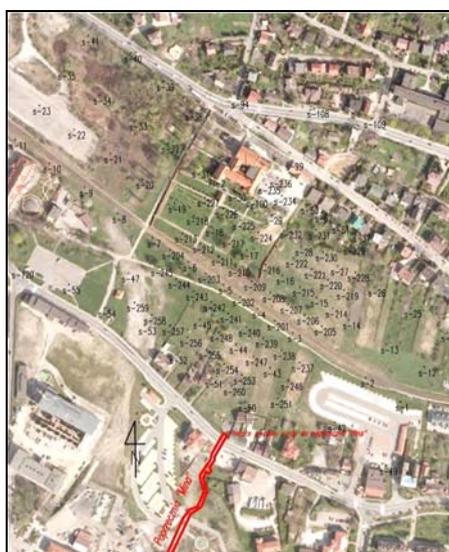
Fig. 4. Location of observation points of fallen trench along the course of transverse

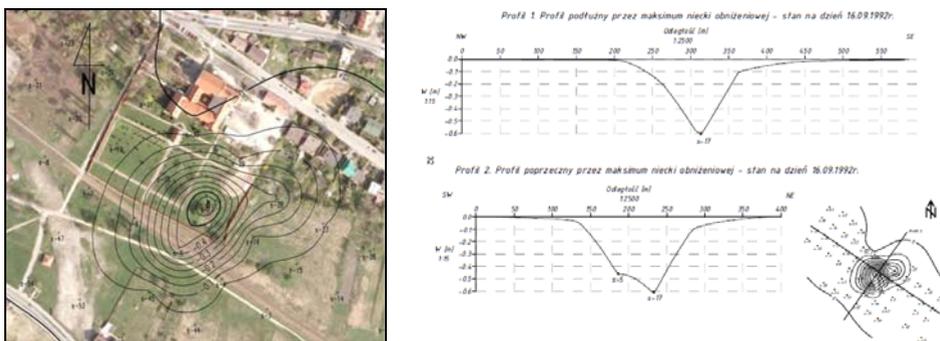
Initial measurements from June to September 1992 showed no significant changes in the surface area. Maximum reductions reached 22 mm in the two points of the observation network during that time. A sudden vertical displacement occurred at the beginning of September as a consequence of another rapid flooding of the water to the transverse, along with a large amount of rock material. The largest subsidence within 4 days reached almost 40 cm, and in the following week increased by another 21 cm. The situation of the depression formed at that time is shown in Figure 5. The reduction covered almost 3 ha and its volume amounted to over 3,800 m³, which gives an idea of the amount of material displaced in the transverse region.

Fig. 5. Subsidence basin –September 1992

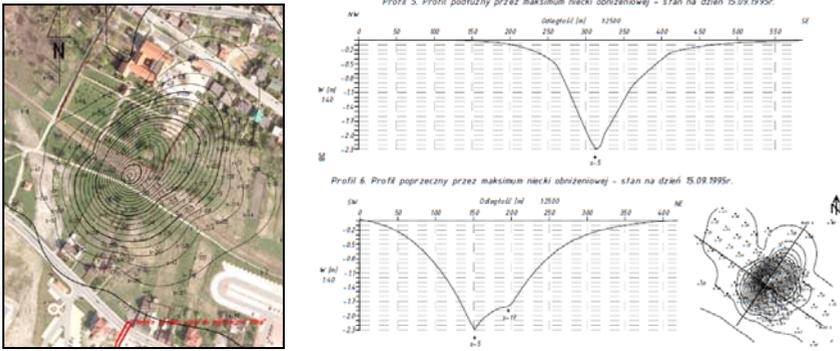
At the end of April 1993 there was another sudden spill, causing the trough to deepen to 2 m. After this incident the area was settling at an uneven speed until the end of 1994, when it was mastered and the leak was closed. The map below (Fig. 6) shows the state of deformation in 1995, after mastering the leakage. The trough covers an area of almost 8 hectares and its volume reaches 30000 m³. The largest decreases occur all the time at the same point of the observation network, reaching the value of 2.3 m. The comparison of the spatial shapes of the basin from 1992 and 1995, when recorded its greatest development, is presented in Figure 7.

Fig. 6. Subsidence basin – state for 1995, after mastering the leak

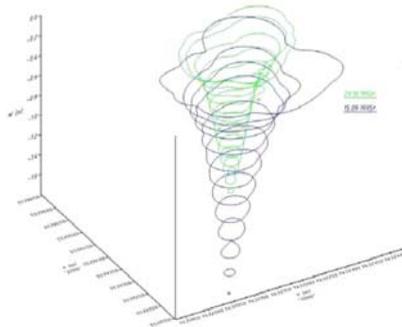
Fig. 7. The development of the subsidence basin in 1992–1995

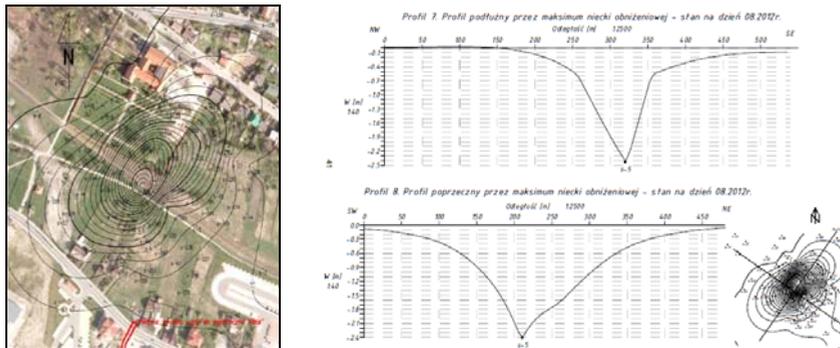
Figure 8 shows the state of the subsidence basins of the 2012 subsidence. Long-term and slow summation of the reductions has led to the expansion of the basin to more than 12.5 hectares and its volume has increased to almost 37,000 m³. The center of the basin has decreased by an estimate of about 2.4 m (unfortunately the point of the network has been damaged).

Fig. 8. Subsidence basin – August 2012

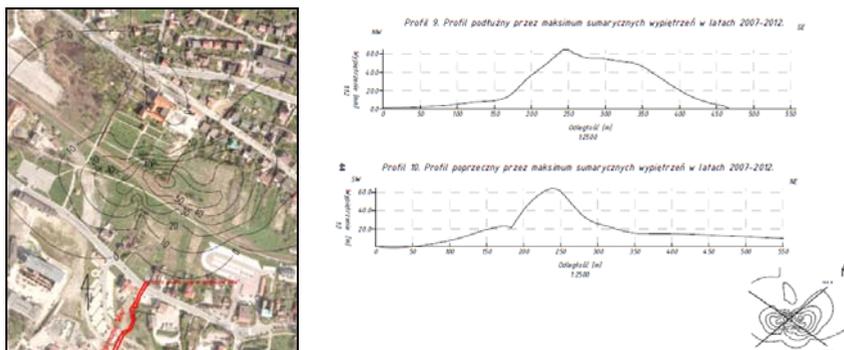
The 2012 series did not show any real reductions compared to 2011, but began to observe, since 2007, a few millimeters uplifts, significant from the point of the accuracy of the

observations. It has been reported even in the years 2007–2008 that the uprising reached up to 20 mm. This is probably due to the rebuilding of the water column in the ground, after the water has completely stopped draining from the front of the transverse dam [9]. The following years of observations confirmed the revealed tendency to rise at an average of several mm per year in the discussed area. On the map shown in Figure 9, the summary uplifts from 2007 to 2012 are shown, reaching up to 50–70 mm, which suggests that the average annual value of the uplifts oscillates within 10 mm/year. The centers of reductions and uplifts initially overlapped, but later the maximum uplift shifted north.

Fig. 9. Uplifts recorded in the period 2007–2012

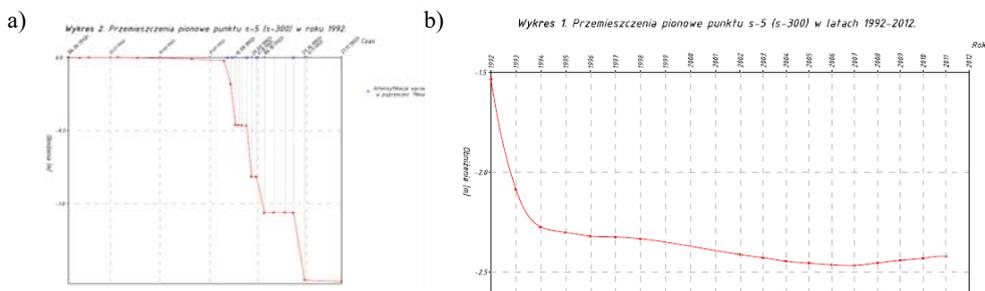
The nature of elevation changes can be shown not only on the basis of surface analysis. Very good dynamics of changes are reflected in the graphs, that show the behavior of individual points of the research network. The first period, when catastrophic changes occurred (1992), presents a graph of changes in the height of one of the points shown in Figure 10a, and 10b presents the reductions over the period of 20 years (1992–2012). On the first one, there is a visible, instantaneous process of revealed deformation, however after this period, the reductions take a character similar to the curve striving for, almost asymptotically, zero altitude changes. The end of this curve is again increasing and as mentioned before, it presents the process of upliftment, which as you can see, is not a random phenomenon.

Fig. 10. The dynamics of reduction points in 1992 (a) and during the period 1992 to 2012 (b)
