Morphodynamic effects of stone and wooden groynes in a restored river reach

Abstract. Restoration works on an 11 km long reach of the Spree River near Cottbus in Germany were accomplished in 2014. The overall objective was to improve the biodiversity, changing the morphological structure from a straight single-thread river to a braiding one with reshaped thalweg, and creating zones with varying flow velocities required for fish spawning. Several interventions were made, among which also two types of groynes were constructed along the reach: impermeable stone groynes, with an inclined crest so that only the tip is typically submerged during normal flow conditions, and wooden groynes made of several large trunks, which are mainly submerged at normal flow conditions. To compare local morphodynamic effects caused by the different types, flow velocities and bed topography were measured at distances of 12 m upstream and 16 m downstream of two selected groynes. The vertical profile was captured by measuring at five levels above the bed. Bed material was sampled at several locations around the groynes. The analysis of the measurements showed the effect of each groyne type on the flow velo

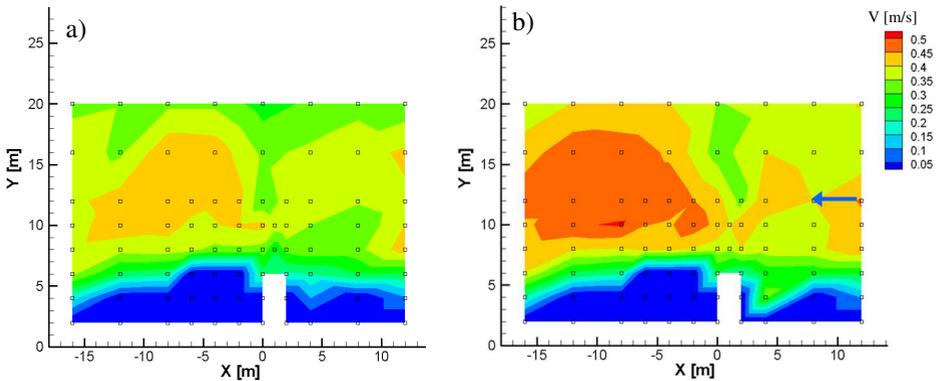
The velocity distribution at the stone groyne is shown in Fig. 4, for two different levels above the bottom, corresponding to 20 and 40% of the water depth. Due to the presence of the groyne, the velocities close to the left bank were significantly reduced. The maximum velocity zone was not centred but shifted slightly towards the right bank. Stagnant water zones upstream and downstream of the groyne were observed, with areas of return flow close to the groyne in the downstream direction. In the vicinity of the groyne the highest velocity was noted at the groyne tip.

Fig. 4. Plan view of the velocity distribution at the stone groyne at different levels above the bottom, (a) 20% and (b) 40% of the water depth.

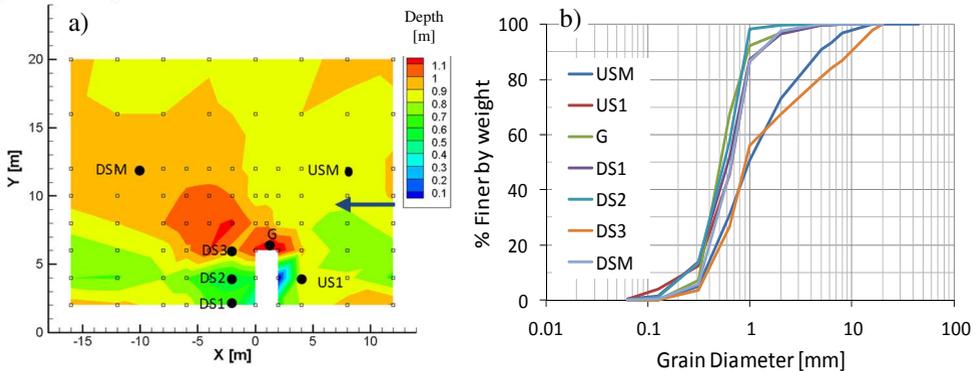
The effect of the stone groyne on the bed topography is presented in Fig. 5a. The maximum scour on the river bed was found at the groyne tip, which is typical for emerged structures (e.g. [9, 10]) whereas the scour develops at a distinct distance downstream of the tip for fully submerged structures, e.g. shallow groynes ([11]). The scour extended in the downstream direction for about 8 m. In addition to the scour, deposition areas were determined locally at the upstream side of the groyne, and in the lee side extending 5 m downstream of the groyne.

Fig. 5. (a) Bed topography with black filled circles for bed material sample locations, (b) bed material grain size distribution.

The bed material mainly consisted of medium and coarse sand with a mean grain size of $d_{50} = 0.6$ mm. Only at two locations coarser sediment was sampled. One location was in the middle of the river (USM), the other one in the scour downstream of the groyne tip (DS3).

As the second sample in the middle of the river (DSM) corresponded to the samples taken at the groyne, distinguishing between the middle of the river and the area close to the bank is not possible. Also up- and downstream of the groyne similar grain size distributions were found, and even in the scour at the groyne tip the bed material was not coarser than the average.

These inconsistencies can be explained by the fact, that small dunes consisting of medium to coarse sand were travelling over the surface made of the coarser sediment shown in Fig. 5b.

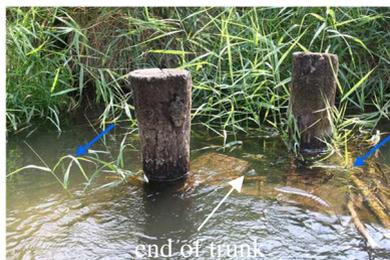
The wooden groyne consisted of several trunks arranged vertically allowing the flow to pass between the trunks. The trunks were fixed to wooden piles up- and downstream of the tip. The trunks were not attached to the bank (Fig. 6) and local bank erosion was observed between the bank and the trunk, allowing water to flow between the bank and the groyne toe. The structure was slightly submerged during the measurements (less than 10 cm under water in the middle of the groyne).

Fig. 6. Scour and flow at the wooden groyne toe.

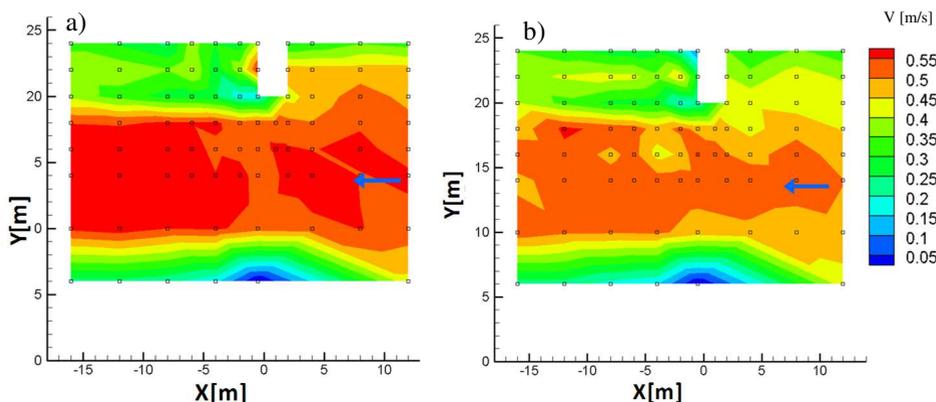
The configuration of the wooden groyne resulted in the flow pattern shown in Fig. 7. The velocities downstream of the groyne were reduced compared to the approaching flow upstream. Although the downstream velocities were reduced, no dead water zone or recirculating areas were noted. A similar scour at the groyne toe was noted for shallow groynes [13], which was attributed to overtopping of the structure. The low velocity zone on the left bank was caused by branches of a large tree which were hanging in the water.

Fig. 7. Velocity distribution at the wooden groyne at different levels above the bottom (a) 80% and (b) 40% of the water depth.

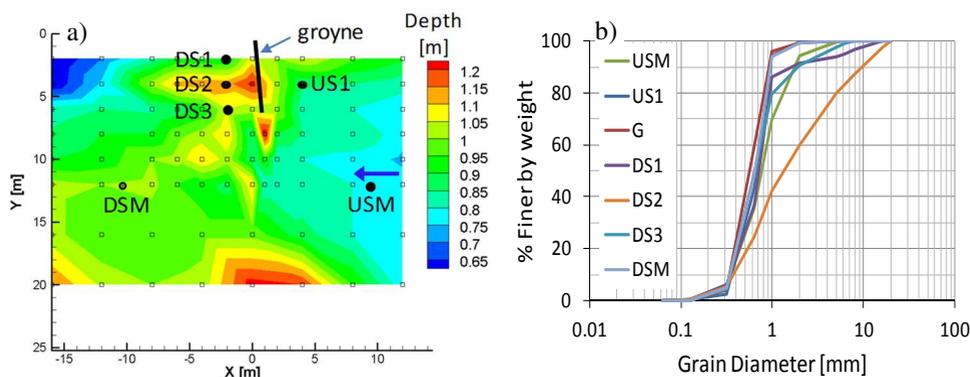
Fig. 8 shows the bed topography. The presence of the wooden groyne resulted in two scour areas around the groyne (Fig. 8a). One scour area was found at the groyne tip and a second larger scour zone was noted around the mid section of the groyne. The second scour started around 1 m upstream of the groyne and extended for about 6 m downstream of it. The depth of the scour at the middle of the groyne was almost the same of the one at the groyne tip. A deposition area was found 12 m downstream of the groyne. The large scour area at the right bank was caused by the aforementioned branches of the large tree.

The analysis of the bed material showed that upstream of the groyne at US1, and at the groyne tip, the bed consists of fine sand (Fig. 8b). The coarsest bed material was found at DS2 in the middle of the scour downstream of the groyne. The composition of the fine

Fig. 8. (a) Bed topography with black filled circles for bed material sample location and (b) bed material grain size distribution.
