Analysis of the possibilities for improvement of thermal comfort of living quarters located in multi-family large-panel prefabricated buildings

Konrad Podawca^{1,*}, Agata Pawłat-Zawrzykraj¹, and Marek Dohojda¹

¹Warsaw University of Life Sciences -SGGW, Faculty of Civil and Environmental Engineering, Department of Civil Engineering, Nowoursynowska 159, 02-776 Warsaw, Poland

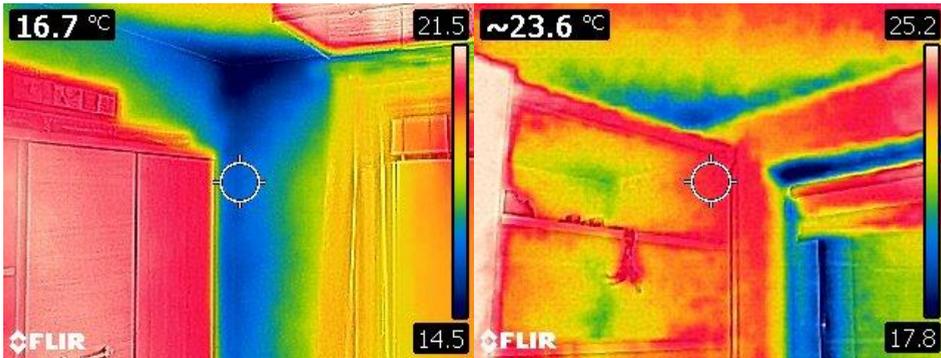
Fig. 2. Thermal image of the corner of the east gable wall south external wall and the ceiling (own elaboration).

- Before thermal modernization, the gable wall did not provide sufficient thermal insulation ($U = 0.646$), temperature differences registered between the surface of the walls, their edges and ceiling were even above 14°C , which clearly indicates errors in the construction of the object, probably due to discontinuity or degradation of the insulation material at ventilated flat roof, in the wall-ceiling connection, on the eastern and gable walls as well as on the corner of external, south and east walls;

- Renovation of the flat and thermal modernization of the gable wall excluding thermal modernization of the flat roof, resulted in limited success - very low temperatures registered in the east corner, between the east and south walls and ceiling are the best evidence;

- Thermovision measurements have clearly indicated spots with reduced temperature, especially in joints between prefabricated wall panels or such walls and ceiling panels;

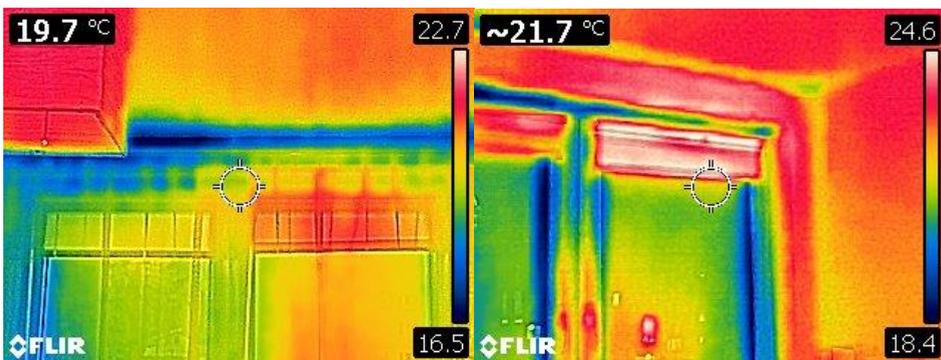
Fig. 3. Thermal image for the joint of the external south wall and the flat roof before and after applying Eurothane G panels (own elaboration).

- Internal insulation of the east and south walls with Eurothane G panels moved the edge connecting the wall and flat roof 3 cms towards the interior of the room, which increased the surface temperature in this place by about 2.5°C ; it is a small value compared to the increase of temperature on the surface around windows and on fragments of walls with Eurothane G panel (over 4°C);

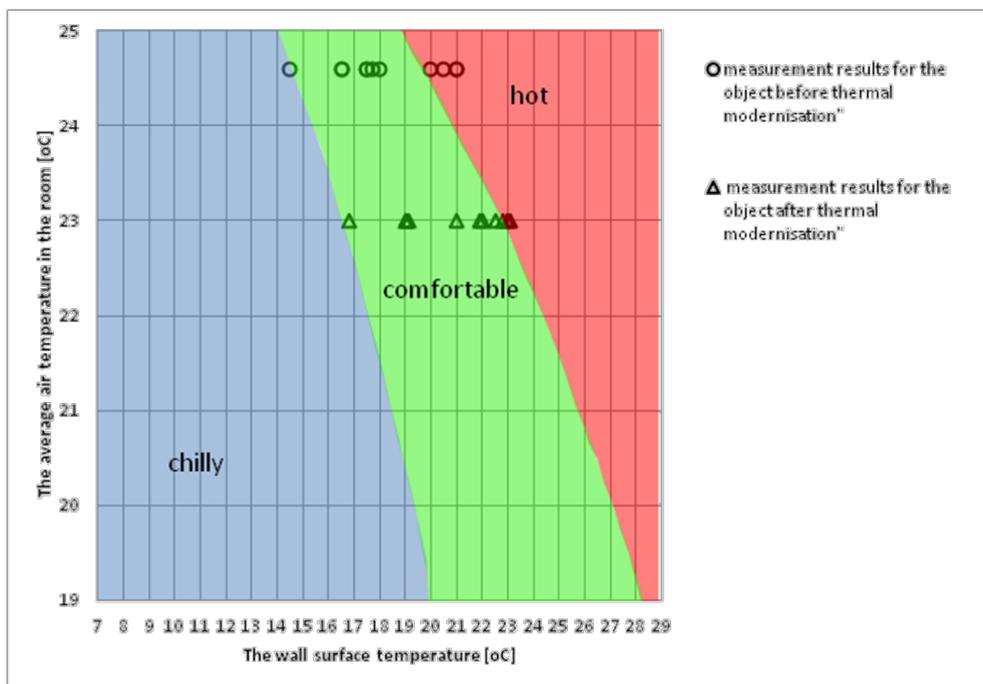
- Irrespective of the existing mistakes introduced during the construction of the multi-family building, renovation of the room and thermal modernization of the building brought significant changes in individual measurement results of wall, ceiling and floor surface temperature in the tested room, thus improving the thermal perception by its residents with less intensive heating requirements;

Fig. 4. Heating comfort in the analysed room, 1–11 measurement points according to the Table 3, ○ – before thermal modernisation, △ – after thermal modernization (own elaboration).
