The problem of stabilization of landslides in glaciotectonically disturbed areas. Case study: road engineering structure

Urszula Kołodziejczyk¹, Jakub Kostecki^{1,}, Agnieszka Gontaszewska-Piekarz¹, Adam Wysokowski¹*

¹ University of Zielona Góra, Faculty of Civil Engineering, Architecture and Environmental Engineering; 15 Prof. Szafrana St., 65-516 Zielona Góra, Poland

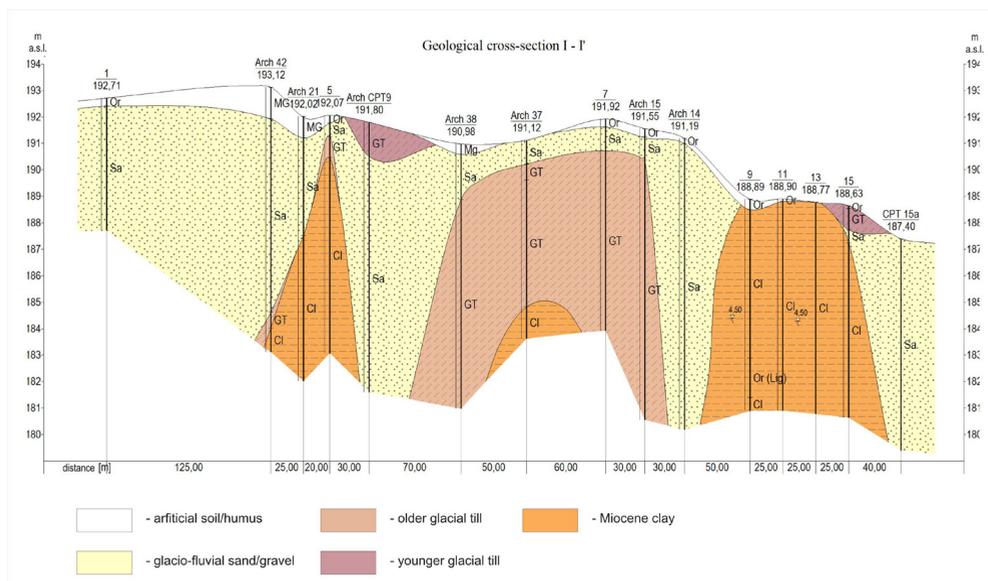
During the construction of the Wilkanowo bypass, the Geoprojekt company from Poznań prepared documents in 2005 [17], which indicated that the geological structure of the area consisted of Pleistocene sandy-clay sediments of glacial (gQp) and fluvioglacial (fgQp) origin and Tertiary (LLTr) cohesive formations, and that the area under research was characterized by strong glaciectonic disturbances. They were formed as continuous deformations, including anticlines or diapirs elevated over 20 m, as well as numerous discontinuous deformations, such as scales and seismic faults.

Fig. 2. Geological and engineering cross-section of the Wilkanowo bypass.

The hydrogeological conditions of the area analysed are very complicated and determined by glacitectonic disturbances. Underground water was found in only 4 archival drillings, mainly in the form of oozes. The geological structure of the area was presented in a geological and engineering cross-section (Fig. 2).

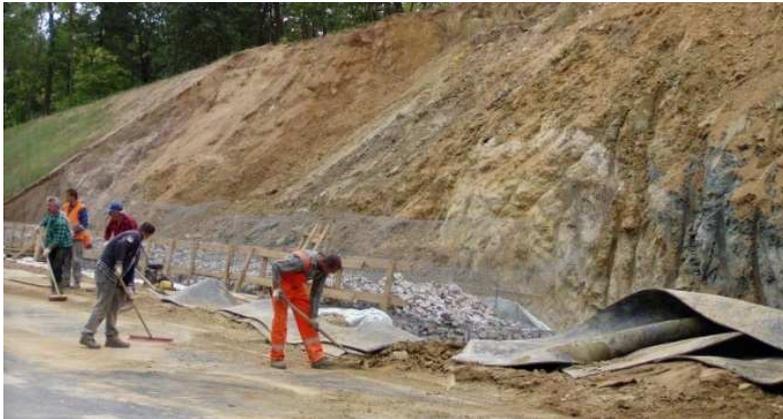
Despite the known, complicated soil conditions, the Wilkanowo bypass was designed and built with high (up to 8.0 m) and very steep slopes (up to 45°). As early as during the road excavations, strong erosion processes caused by the migration of rainwater into the rock mass and glacitectonic deformations were revealed (Photo 1).

The cohesive soils were much brecciated, which indicated intense glacitectonic deformations in this area and changes in soil stresses caused by multiple ice sheet pressure, and also by relieving the soil after the excavations. This phenomenon was particularly intensified in the areas where hydrated sands slipped over the clay substrate.

Photo 1. Glacitectonic structures revealed during the road excavations (U. Kołodziejczyk, 2005).

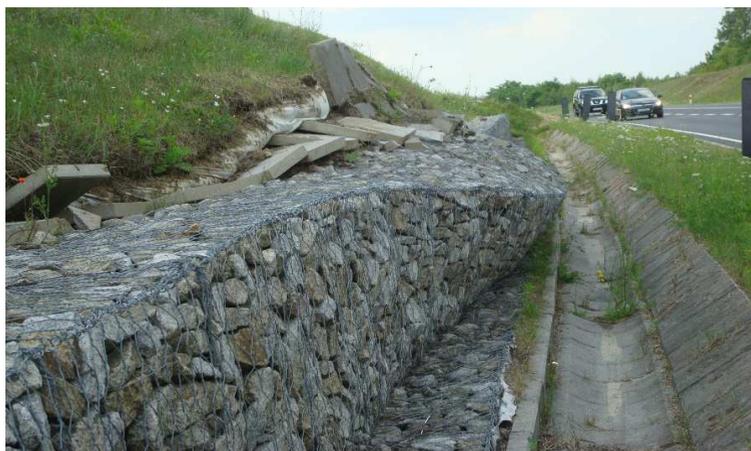
The use of the road caused further landslides. Soil thixotropy and the weight of heavy vehicles led to further landslide movements. Retaining walls and gabions were used for temporary protection, as well as slope and surface drains.

However, such methods as soil exchange and changing hill geometry were not used, despite the lack of objections from the owners of the nearby lands (the Regional Directorate of the State Forests in Zielona Góra) to the purchase of the land adjacent to the road strip. The results were soon to be seen.

In the years 2011-2012, further modernization work was carried out, including modernization of the slopes and removal of the abovementioned humps. During that work numerous water channels appeared. In 2013 the slope strengthened in 2006 collapsed again (Photo 2).

Photo 2. Damage of the retaining wall structure built in 2006 (U. Kołodziejczyk, 2013).

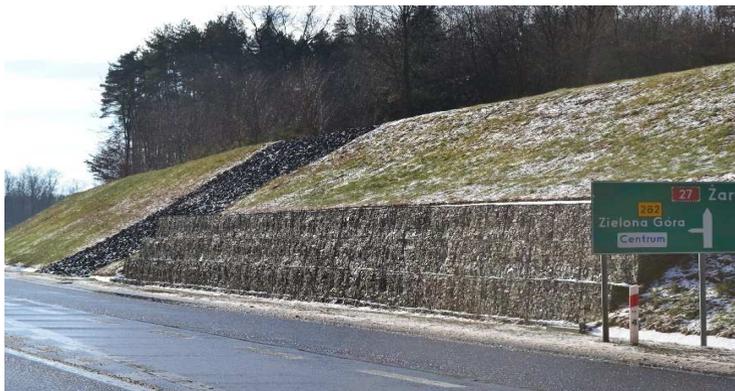
Photo 3. View of reconstructed retaining wall and the slope, damaged in 2013 (M. Hudak, 2017).

In 2017, thorough work was done to secure the landslides on the Wilkanowo bypass [22]. The work included: removing the soil from the area of the existing slides and landslides, making steps in the slopes, restoring the damaged sections of the retaining structures with gabions, rebuilding or securing the existing drainage systems of the road

excavation slope, laying out separation and filtration geotextiles, rebuilding the slope with crushed aggregate - crushed stone and adding an external 0.3 m thick layer of the slope façade from crushed aggregate. The results of the work can be seen today (Photo 3). Time will tell how effective they are.
