The displacement of structures founded on expansive soils – unapparent causes

The article presents the method of diagnostics of structures, located on expansive soil in Bydgoszcz (Poland). The methodology and preliminary results of the measurement of displacements of a investigated construction were presented. On the basis of these results, the actual causes of damage to the diagnosed structure were analysed.

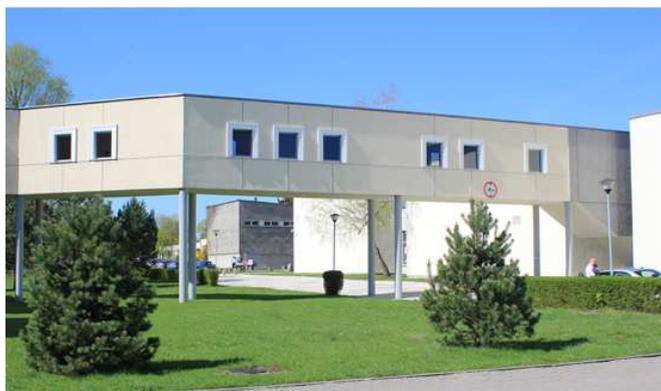
Fig. 1. The investigated structure.

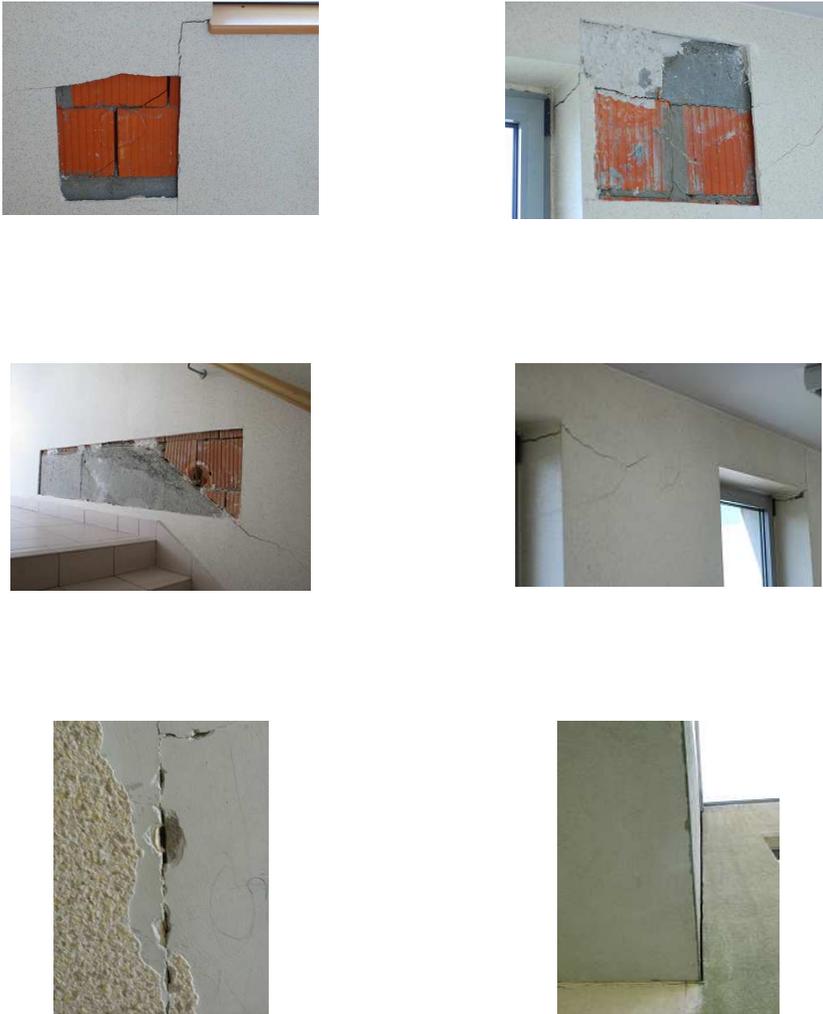
Since completion of the construction process in 2000-2001, and despite ongoing repairs, it showed increasing damage, the highest in the first years of use. In 2016, the technical condition of the facility was assessed. The largest cracking and delamination was noted on the inner layer made of plasterboard (Fig.2). In the exposed areas, made in the places with the greatest damage to the plasterboard, the reinforced concrete structure (pillars, downstand beams and slabs in the floor level) showed no serious damage. Clearly visible was some horizontal delamination at the junction of the beams with brick wall filling and cracking of the wall structure, both along the joints as well as through the brick. There were also cracks in the ceiling, running over the contacts of the prefabricated slabs. The damages, however, do not endanger the safety of the structure. After repairs that were carried out in 2016, the further development of internal cracks in the plasterboard panels is observed, indicating further work to the structure. In addition, damage was found in the dilatation zone, where the passage way connected to the building both join.

Fig. 2. Damage to the investigated structure.

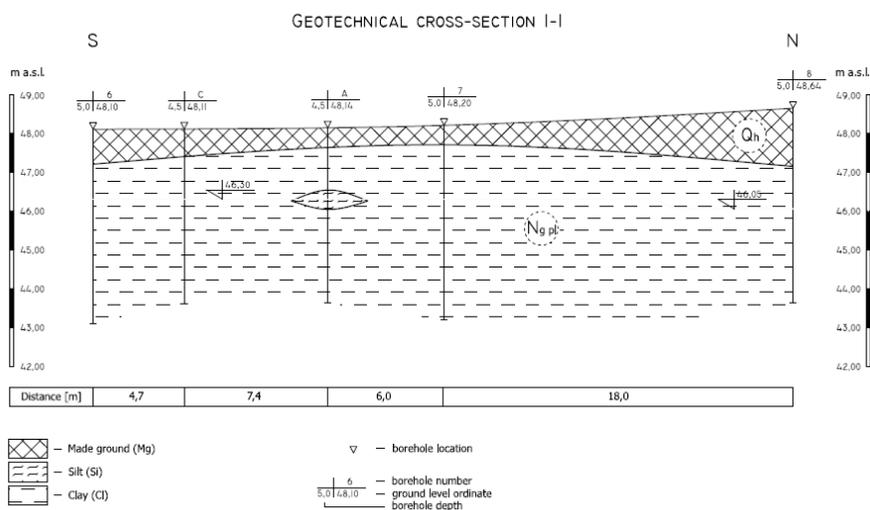
Analyzing the progress of damage, attention was first drawn to the occurrence of geotechnical reasons. In the foundations level of the overhead expansive clays were found. These are clays representing the geological Poznań series, common for Bydgoszcz subsoil, which are characterized by high expansion (Tab.1).

Fig. 3. Profile of subsoil under the overhead passage.

The reasons for damage to the construction, in relation to the expansive subsoil, were derived from the fact that dozens of poplars grew under the passage. As research, which was carried out a few years from construction has shown, poplars could cause local shrinkage and settlements of the ground, due to the low water content of expansive clay. The trees were then prophylactically removed. In addition, there is a water supply and sewerage network near the foundation of the passage, which could have an influence on the moisture in subsoil.
