An environmental impact on the condition of an unfinished building in the OWT technology

Michał Baszeń^{1,*} and Czesław Miedziałowski¹

¹Białystok University of Technology, Department of Geology and Structural Engineering, 15-351 Białystok, Wiejska str 45E, Poland

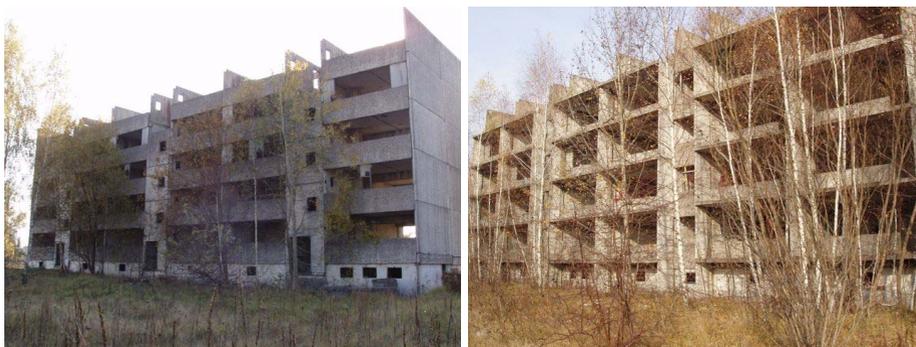
From the moment of stopping assembling works the analyzed building remained unused without the roof covering, window and door carpentry. The current state of the building is shown in Figure 1.

Fig. 1. Analyzed OWT building: front view (left); rear view (right).

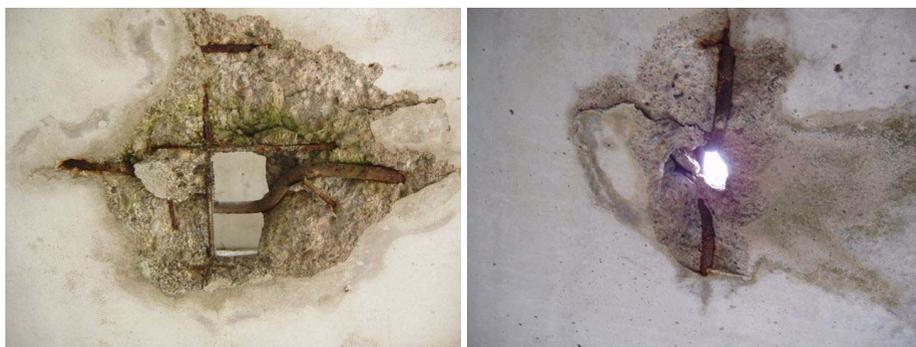
Long-term environmental impacts on the building structure caused significant damage of the construction elements [11]. Precipitation caused the accumulation of water on the surface of the floor element of the last storey. It caused the infiltration of moisture into the concrete and contributed to the corrosion of the surface layer but also to the destruction of concrete on the entire thickness of floor slab, which is shown in Figure 2. These phenomena were intensified by the temperature change from positive to negative values.

Fig. 2. Degradation of concrete in floor elements.

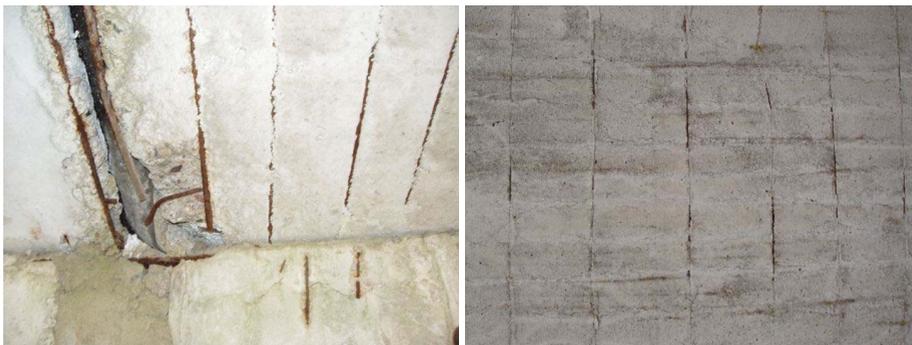
Atmospheric interactions affected not only the structural elements embedded into last storey. Concrete degradation appeared also on wall and floor elements of lower storeys. The influence of moisture and temperature changes led to the destruction of the concrete cover, exposure of the reinforcement and finally to corrosion of steel bars, as shown in Figure 3.

Fig. 3. Corrosion of reinforcement steel in floor element (left) and wall element (right).

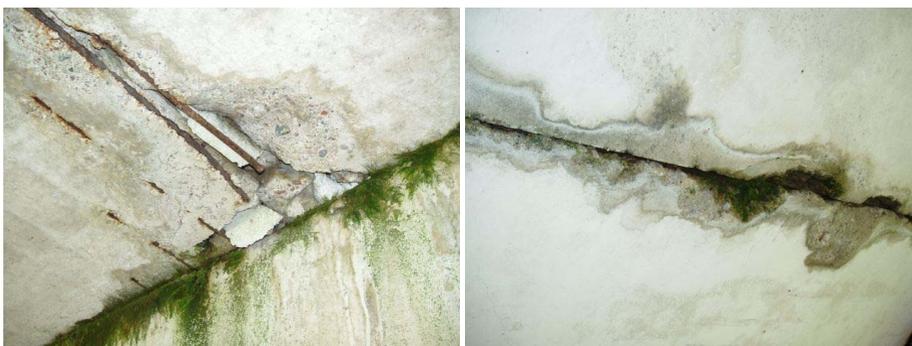
Moisture caused by rainfall and high temperatures in the summer meant that it was possible for various types of lichens and mosses on structural elements to grow, shown in Figure 4. In addition, traces of mold are noticeable in shaded areas like the corners of transverse and external walls, shown in Figure 5.

Fig. 4. Lichen and moss on contact area between: wall and floor (left); two floor elements (right).

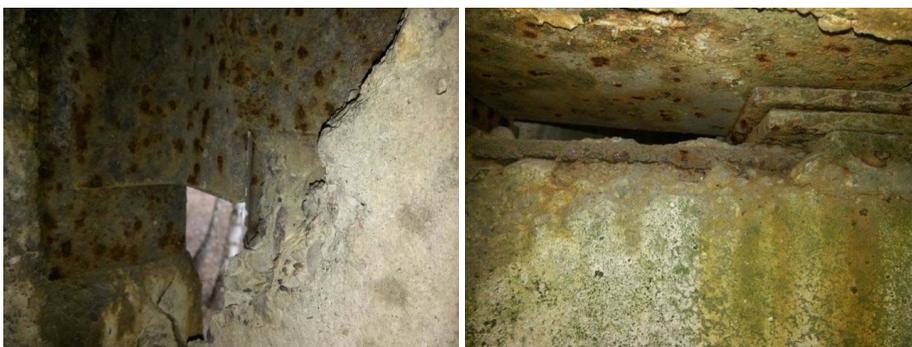
Fig. 5. Mold on joint (left) and structural elements (right).

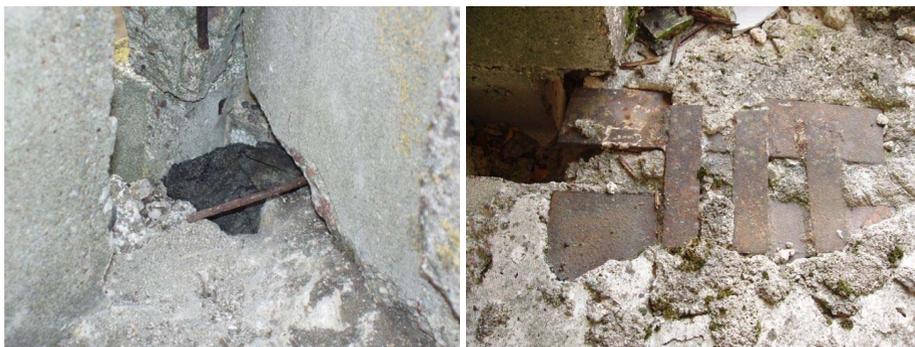
Precast slabs were made in an in-situ manufacturing factory that affects the quality of the structural elements. The low level of technical knowledge of the workers, the possible lack of supervision, and the problem of material supply caused the manner of the slabs' incorporation into the construction - and the realization of the connection didn't comply with the designed requirements. The quality of workmanship of the joints is shown in Figure 6.

Fig. 6. Connection: floor-to-external and transverse walls (left); floor-to-floor (right).

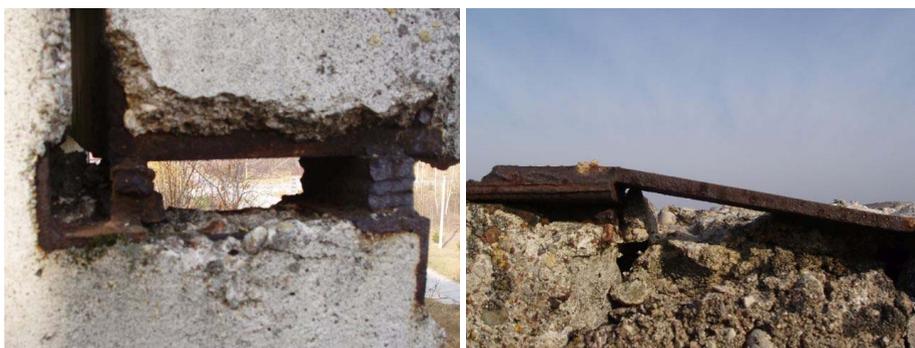
Difference in dimensions of the structural elements and lack of proper rectification disturbed the positioning of the incorporated elements. The top surface of the longitudinal and transverse walls were on different heights. It led to the need to bend the flat bars to make a connection with the steel hooks in the top surface of wall, shown in Figure 7 (right). Additionally the various types of flat bars were used and the lengths of the welded connections were shorter than necessary. In the case of the connection of transverse and external walls, the additional flat bars were used to provide the horizontal orientation of the external element of the construction, shown in Figure 7 (left).

Fig. 7. View of joints: external-to-transverse wall (left); transverse-to-longitudinal wall (right).

The above presented implementation errors caused the joint to be made incorrectly contrary to the system requirements. Empty spaces appearing between connected structural elements were filled by dry-mortar and additional materials achieved on the site. That situation led to free access of moisture to the interior of the junction and caused the

corrosion of steel elements. Other effects of improper joint construction were the rising of mortar and crumbling of the concrete which finally weakened the load capacity of the joint.

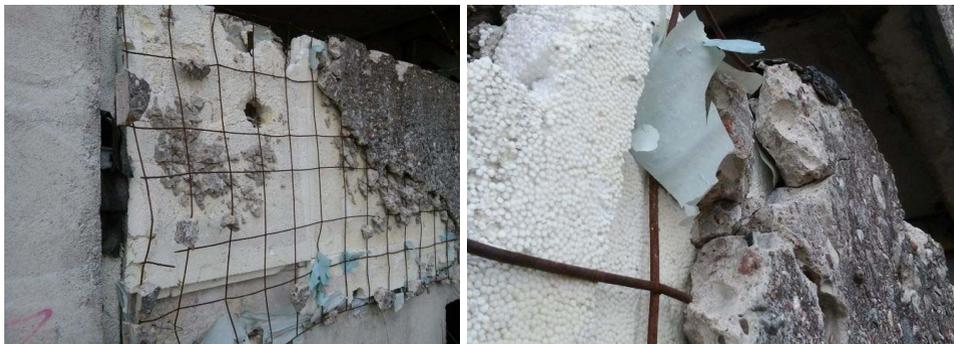
As with any other system, besides the advantages, the OWT technology also had disadvantages. One of them was the method of construction of the façade layer in external wall elements and connection of the cladding with the load bearing part of the external wall. Hooks, anchoring the façade layer with the load bearing layer of wall, were destroyed due to an increase of the stress in the steel [12] as well as the access of the moisture. Similar situation occurred in the case of reinforcement of the façade layer in form of a grid of the steel rods. Due to the lack of concrete cover the reinforcements were often located directly at the layer of insulation, as presented in Figure 8.

Fig. 8. Degradation of façade cladding in external wall.
