Damage Analysis of Moldboard Plow

Abstract. Moldboard plow is a tool used to cultivate the agricultural land. The material of the moldboard is a double layer where the outer layer is high carbon steel and the inside is a low carbon steel. The findings on the side edge of the moldboard plow are often damaged due to bent deformation and then broken. The study was conducted to determine the cause of the damage through simulation and testing laboratory. The simulation results show that the moldboard is overloaded by its material capability. This is shown also from the results of testing the chemical composition that this material is a low-alloy steel single layer without surface hardening. Hardness tests conducted using Rockwell C show that this steel has a tensile strength of only about 400 MPa. This is reinforced by the results of microstructural observations showing that more than 99% of the phases are ferrite.

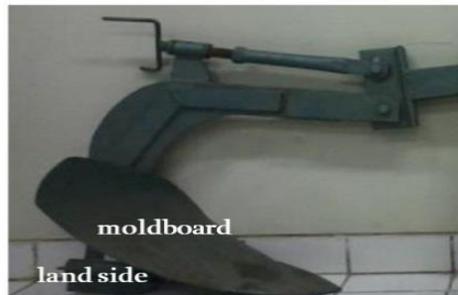
Fig. 2. The bottom of moldboard plow

Currently, multiple moldboard plows are used as shown in Figure 1 (a) and (b) show the bottom of the moldboard plow. The edge of the moldboard is the most easily cracked, broken, or deformed plastic part.

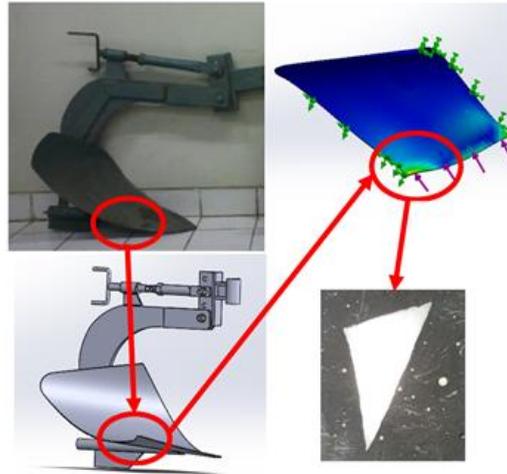
Fig. 5. The stress simulation of moldboard plow

From simulation shown that the critical area is at the edge tip in the corner. This area gets greater stress than other areas i.e. 713 MPa. While tensile strength material is 403 MPa.

The result of the stress analysis simulation is that the load received during the plowing process is greater than the tensile strength of the material. This suggests that the material is very susceptible to plastic deformation which will cause a deformation. Hence, moldboard material will easily experience cracks that cause damage.

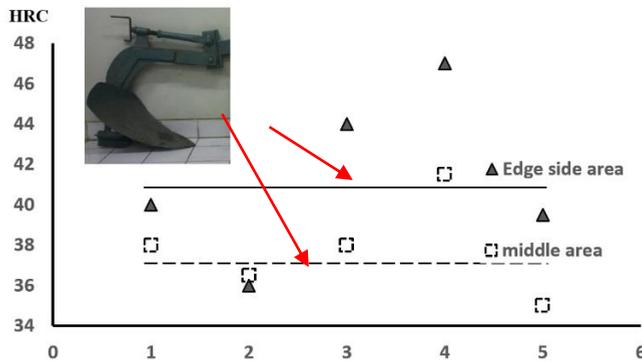
Fig. 6. Hardness graph by position tested

The graph in Figure 4 indicates that the average of the harness in the middle moldboard 37.8 HRC and in the edge side 41.3 HRC. The difference of the hardness value between that area is not very significant.

Hardness test by Rockwell C shows that material has low HRC value i.e. 35 to 47. It is mean that tensile strength moldboard material only around 400 MPa. This reality has shown that why the moldboard easy to be damaged.

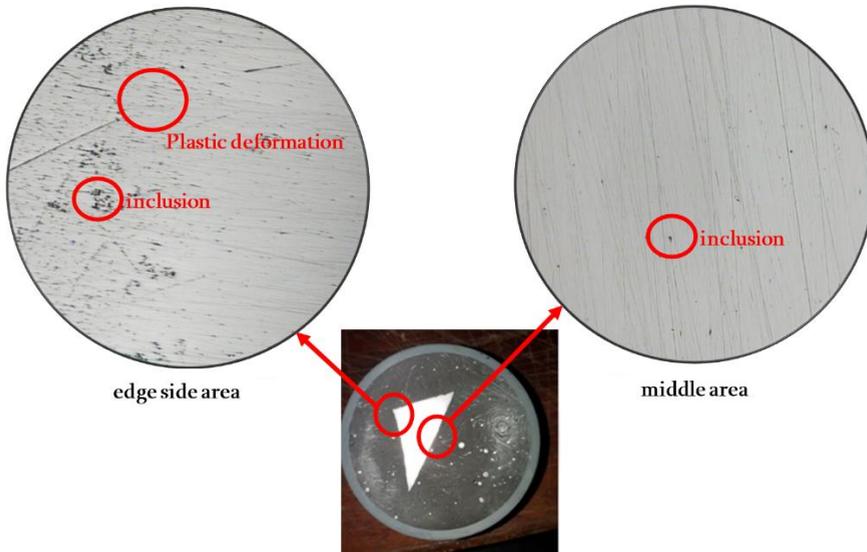
Fig. 7. The microstructure of the non-etch specimen, magnification 200x There are many inclusions and plastic deformation in the edge side more than in the middle side.

Non-etch microstructure analysis indicates that the edge side has inclusions denser than at the middle area. In the edge side area, inclusions are concentrate in many places. The inclusions inside to the moldboard material by diffusion from soil during plowing process. Meanwhile, impact forces from soil and matters contained in it cause plastic deformation in the edge side of the moldboard.

In the center of the moldboard, inclusion is not as much on the edge. This is because the interaction between the material and the surrounding soil is not accompanied by impact force at the edge side. Hence, the plastic deformation experienced is also not so great. However, it appears that the scratches on the surface of the specimen are due to the presence of manganese that forms the martensite phase.

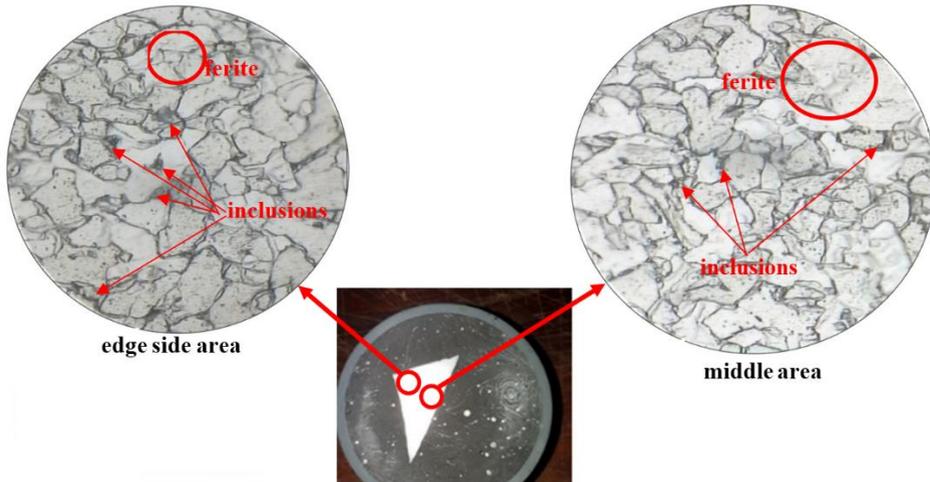
Fig. 8. Phase structure in moldboard material indicate inclusions and ferrite in a different size, magnification 1000x

Inclusion is more dense on the edge of the moldboard than in the middle area. inclusion on the edge of the moldboard is more dense and more than in the middle area. In addition, the ferrite grain size is smaller because it is influenced by the moldboard manufacturing process.

Microstructure feature reveals that grain size on the edge side is little than the middle area. this show that the hardness value in the edge side slightly higher than in the middle.

The cause of the damage is because the composition of carbon is too low and on the outside surface is not done heat treatment on the surface of the moldboard so that no martensite phase. should the material used to make the moldboard plow has been done the addition of carbon composition on the surface through carburization process that will form martensite phase plated outside the bottom plow.
