Research on Post Fire Detection and Evaluation of Liu Jiang the Yellow River Bridge

Abstract: After the bridge is damaged by fire, it is necessary to quickly probe the situation of the damaged structure, to take a response as soon as possible to ensure the safe passage of the bridge. A series of related work such as the component surface damage detection, carbonation depth, concrete strength testing and Axial compressive strength tested by core drilling combined with the analysis and calculation after fire had provided a basis for the safety assessment of structures. According to the results of the test and the conclusion of the finite element calculation, it was found that the bridge belongs to the dangerous situation, and the relevant strengthening measures should be taken.

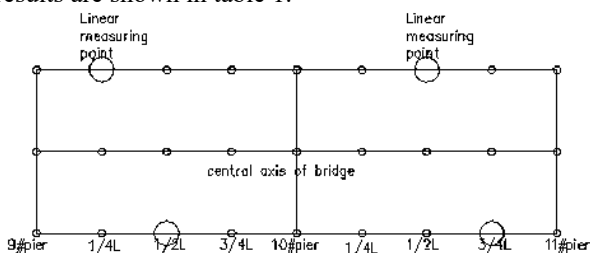
Fig. 1. Layout map of bridge alignment point.

The closed levelling measurement was executed according to two engineering levelling requirements. As shown in Figure 1, measuring points arrangement, test results are shown in table 1.

It can be seen from table 1 that the elevation distribution was basically straight line along the upstream- edge and downstream- edge but the middle axle position appeared a concave state which was due to the measured points located in the chiselled deck. In a cross section, the three points measured still maintained

a straight which basically coincided with the bridge cross slope. The results show that the bridge stiffness was basically not affected after the fire.
