Activity Characteristics and Safety distance of Gaoliying Ground Fissure in Beijing

Abstract. In all ground fissures in Beijing, Gaoliying Ground Fissure has characteristics of highly activity, and it cause serious damages on constructoins. With the distribution as well as the development of land subsidence and the change of the groundwater level, a series of work has been conducted to explain the mechanism of the formation of Gaoliying Ground Fissure. For example, field damage investigations and trench observations were used to define the affected distance of ground fissure; three-dimensional deformation was monitored to determine active characteristic of ground fissure. This paper points out that Gaoliying ground fissure is controlled by Huangzhuang-Gaoliying Fault, which mainly moves in the vertical direction. The rapid decrease of the ground water level greatly increases the development of ground fissure. The distance of damaged zones affected by ground fissure in the hanging-wall of the fault reaches 49.5m, and the distance of damaged zones in the footwall of the fault is 17.5 m. A suggested safety distance of type-one and type-two buildings is 100 m. For type-three buildings

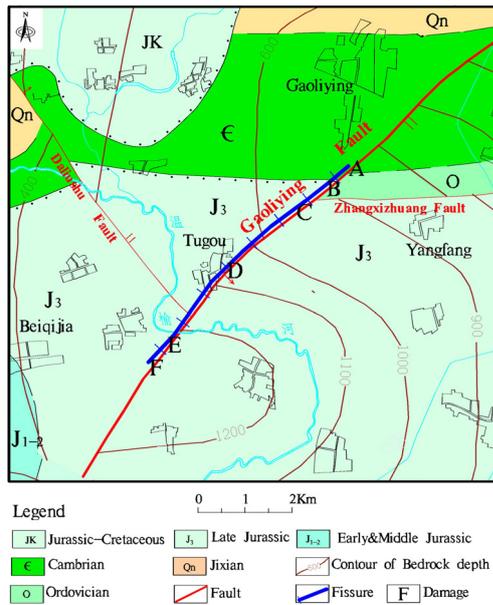
Fig. 2. Distribution of Gaoliying ground fissure and fault.

Gaoliying ground fissure was firstly found in the 1990s. This ground fissure starts from Baxianzhuang Villa and ends to Gaoliying School. It goes along the north-east direction and pass through Tugou village, Tangzitou village, and Xiwanglu village (see fig. 1 and fig 2).

As shown in fig. 2, The total length of Gaoliying ground fissure is close to 7km. Damages on the surface reveal that the ground fissure mainly moves in the vertical direction. The right part (the south-east side of the terrain) of the fissure has a relative downward trend. The largest steep slope on the surface is 53 cm in the woodland on the north side of Tangzitou Village.

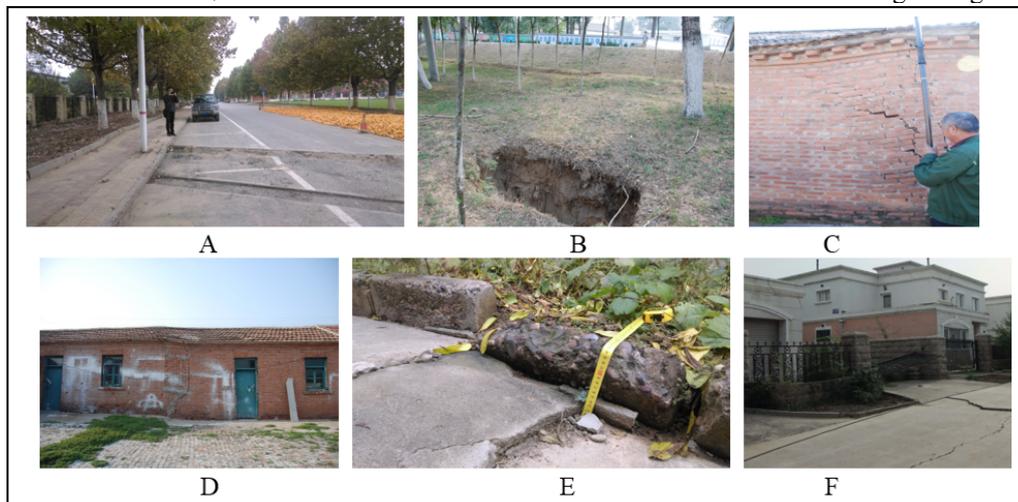
Fig. 3. Typical pictures of damages caused by Gaoliying ground fissure.

Fig. 3 shows five typical pictures of damages caused by Gaoliying Ground Fissure.

The farmhouse in fig. 3C was constructed in 1970 and deconstructed in 2012. The extension direction of the ground fissure is north-east 75° (NE75°). As illustrated, the wall of the farmhouse was seriously distorted like a dough. Vertical deformation and numbers of cracks distributed from top to bottom. Measurements indicated the height of the right wall (the wall in the hanging-wall side of the fissure) is 18.6 cm lower

than the height of the wall in the left side. The deformation rate of the height of the wall in the right side is 4.7 mm/a, whereas the deformation rate is much smaller in the left side. The maximum distance between the fissure and the place where the deformation occurs is 19.5 m in the hanging-wall and 17.5 m in the footwall of the fissure.

The villa in fig. 3F was constructed in 1996 and unoccupied now. As shown, the pavement in front of the villa has been deformed as a result of the rise in the right side (the part in the hanging-wall of the fissure). The surface of the pavement has been destroyed by two main cracks. One crack extends to the surface of the yard of this villa, which has the same extension direction as the main ground fissure. The vertical subsidence in the hanging-wall of the fissure is 6.3 m with a deformation rate of 4.5 mm/a.

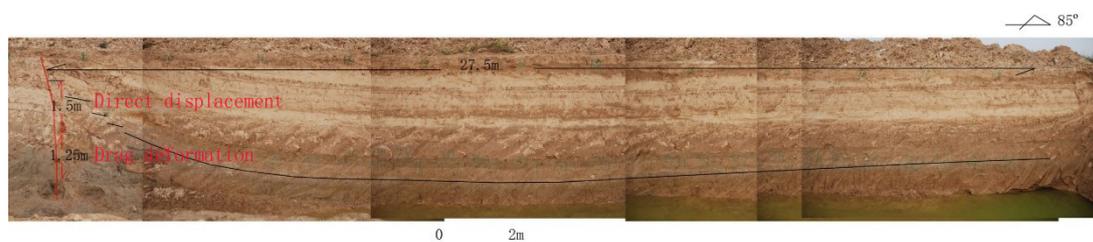
Fig. 4. Cross-section of TC11 trench.

The direction of TC11 trench is SW265°. The Cross-section of TC11 trench is shown in Fig. 4. Two positive fractures extend from top to bottom. The main fracture goes in the direction of NE62°. Its attitude is SE∠81°.

According to geotechnical characteristics and formation era, cross-section of TC11 trench can be divided into 10 soil layers from top to bottom: artificial fill layer, clay layer, silty clay layer, clay layer, fine sand layer, silt layer, clay layer, silt layer, silty clay layer, and clay layer. In the 4th layer, the vertical difference of the clay layer in two sides of the fracture reaches to 0.72 m. In the 5th layer, the vertical difference of the fine sand layer is 0.39 m. In the 6th layer, the vertical difference of the silt sand layer is 0.12 m. In the 7th layer, the vertical difference of the clay layer is 0.08 m. The top artificial layer has no vertical difference. The 4 layers, 5th to 8th layers (fine sand layer, silt layer, clay layer and silt layer), are broken by the fracture. A small amount of soil and rock blocks are contained in the gap of the main fracture. Associated sub-fractures cause smaller displacement in 5th to 8th layers, which ranges between 0.1 and 0.2 m.

In the hanging wall of the fracture, a remarkable thin layer with dark organics well distinguishes the 3rd layer and the 4th layer.

Affected by the fracture, layers were broken and moved four times, forming 1.5 m accumulated displacement, 1.25 m drag deformation, and 2.96 m vertical displacement (1.71 m direct displacement and 1.25 m drag deformation). As shown in fig. 4, deformation width in the hanging wall is 25.5 m, and deformation width in the footwall is 9 m

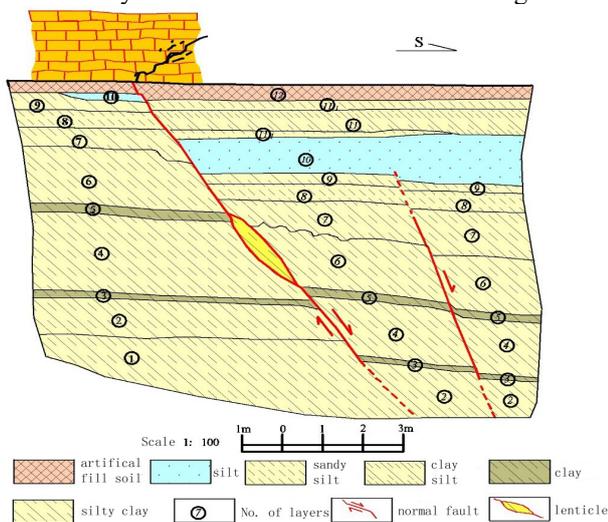
Fig. 5. East cross-section of Xiwanglu Trench.

Xiwanglu Road Trench was excavated in 2007. It goes in the direction of SN, with 20 m length, 9 m width, and 8.4 m depth.

As shown in fig. 5, the stratum can be divided into 12 layers based on geotechnical characteristics. Two main normal fractures distribute in the cross-section. The left one is the main fracture, which extends to the surface of the terrain and displaces the whole stratum with the difference of 1.56 m. The right one is the sub-fracture, which extends to the sand layer (10th layer). Thickness and the number of layers in two sides of the main fracture are different. The top of the 6th layer in the right side of the main fracture shows a zigged shape. The top of the 6th layer in the left side shows a decreasing trend

from left to right. These two phenomena indicate that the 6th layer was cut and severely dragged by the geological stress.

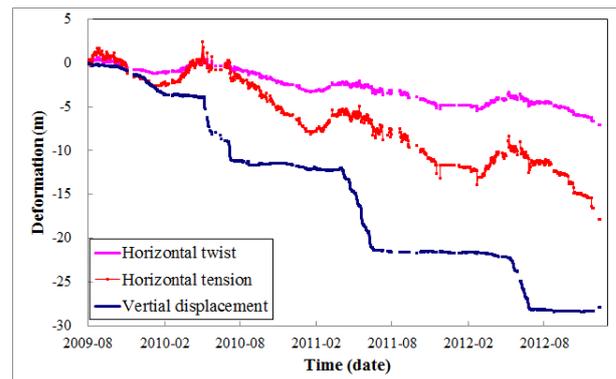
Fig. 6. The accumulative curves of three-dimensional activities of the ground fissure.

Xiwanglu Road Ground Fissure Station was established To monitor the activity characteristics of Gaoliying Ground Fissure. According to analysis of monitored data, Gaoliying Ground Fissure has three-dimensional activity characteristics. In the vertical direction, the hanging wall of the fissure shows a relative rising trend. In the horizontal direction, the fissure shows characteristics of right-handed twist and horizontal extension. From August 2009 to November 2012, the ratio of horizontal twist, horizontal extension, and vertical displacement is 1: 2.5: 4.6. The accumulated deformations of the horizontal twist, the horizontal extension, and the vertical displacement are 6.1 mm, 15.8 mm, 28.35 mm, respectively. Therefore, the deformation of the vertical displacement is larger than other two deformations. The horizontal twist has the smallest deformation in three-dimensional activities.

The three-dimensional activity characteristics of Gaoliying Ground Fissure are consistent with that of Huangzhuang-Gaoliying Fault, which is the evidence that the ground fissure is controlled by the fault.

The activity of Gaoliying Ground Fissure shows time regularity. From May to December, the activity is controlled by right-handed twist and extension, whereas it changes to be controlled by left-handed twist and contraction from January to April. Vertical displacement is larger from April to June. Vertical displacement decreases in other months.
