Safety analysis of Novat tailings dam

Florian Tatu^{1,*} and Dan Stematiu¹

¹ Department of Hydrotechnical Structures, Technical University of Civil Engineering Bucharest, Romania

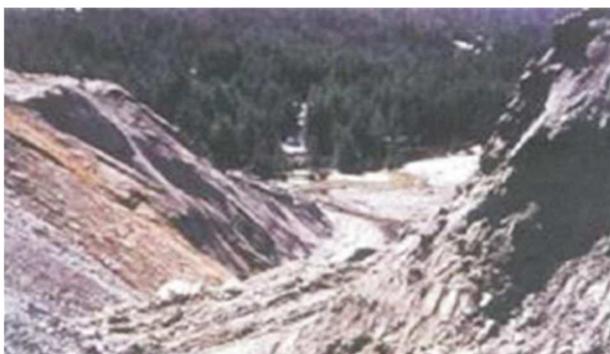
On 10 March, at 11:00, the main dam was overtopped and a 25 m wide and 10 m deep breach formed the right slope. The breach subsequently expanded until the leakage out of the pond was stopped by a coferdam made of tailings and fir branches. On 13 March, any waste water evacuation in the Novat stream was completely stopped. The main damage caused by the accident in March 2000 was materialized by:

- the partial destruction by overtopping of the main dam with the area adjacent to the right slope over a length of about 50 m and 20 m deep.
- destruction by overtopping of the downstream toe dam over a width of about 50 m, in the area of the right slope connection and practically full clogging of the volume created by this dam.
- destruction by overtopping of the seepage collection dam on a side of about 45 m, also in the right bank connection area; the discharge also produced the destruction of the existing concrete diaphragm in the dam body to prevent infiltration.

Fig. 4. Breach - upstream view

The main cause of the technical accident was the closed circuit operating system. The area downstream of the pond is a protected area so that any discharge of downstream pond is prohibited. As a result, the Novat pond did not have a safety deck capable of evacuating the water surplus that would have entered the pond due to excessive precipitation on the surface of the pond and its slopes or the upstream basin. The waters decanted into the pond were recirculated to the processing plant. Excessive precipitation was coincident with the melting of snow on the surface of the pond, and the tributary flows exceeded the hydraulic capacity of the derivation gallery. Rapid raising of the water in the pond due the upstream inflow has shut down the water pumping station and discharge towards the plant was stopped, so that the overtopping of the dam occurred.

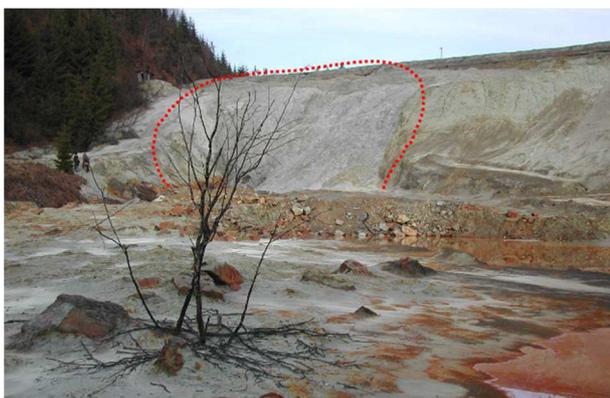
Fig. 5. Novat TDF – area of breach from March 2000

After the accident, repair works on the destroyed or damaged facilities were conducted as a matter of urgency, to restore the tailings dam functionality [4].

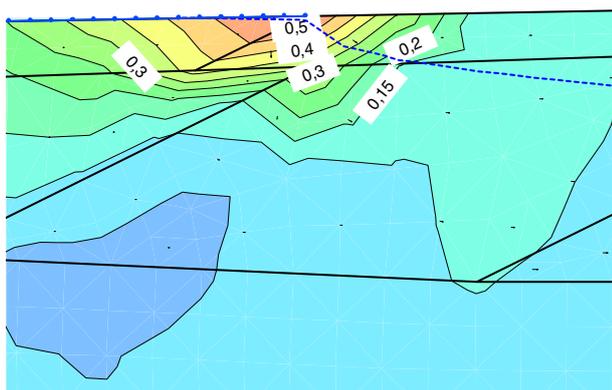
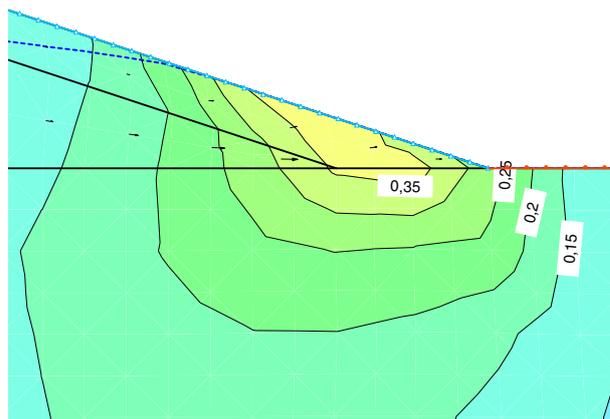
Fig. 8. Upstream Hydraulic Gradients

Fig. 9. Downstream Hydraulic Gradients

It can be seen that the maximum hydraulic gradients are below the value of the critical hydraulic gradient, not leading to hydrodynamic erosion of the tailings. The safety factor obtained is greater than 1, which means that there are no problems under these conditions. Later, the model was analyzed considering the level of water mirror at 805.50 maSL, the water being in contact with the upstream slope and 0.50 m below the crest. Two hypotheses were analyzed: first one in which the structure of the pond is unchanged and the second one corresponding to the effect of siphoning (that creates a zone with a material having weaker geomechanical properties). After the analyzes, the following results were obtained:

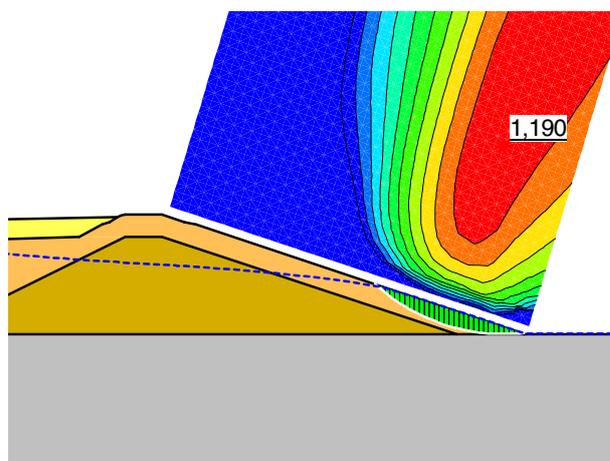
Fig. 10. Safety factor (FOS), water level at 803.50 maSL

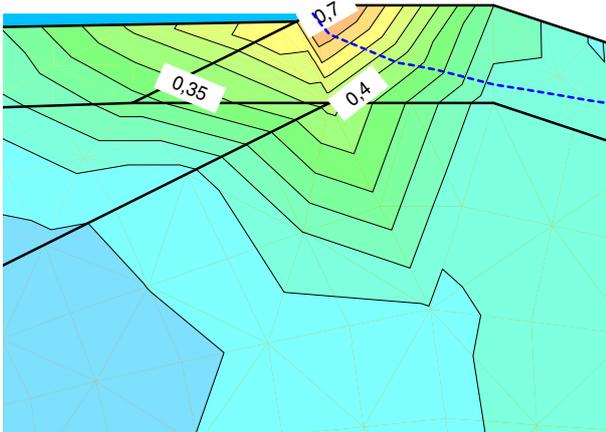
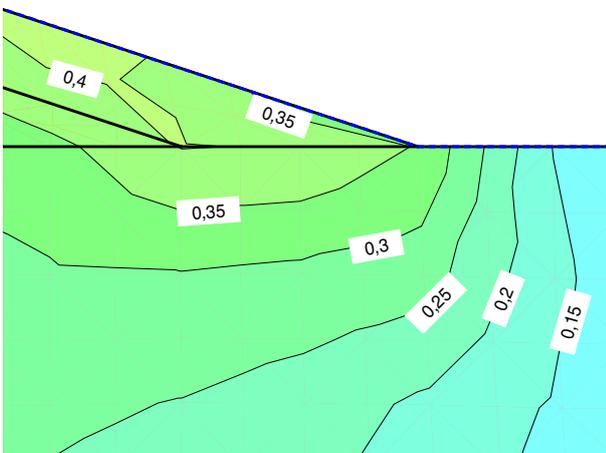
Fig. 12. Upstream Hydraulic Gradients

Fig. 13. Downstream Hydraulic Gradients

It can be seen that the maximum hydraulic gradients are above the value of the critical hydraulic gradient, leading to hydrodynamic entrainment of the tailings.

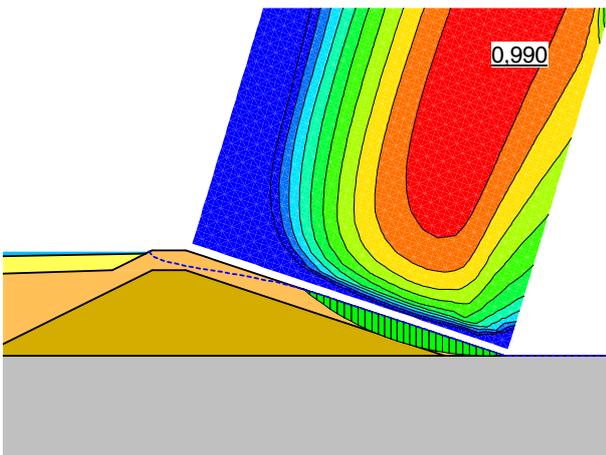
Fig. 14. Safety factor (FOS), water level at 805.50 maSL

The safety factor obtained is below 1, which means that in these conditions there are problems with the stability and safety of the tailings dam.

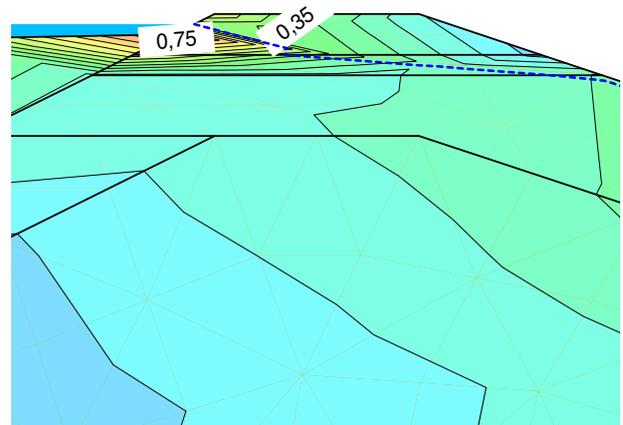
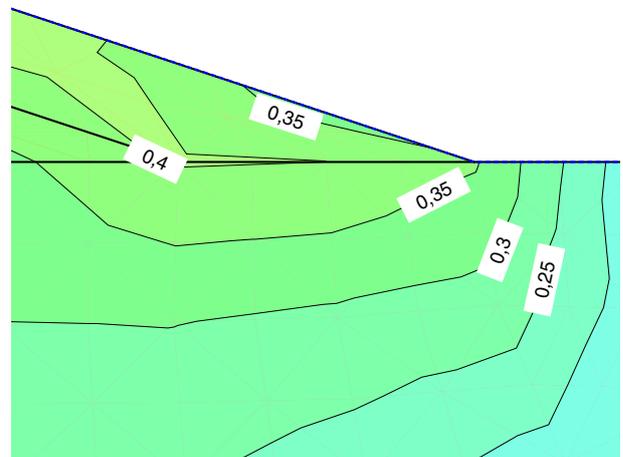
Fig. 17. Upstream Hydraulic Gradients

Fig. 18. Downstream Hydraulic Gradients

It can be seen that the maximum hydraulic gradients are above the value of the critical hydraulic gradient, leading to hydrodynamic internal erosion of the tailings.

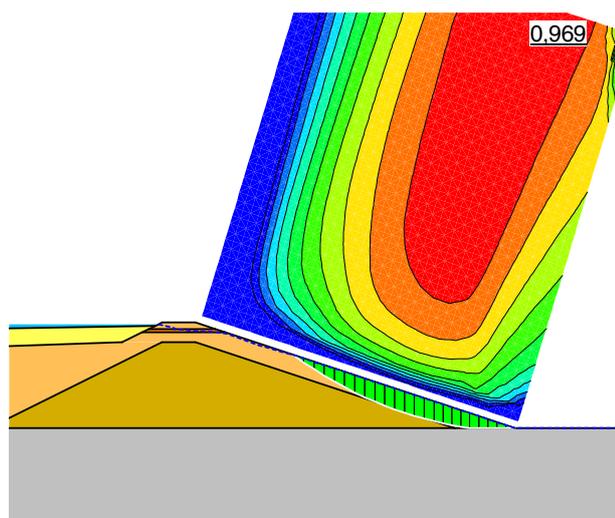
Fig. 19. Safety factor (FOS), water level at 805.50 maSL

The safety factor obtained is below 1, which means that in these conditions there are problems with stability and safety of the tailings dam [5].
