# Characterization of the geological and geotechnical conditions at the village of Monsanto

**Abstract.** The stability of slopes and hillsides involving rock or soil masses depends crucially on the occurring geological and geotechnical conditions. The village of Monsanto, municipality of Idanha-a-Nova, is located on a granitic inselberg. The tourist interest of the village lies largely in the fusion of the granitic rock mass with the man-made constructions and in the aesthetics of several granitic boulders scattered throughout the village. In the present work the geological and geotechnical characterization of the rock mass has been carried out, namely by the field survey of the entire intervention area and by a set of laboratory tests on samples collected in the field (ultrasound propagation velocity and the uniaxial compression test). Based on this information, the shear strength of the discontinuities was estimated and a kinematic analysis was performed using the Dips 7.0 commercial software, with the objective of defining the predominant sets of joints and identifying the most probable failure mechanisms in each hillside.

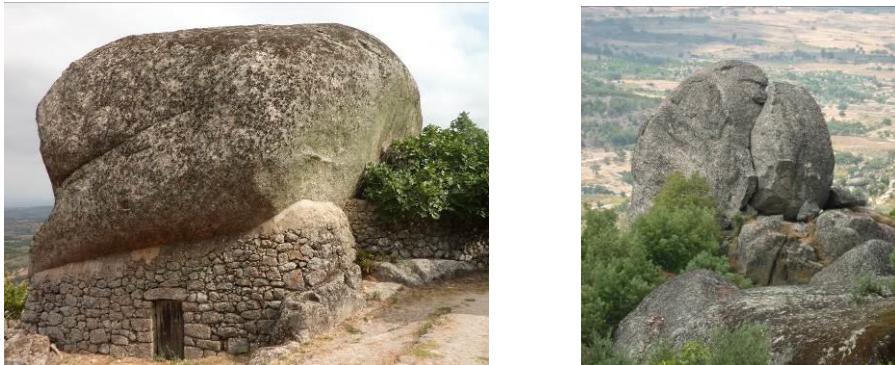
**Fig. 1.** Some rock blocks and boulders in Monsanto village. The boulders form the roofing and/or the walls of some houses and, outside the urban area, the rock mass forms blocky outcrops of moderately weathered to highly weathered granite.

The rock blocks show a coating over the surface that might be whitish to dark in colour due to the presence of lichens, the colour varying with the exposure conditions. The blocks exhibit a yellowish coloration due to weathering, being classified as W<sub>3</sub>, sometimes W<sub>4</sub> [9]. Locally they can present reddish coloration and evidence of oxidation. On the walls of the joints, in particular of sub-horizontal joints, it is common to observe quartz crystals standing out in relation to the rock matrix that has been eroded due to chemical and physical weathering. The blocks and boulders have large dimensions and show rounded edges and faces due to erosion. Frequently the contacts between blocks, or between the blocks and the supporting ground, are fully weathered, occurring as a sandy residual soil, and the contact area is very limited. In the NW area, the blocks are mainly prismatic with the larger dimension close to the vertical; conversely, in the East area the blocks are tabular and rest on sub-horizontal joints.

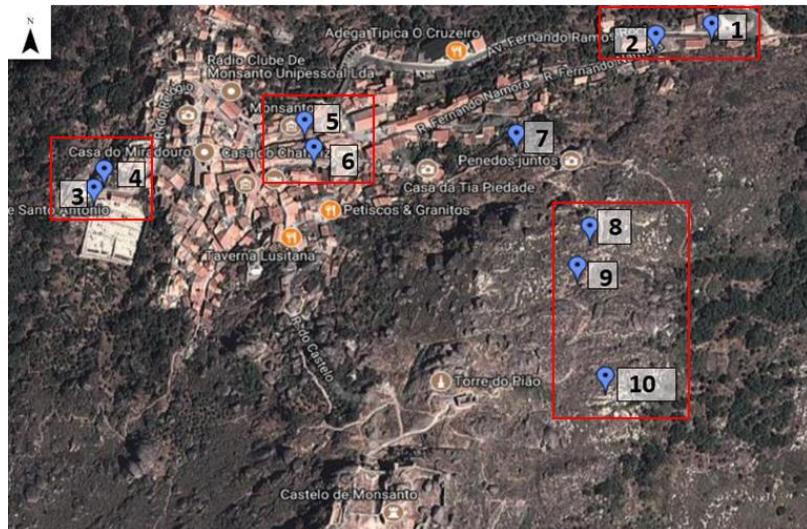
**Fig. 3.** Map of the intervention area with indication of survey locations for study of the joints sets. In general terms, it is found predominant subvertical joints with orientation NNE-SSW to NNW-SSE and ENE-WSW to ESE-WNW. The sub-horizontal joints show more scatter but dip predominantly to north.

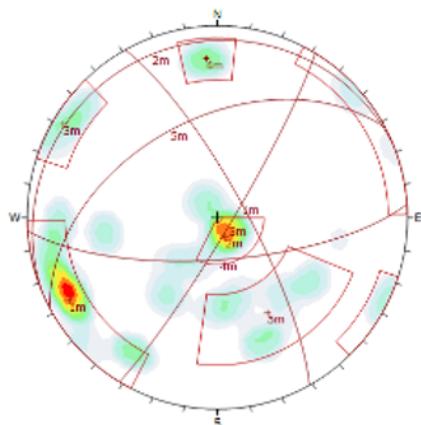
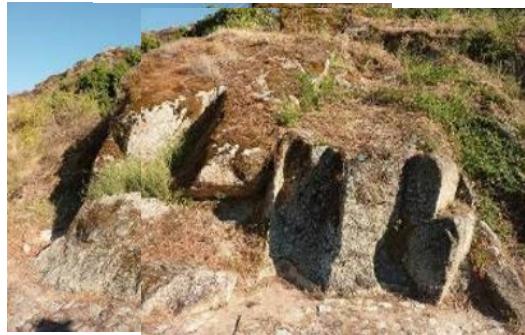
**Site 1 (JS 1 + JS 2) 76 poles**

**Fig. 4.** Contour diagrams representing the orientation of the main sets of joints in Sites 1, 2 and 3 plotted on an equal-area net. (JS- joint station).

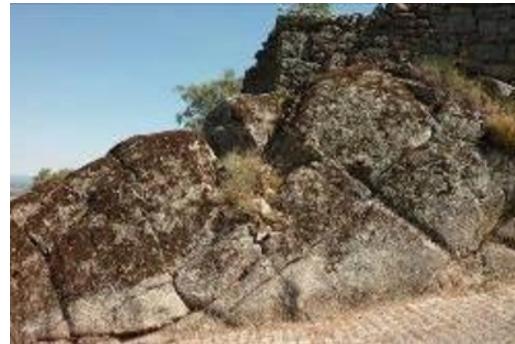
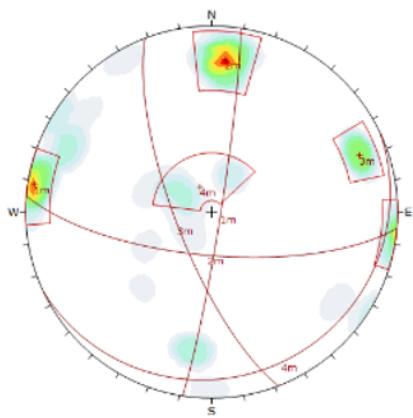
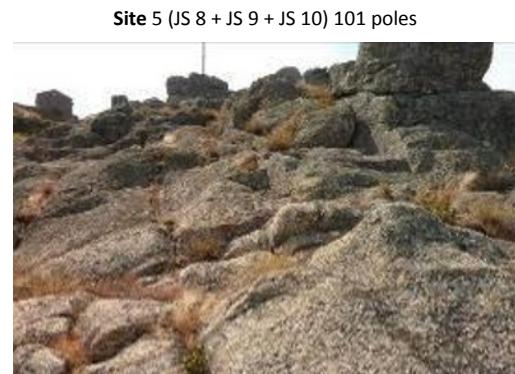
**Fig. 5.** Contour diagrams representing the orientation of the main sets of joints in Sites 3, 4 and 5 plotted on an equal-area net. (JS – joint station).
