Ensuring safe operation of buildings and structures

*Elena Gryaznova**

Moscow State University of Civil Engineering, Yaroslavskoe shosse, 26, Moscow, 129337, Russia

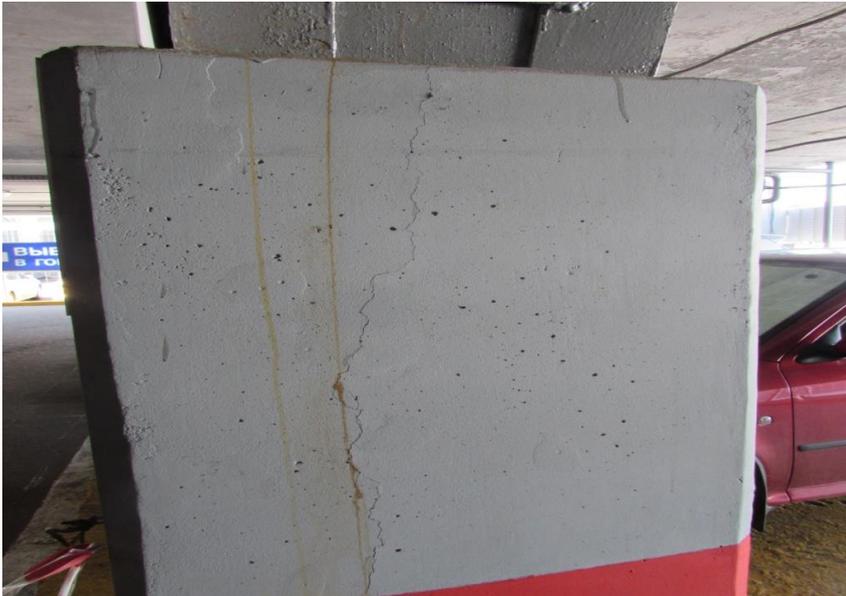
- Cracks in columns, due to corrosion of the reinforcement (Fig.3, 4);

Fig. 3. Parking No.1, 1st floor. Vertical column crack.

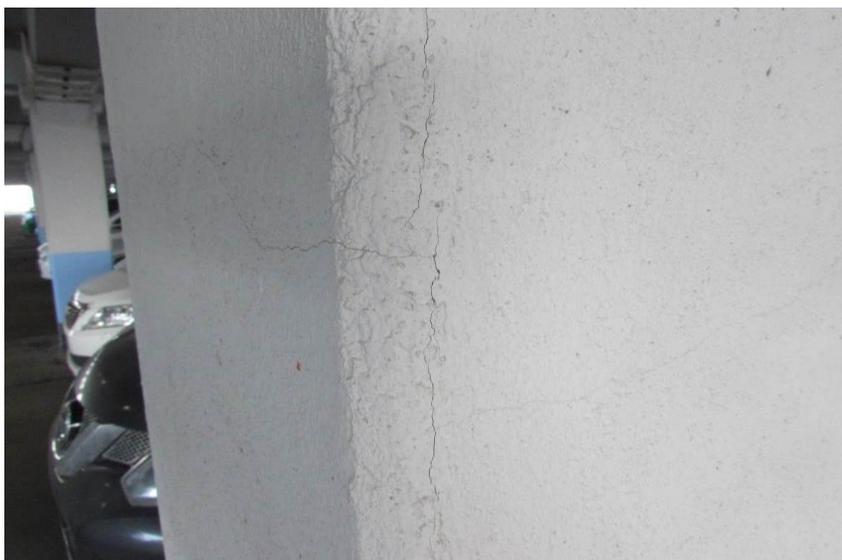
Fig. 4. Parking No.2, 1st floor. Vertical column crack.

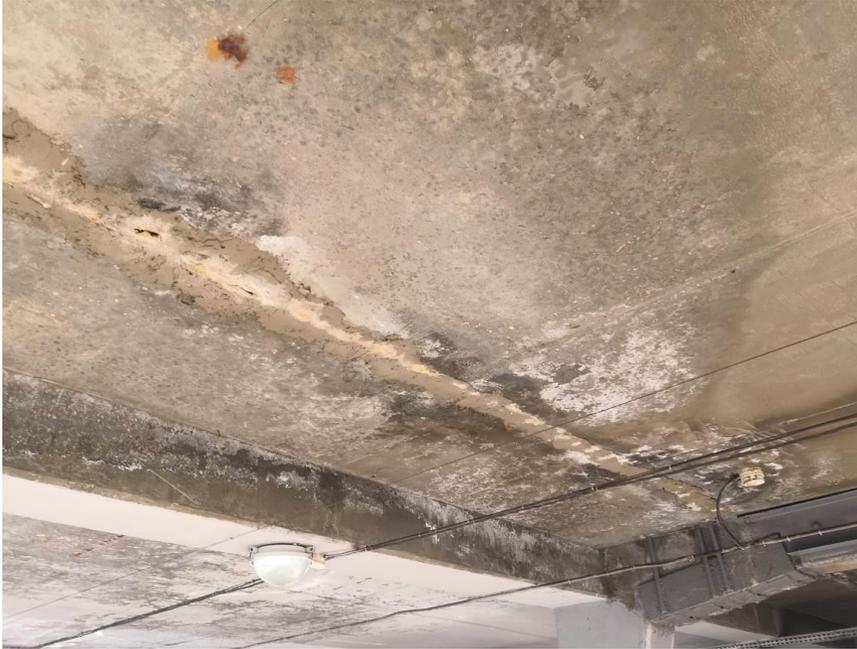
- Extended cracks on the lower surface of the floor slabs, with an opening width of more than 0.3 mm, with traces of rust and efflorescence (Fig.5, 6);

Fig. 5. Parking No.1, 3rd floor. Efflorescence on the slabs surface at the expansion joints

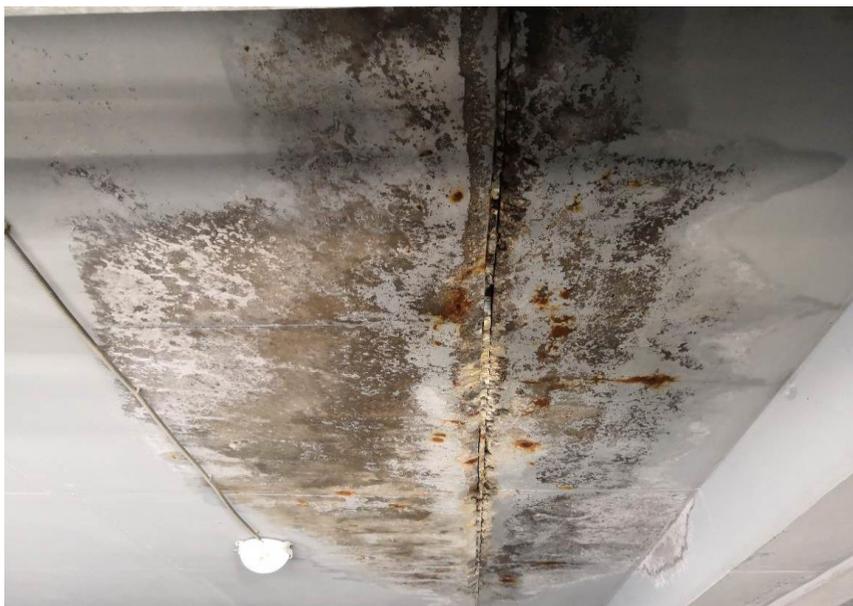
Fig. 6. Parking No.2, 2nd floor. Cracks in the slab with traces of efflorescence and corrosion of reinforcement

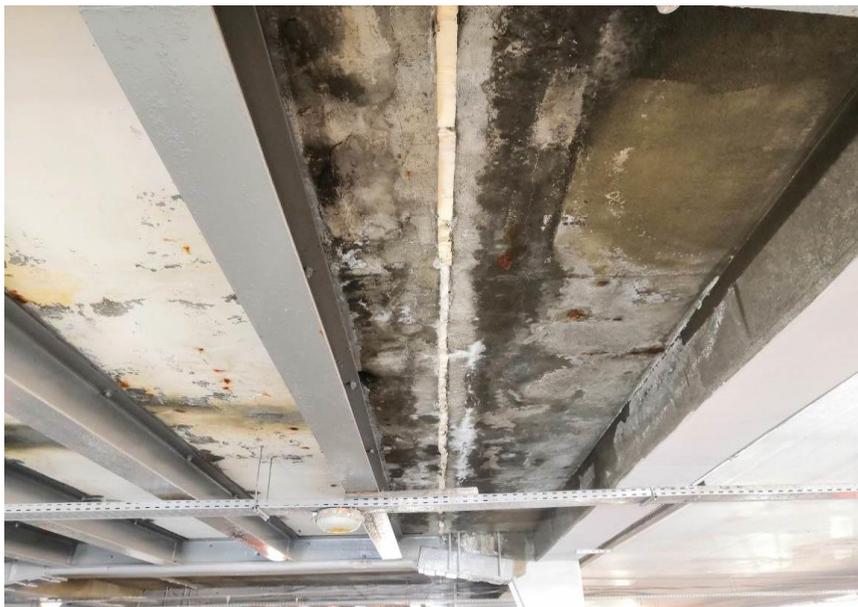
- Deflection of floor slab sections between expansion joints (Fig.7, 8).

Fig. 7. Parking No.1. Deflections and efflorescence on the floor slab surface between the expansion joints

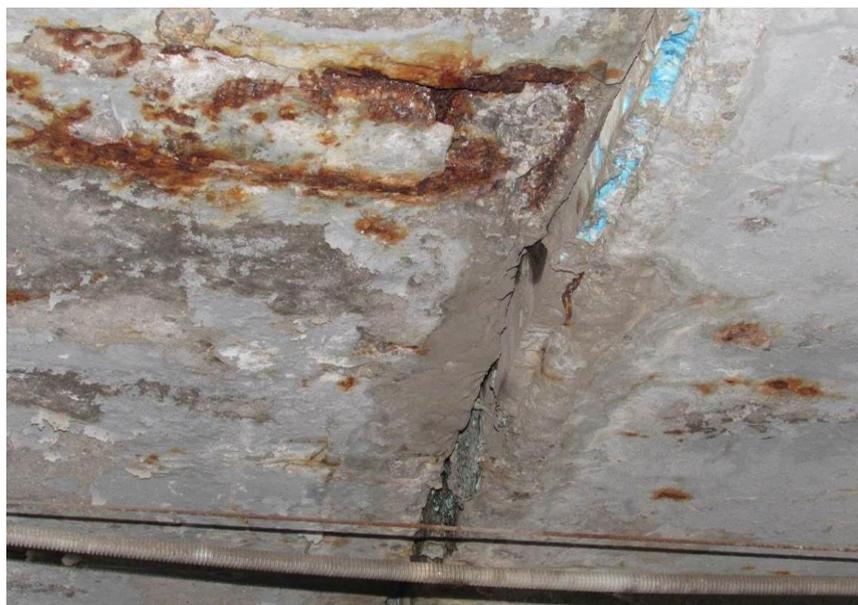
Fig. 8. Parking No.2. Deflections of floor slab sections between expansion joints. 1st floor

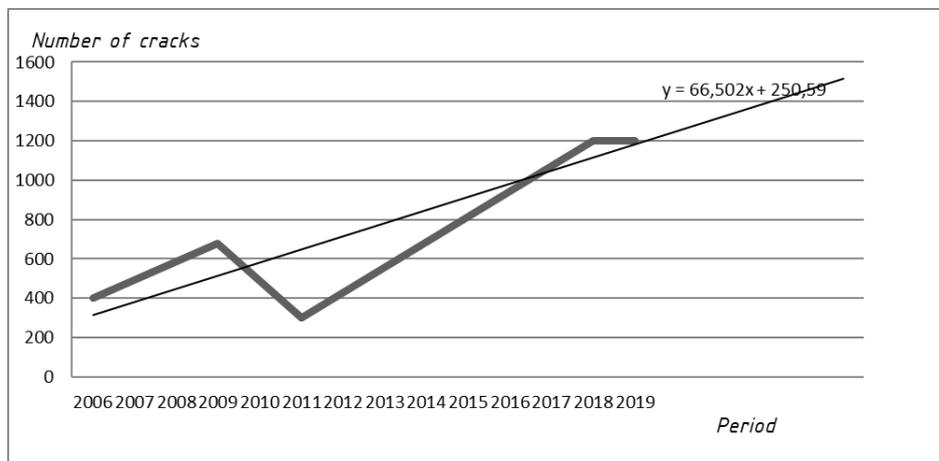
Fig. 9. Approximation of damage increment graph

From Fig.9 it follows that over time, there is a clearly pronounced tendency for defects growth in structures of the observed buildings. Moreover, main damage increment is observed in the winter-spring period of the year. According to the results of object monitoring, the state of parking No.1 is assessed as operational, and parking No.2 is assessed as limited in operation.

According to the data obtained over the course of monitoring, damageability of the structures was assessed according to the methodology [3] for assessing reliability of buildings and structures by external signs. Remaining operational life expectancy of parking No.1, i.e. projected period for repair works and strengthening of structures to extend service life is 2 years, at the same time remaining operational life expectancy for parking No.2 is absent. In this regard, parking No.2 requires full repair and strengthening of building structures.
