Considerable cracking in the foundation slab in a multi-storey underground garage

Marek Maj*, Tomasz Kowalik and Andrzej Ubysz

Wroclaw University of Science and Technology, Wybrzeże Wyspiańskiego 27, 50 370
Wrocław

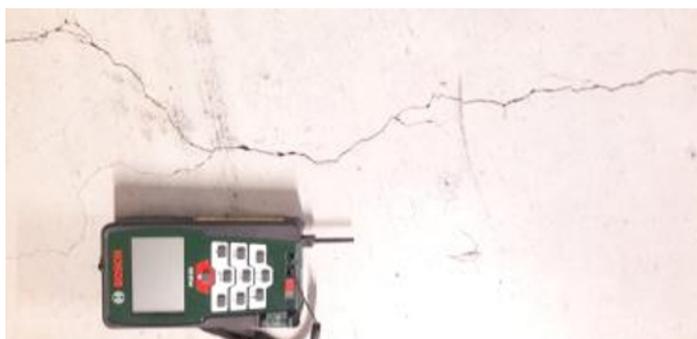
Fig. 1. Cracks in the parking slab with a width of over 0.6 mm

In addition, an ongoing process of crack propagation can be observed (according to the interview carried out with the user's representative); their number, width and aperture is gradually increasing. The distance between cracks, in places strongly outlined, the width of which is more than 0.1 mm, is on average 0.40 m.

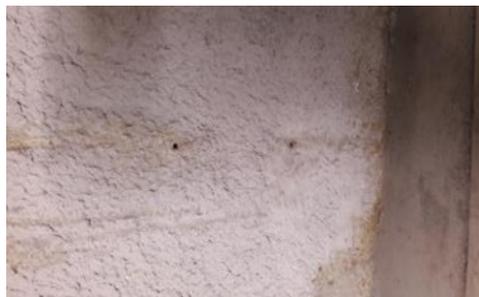
segments of the diaphragm wall. Local dampness is also observed at the connection points of the diaphragm wall with the foundation slab (Fig. 2). This means penetration of groundwater through some expander connections and through the walls. Leaks in the floor over the foundation slab are shown in Fig. 3. After every major atmospheric precipitation, it is necessary to perform injections in order to seal the walls in places of leaks.

Fig. 2. Dampness in the connection between the diaphragm wall to the foundation slab

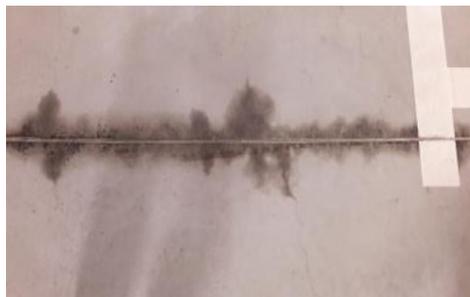
Fig. 3. Leaks in the floor over the foundation slab

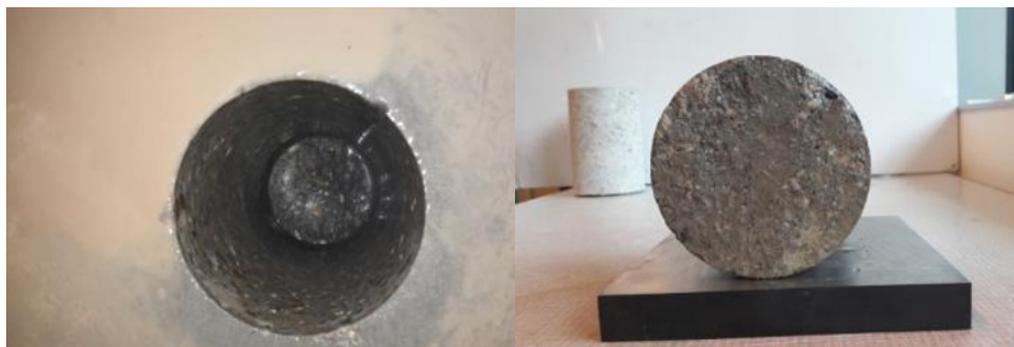
- In one of the samples, separation of the foundation slab from the floor was observed, which may indicate that the bonding layer had been cut.

Fig. 5. Place of borehole

Fig. 6. Sample cut from the concrete slab,
bonding layer
