Case Analysis of Damages to Control Hydraulics of the Leg in the Powered Roof Support Section

¹ The Central Mining Institute, Poland

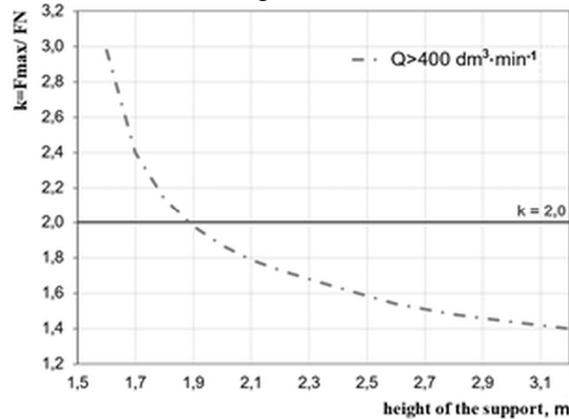
Fig. 2. Predicted overload of powered roof support's leg in the analysed case (for $n_{tz}=1.22$ and application of hydraulic system with a flow of at least $Q>400 \text{ dm}^3 \cdot \text{min}^{-1}$).

The results indicate that the powered roof support should be yielded from a height of 1.9 m, using a system with a minimum capacity of $400 \text{ dm}^3 \cdot \text{min}^{-1}$. This requires maintaining the liquid column under the first stage piston with a minimum height of 0.35 m, with the correct section geometry.

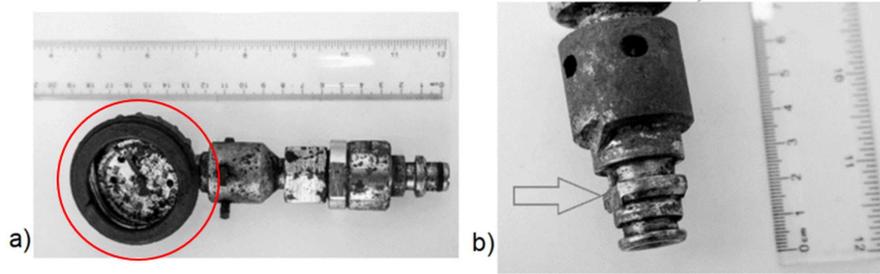
Photo 1. Damaged manometers

- damage to five pressure gauge systems (cutting off connection DN12 and damage to pressure gauges) – Photo 1, Fig. 3;
- damage to pressure limiting valves (loss of tightness, damaged seals) – Photo 2, Fig. 3;
- slip off two sections of the support due to damage to the pressure gauge systems (backrest of the canopies on the conveyor);
- roof rock fall.

Immediate safety measures were applied successfully. They were aimed at minimizing the conditions dangerous to the crew. The section was withdrawn and spragged again. As a result, the leg operated in full extension mode of the 1st hydraulic stage, obtaining the required strength and geometry of the section and the leg.

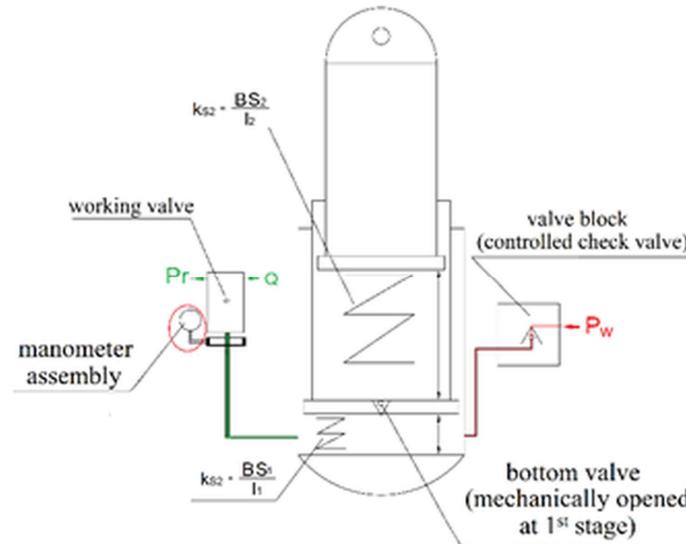
In the case of leg operating in the range of shifting from 1st to 2nd stage and clamping of the leg at 2nd stage, the relations given above change. The load-bearing capacity of the leg changes (due to the smaller surface of the second stage of the leg), its rigidity changes rapidly, which often leads to vibrations in the control system, as well as difficulties in maintaining the roof. Fig. 4 schematically shows the cases described.

As presented in Fig. 4, during the shift of the leg from 1st to 2nd stage, the work of the leg is unstable, which can be described by the following formulas:

Fig. 4. Operation of the leg within the range of shifting from the 1st to the 2nd stage, where: k_{s1} – stiffness at the 1st stage, k_{s2} – stiffness at the 2nd stage, S_1 – surface of the 1st stage, S_2 – surface of the 2nd stage, l_1 – length of the 1st stage, l_2 – length of the 2nd stage, Q – capacity of the hydraulic system, B – compressibility of the hydraulic fluid.

In addition, as shown in Figure 4, an area where dangerous phenomena may occur is formed during the shift from 1st to 2nd stage, i.e. at the height of support of 2.3 to 2.6 m. The research team estimates that the whole system excites within this range, which causes the occurrence of adverse phenomena in the form of impacts.

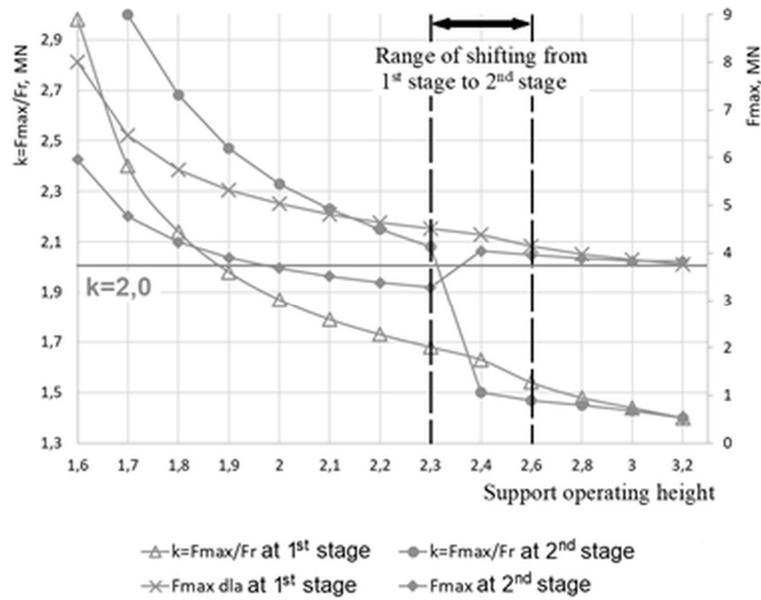
The calculations presented indicate that the bearing capacity of the leg significantly decreased and corresponds to the load capacity of the leg with the diameter resulting from the second stage, which in the given case is $\varnothing 0.23$ m. The reduced working load was taken into account in further analysis regarding the condition for the support to be yielded. A back analysis of the condition of the section's positive state was made using a valve with a capacity of $400 \text{ dm}^3 \cdot \text{min}^{-1}$, as shown in Fig. 5.

As can be seen in Figure 5, in the case of proper support (1st stage), it is compressed in the range from the height of 2.0 m, while maintaining the liquid column under piston at the 1st stage $PT \geq 0.42$ m. During incorrect operation (2nd stage) the support is yielded from the height of 2.35 m, which results from the diameter of the 2nd stage cylinder, while maintaining the height of the liquid column under the 2nd stage $PT \geq 0.78$ m. It should be noted, however, that in this case the height of the liquid column under the first stage piston is practically nil, in which case the leg is not working properly.

Fig. 5. Expected overload during operation of the hydraulic leg at 1st stage and during operation at the time of shift from 1st to 2nd stage.

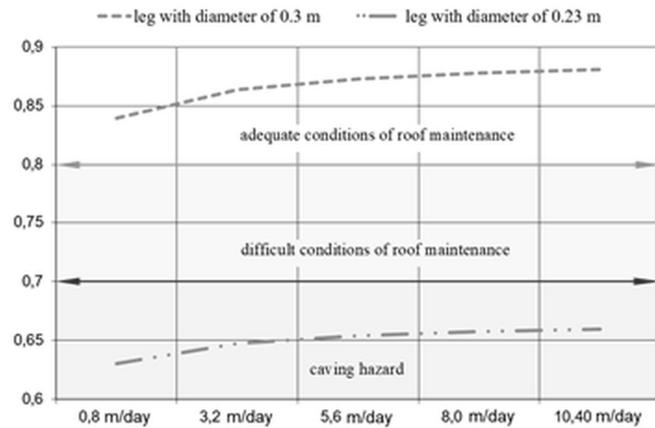
Fig. 6. Index of load-bearing capacity of the g roof during the operation of the leg at the 1st and 2nd stage.

The calculations indicate that when the operating parameters of the leg are correct, the bearing capacity of the roof support will be sufficient to protect the excavation against the dynamic impact of the rock mass, which largely depends on the diameter of the leg $\varnothing 0.30$ m – the g factor ≥ 0.84 . In the case when the load-bearing capacity of the operating support resulting from the diameter of the 2nd stage, the g indicator significantly decreases – $g \geq 0.63$, and in accordance with the method developed at GIG, there is a risk of caving. This was confirmed in practice. The drop in the value of the g indicator in this case results mainly from the size of the 2nd stage cylinder’s diameter, $\varnothing 0.23$ m (too low bearing capacity of the support).
