Sinkhole hazard in the post-mining area of Old Copper District, Lower Silesia, Poland

Abstract. This study discusses the occurrence of sinkholes and the removal of their effects in the territory of the Old Copper District in the municipality of Lubków, Warta Bolesławiecka, located in the voivodeship of Lower Silesia. Three sinkholes appeared more than 25 years after mining activities ceased with the closure of the “Konrad” Mine of KGHM Polska Miedź S.A. The sinkholes appeared in the former mining areas in the years 2017 – 2018: the first in the area of the Lubichów III shaft located in the municipality of Lubków – the downcast and transport shaft of the “Lubichów” and “Konrad” mines; the second in the area of Lubichów IVa in Lubków – the ventilation shaft of the “Lubichów” and “Konrad” mines; and the third in the area of the Lubichów IVa shaft - in the village of Lubków. The “Lubin” Mine of KGHM Polska Miedź S.A. commissioned development of projects to mitigate the risk and to secure the areas and remove the dangers.

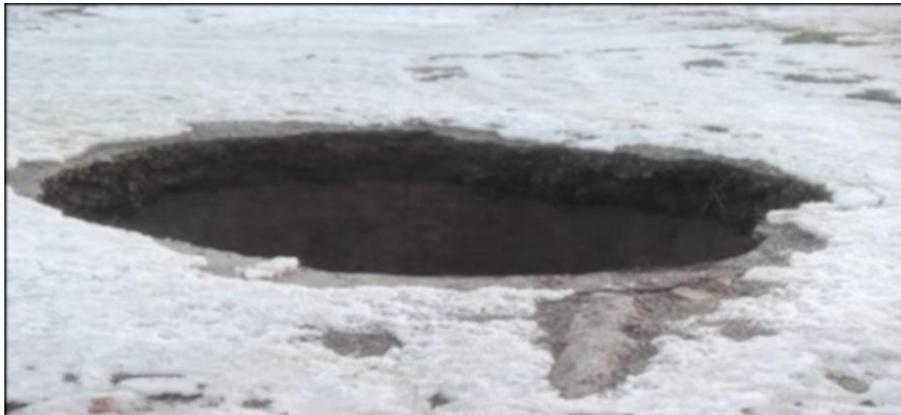
Fig. 2. Open part of the Lubichów III shaft on the day of the mining damage occurrence

The surveying services of "Lubin" Mine determined the size of the sinkhole using laser scanning. The diameter of the sinkhole was about 4.1 m and roughly corresponded to the diameter of the closed shaft. The gap after the shaft barrel was exposed in the sinkhole and the trunk part of the shaft was 0.45m below the ground. There were no deformations found in the ground around the shaft lining except for the bottom edge part of the shaft hole resulting from damage to its integrity on the edge of the cave-in. There was no depression of the surface outside the shaft, which indicates the stability of the orogen around the shaft barrel [16]. The following steps were taken to establish and document the ground-water conditions: core drilling of seven holes in the area from the bottom of the shaft to a depth of about 20 - 22 m; laboratory tests of the properties of the ground collected from the cores; and two tests by impact probing. The results indicated the physical and mechanical properties of the terrain in the area of the shaft; no basic groundwater level; absence of any cavities or hollow ground in the surveyed ground. This was a very important observation for the assessment of land stability around the shaft. A space in the shaft barrel unfilled with the filling material was exposed in the cave-in, with a water surface at a depth of about 39 m below the surface level.

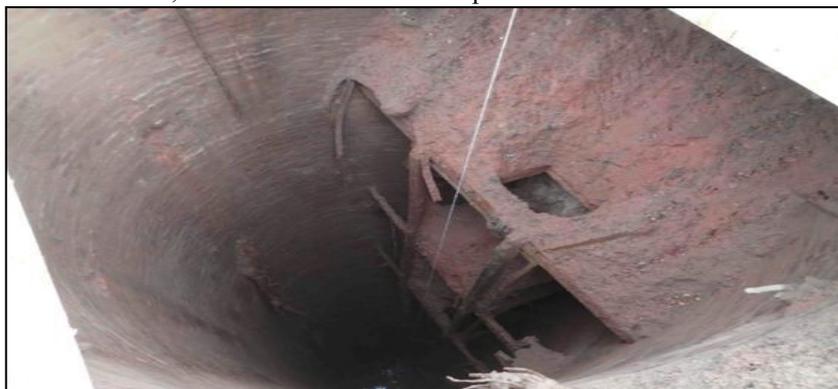
Fig. 3. The inside of the Lubichów III shaft – the entire shaft lining

On visiting the site, it was observed that the construction for the ladder compartment as well as the shaft girders and the hoisting shaft guides were built on the side of the ladder compartment. The presented section of the lining lacks beams that would separate the hoisting compartment. There was a visible overhang on the remains of construction of the ladder compartment which probably was a left-over after backfilling the shaft with rock material from the mining dump (Fig. 3).

This overhang prevented the identification of the integrity of the shaft inlet located at a depth of 6.0m under the ground level directly below the deck of the ladder compartment [16]. KGHM Cuprum performed indicative measurements of the level of the water mirror on 30 March 2017. They showed stabilisation at a depth of approximately 39 - 40m, with a test based on lowering the sinter below the mirror of the water at a depth of about 54m below the surface.

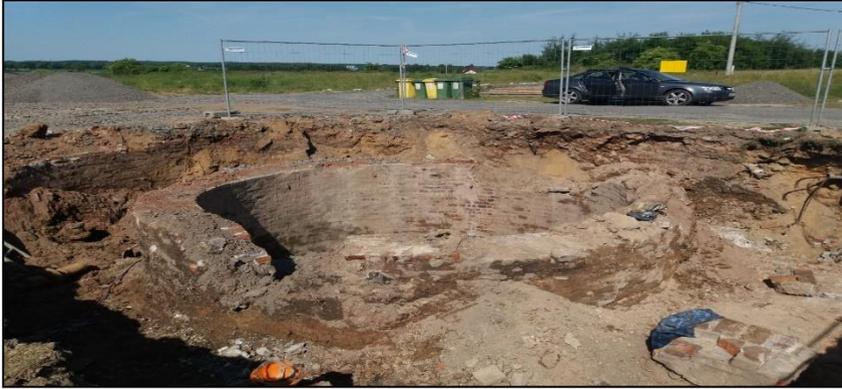
Fig. 4. Exposed Lubichów III shaft barrel.

The liquidation of the mining damage in the region of Lubichów III included the capping of the shaft inlet at its trunk and safeguarding the trunk part of the shaft with a reinforced concrete slab cap. This ensured full security of the shaft, both for the users of facilities located in its vicinity as well as for the environment. For the duration of the time needed to prepare the project fully and analyse the results obtained from the drilled holes, the shaft was fenced and secured with a wooden structure. The site was also monitored. The following actions were taken on the basis of the project to liquidate the collapsed Lubichów III shaft: uncovering of the shaft barrel (Fig. 4); filling the cavity in the shaft barrel; filling the interior of the shaft with crushed basalt stone to the depth of approximately 55m; making of a reinforced concrete slab of 7.5x7.5x0.5m in a central position above the shaft, including insulation and placing of an inspection hole (Fig. 5); to monitor the interior of the shaft, with an inspection planned for July 2019 to determine whether the filling material level has changed and requires further filling; covering of the reinforced concrete slab with soil and return of the land for use by the owner of the property.

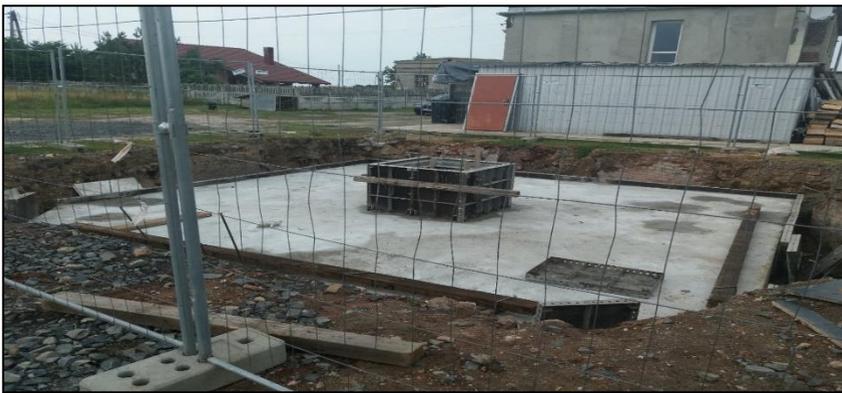
Fig. 5. Reinforced concrete slab with inspection hole securing the Lubichów III shaft barrel.

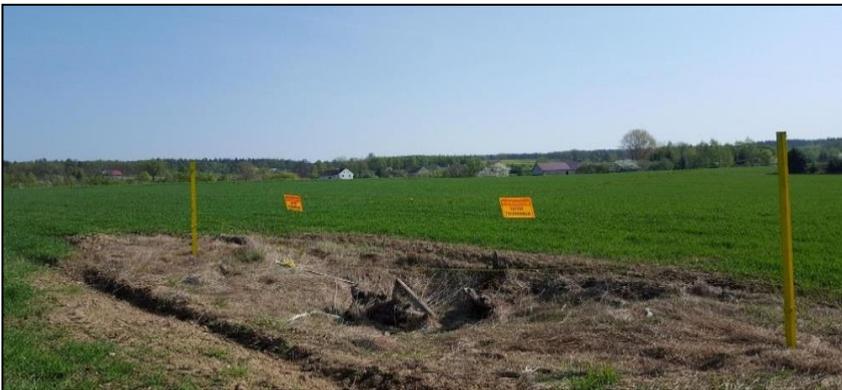
Mining damage in the form of a collapse of the terrain in the trunk part of the Lubichów IVa ventilation shaft (Fig. 6) was observed on private agricultural land in Lubkowo [17]. The exact date of its occurrence is unknown. The cave-in was reported by the owner of the parcel in April 2018 and a notification delivered concerning its location (Lubichów IVa shaft area).

The size of the sinkhole was determined by the "Lubin" Mine surveying services. The cave in is 0.74m in its deepest part with a diameter of approximately 4.0m. The trunk part of the shaft was invisible and the space of the shaft barrel remains covered. It was not possible to identify the material used to fill the shaft barrel [17]. The integrity of the ground on the edge of the deformation was unspoiled and there was no sedimentation of the surface in the area around the shaft. Due to the way the area was used the surface of the land was covered with vegetation, with dead shrubby vegetation visible in the sinkhole.

Fig. 6. The sinkhole in the trunk part of the Lubichów IVa shaft.

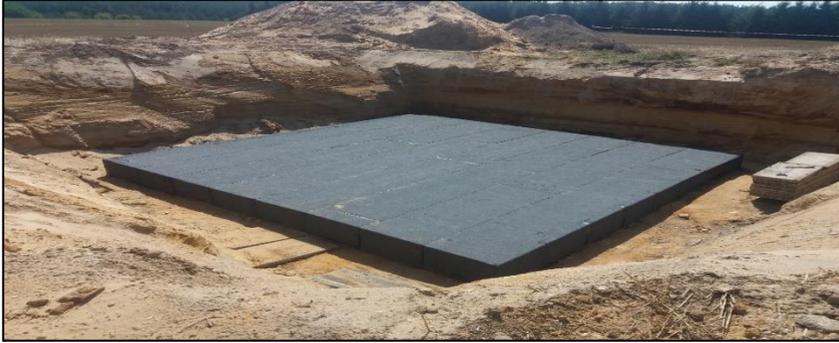
Fig. 7. Reinforced concrete slab approx. 3m under terrain level, dimensions: 7.0x7.0x0.5m

The site was monitored throughout the preparation of the project, for the time needed for the ground-penetrating radar survey (GPR) and the analysis of the results. The following actions were taken following the project: a 10.5m x 10.5m excavation (approx. 3 m deep) to uncover the shaft barrel which in turn was not found at the designated depth; it was decided not to continue the excavations after consulting the company implementing the project; at the level reached by excavation works a 7.0x7.0x0.5m reinforced concrete slab without a revision hole was placed in the central position over the shaft - the slab was insulated (Fig. 7); the cave-in was filled with sand of appropriate fraction and humus to restore the land for use by the owner of the parcel.

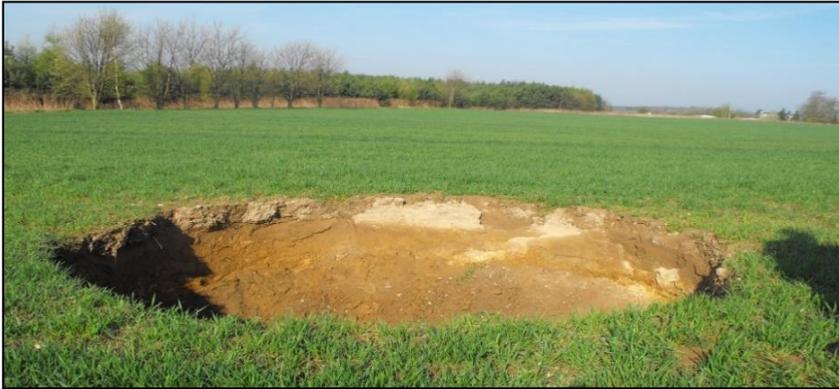
A non-continuous deformation of the area of unknown origin in the form of a rupture was revealed in April 2018 in the village of Lubków in the south-western part of the mining area "Lubichów". The sinkhole was created during field work using agricultural equipment. The deformation was about 60m south-west of the Lubichów IVa ventilation shaft. The elevation of the terrain near is at an altitude of about 216m above sea level. Measurements have shown that it has a circle shape of approximately 4.0m in diameter. The estimated depth of the sinkhole is approximately 2.0m [18].

Deformation was caused by the collapse of the terrain into the orogen to a depth of about 2m. It was a circular rupture due to the geometry in the horizontal section. The rupture walls were steep near the edge of the surface while the deeper part was shaped as a conical funnel (Fig. 8). The ground was damp and not covered with vegetation inside [18]. There was no subsidence of the terrain or other forms of deformation in the perimeter. The area around the sinkhole was secured by a ring-fence and signage (Fig. 9) the genesis of the sinkhole could not have been determined and it was impossible to confirm the stability of the soil.

It should be considered that the formation of non-continuous sinkhole is of anthropogenic origin due to its location and nature because, according to all available indications, it constitutes an unintentional side effect of the former mining activity of "Lubichów" Mine. All things considered, it can be assumed that the "Lubichów" sinkholes were mainly influenced by the following factors [18]: location in the shallow located drifts of "Lubichów" mine, including above all the ventilation drift pos. 52; insufficient thickness of the rock mass in the overcap for filling the void; the hydrogeological situation in the region related to the restoration of groundwater level; the activity of rainwater infiltrating into the ground; presence of the active fault in the area.

Fig. 8. The sinkhole in Lubichów IVa shaft area.

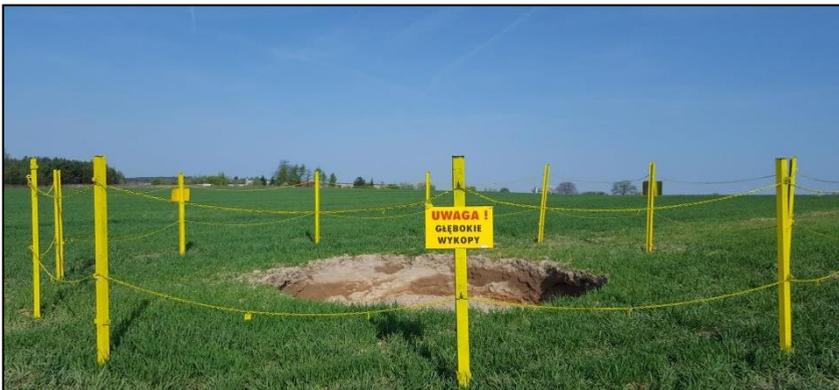
Fig. 9. Secured sinkhole in Lubichów IVa shaft area.

The site was monitored throughout the preparation of the project, for the time needed for the ground-penetrating radar survey (GPR) and the analysis of the results, the sinkhole was adequately secured. It was decided to secure the sinkhole by deepening it and filling with crushed basalt rock of the indicated fraction (Fig. 10) and to build a fence around about 0.10 hectares of the parcel (Fig. 11) in order to monitor the position of the level of the upper surface of the filling for a period of three years until 06 September 2021 based on part II of

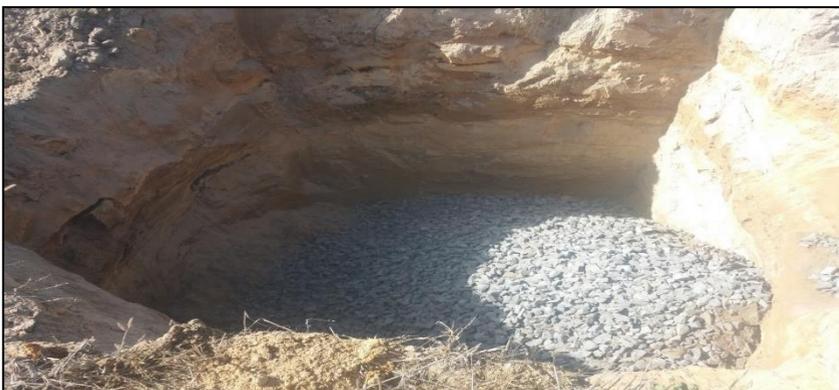
Fig. 10. The filling of the landslide located in the area of the Lubichów IVa shaft.

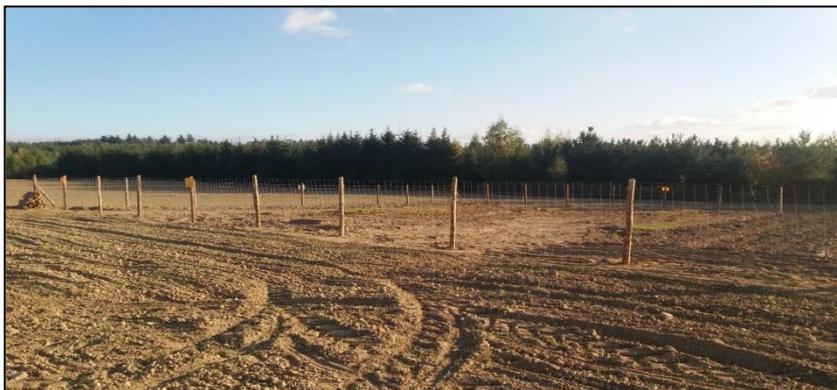
Fig. 11. The fence around the area of the landslide under surveillance.
