# Resource-saving preparation of the 38KHGNM steel surface for heading of automobile components

**Abstract.** To produce high-quality fasteners for motor group components of automobiles it is necessary to follow the increased requirements to calibrated rolled stock in terms of surface defects. Therefore, the goal of this paper is to study the reasons, types and depth of the surface defects on the calibrated rolled stock from steel 38KHGNM Ø 12.0 mm on the basis of the metallographic analysis. Before cold upsetting, the hot-rolled products are subjected to metal flow and removal of unacceptable surface defects by means of expensive turning operation during which the screw cuts and cracks might appear. It has been defined, that the hot-rolled stock from steel, grade 38KHGNM, diameter 12.0 mm has nonuniform mechanical properties, grooves, laps and partial decarburization on the surface. The heat treatment of the rolled stock with a decarburized layer on the surface contributes to its further decarburization. Poor alignment of calibrated stock during its turning at the turning machine does not enable to completely remove the decarburized layer with minimum skinning of rolled stock. It

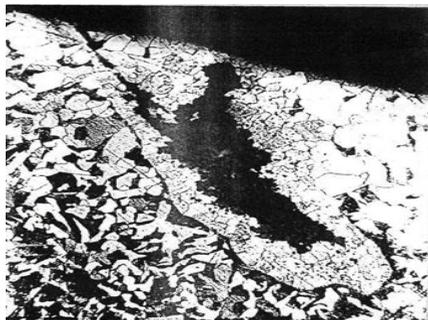
It has been found that hot rolled stock of 38KHGNM steel with a diameter of 12.0 mm has nonuniform mechanical properties, partial decarburization, grooves and laps on the surface. An example of the "lap" type surface defect in hot rolled stock is presented in Fig. 1, "rolled gas blowholes" - in fig. 2, and "grooves" - in Fig. 3.

**Fig 2.** Rolled gas blowhole at the surface of stock material. Transverse microsection. Etching by 4% HNO<sub>3</sub> in alcohol. Magnification x100.

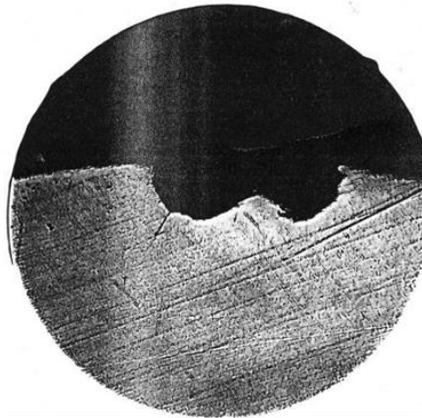
Batch No. 2 of the rolled products complies with GOST 10702-78; a groove, 0.1 mm deep has been detected on one sample.

**Fig. 3.** Grooves on the surface of hot rolled metal. Unetched transverse microsection. Magnification x100.
