Cause Analysis of SA-210 Steel Water-Cooled Wall Leakage

Abstract. When the SA-210 steel water-cooled pipes are under high temperature and high pressure, high pressure steam will generate an outward pressure on the inner wall of the pipes, which will cause the pipe to swell outward. If there is a small defect on the inner wall of the water-cooled tube, this defect will become a stress concentration point. The additional pressure acts on the stress concentration point to cause cracks, and after the cracks generated, lead to the cracks to expand at the same time. In the cracks, vapor will diffuse into the matrix along the cracks, occurring corrosion under the action of high temperature, which further accelerates crack growth. Eventually, it leads to water-cooled tube wall leakage.

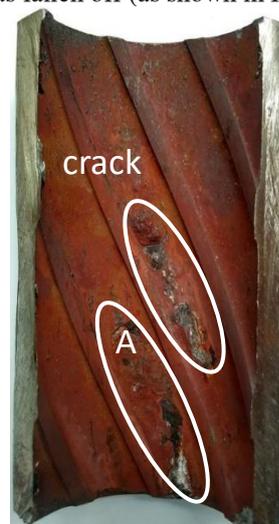
The water-cooled tube wall was cut along the longitudinal direction of the tube bundle and observed. There were

cracks in the inner wall of the tube. These cracks were distributed linearly along the direction of the tube bundle. The oxide skins of the inner wall cracks were loose and part of them has fallen off (as shown in Figure 1).

Fig. 1. Macro morphology of cracks on the water-cooled tube wall inner wall

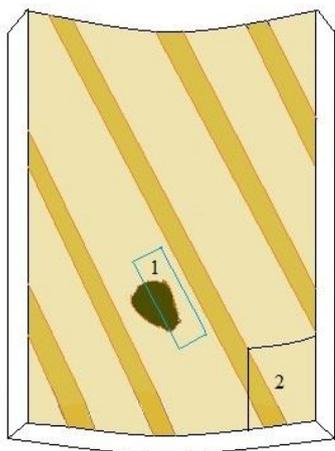
Sampling was performed on the inner wall of the tube where the crack was obvious and the oxide skin did not fall off (point A in Figure 1), which was labeled as Sample 1. Sample 2 is obtained where no crack is found, and the specific sampling location is shown in Figure 2.

Fig. 2. Sampling position

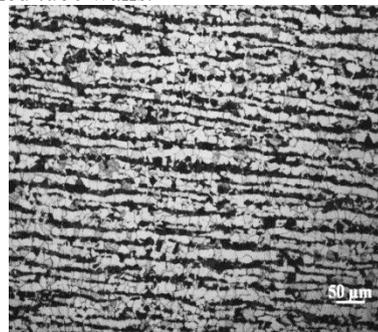
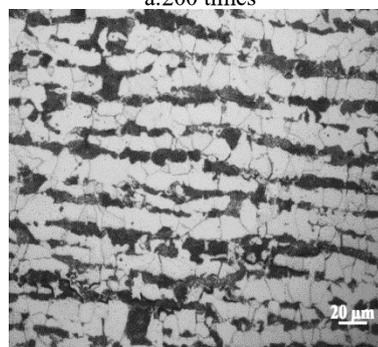
Figure 3 is the metallographic structure of Sample 1 without cracks, and Figure 4 is the metallographic structure of Sample 2. The metallographic structure of both samples is a mixture of ferrite and pearlite. It can be seen from the Figure that the rolling line of water-cooled tube wall structure is relatively obvious.

The existence of rolling streamlines in the metallurgical structure of the material will affect the mechanical properties of the steel and reduce the toughness and strength of the material. At the same time, the chemical composition of ferrite and pearlite is different, which can also cause electrochemical heterogeneity inside the material, and become a potential factor for corrosion.

Through metallographic analysis, it can be seen that there are obvious rolling streamline defects in the metallurgical structure of the water-cooled tube wall, and the chemical composition of pearlite and ferrite is not the same. The heterogeneity of the electrochemical properties inside the steel structure is one of the reasons for cracks in water-cooled tube walls.

Fig. 3. Metallographic structure of Sample 1

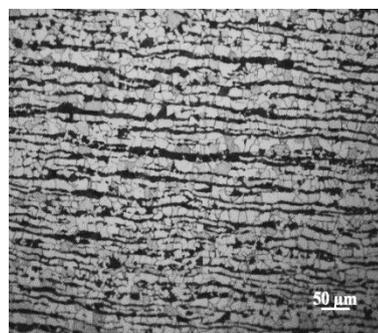
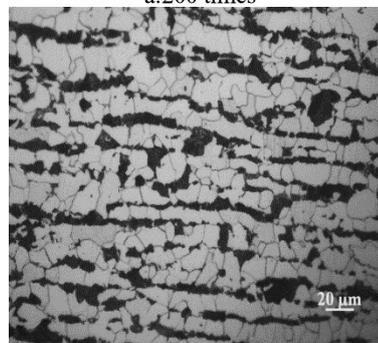
Fig. 4. Metallographic structure of Sample 2

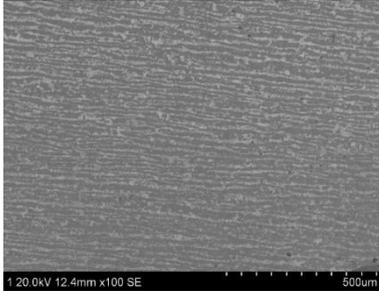
Figure 5 is a 100 times magnification scan of Sample 2. No obvious defects are seen in this figure.

Fig. 5. Scanning image of sample 2

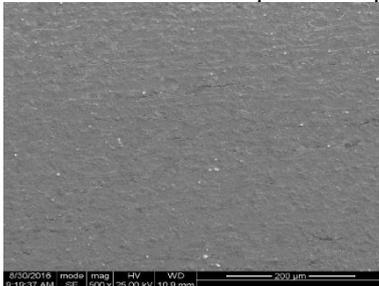
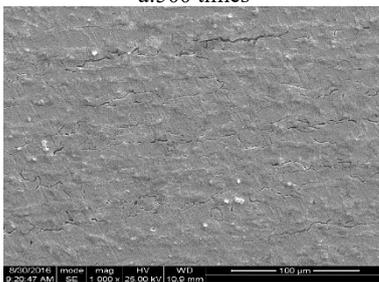
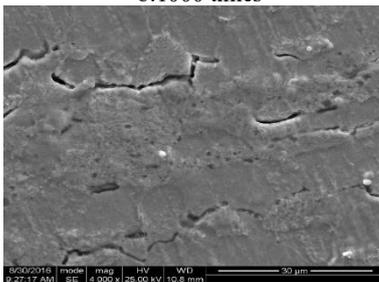
Figure 6 is a scan of the cracked part of Sample 1 at 500 times, 1000 times, and 4000 times magnifications. Obvious cracks can be observed from this figure. The cracks are linear and distributed along the rolling direction of the pipe. It has developed from the inner wall to the outer wall of the pipe, and has cracked through seriously; the crack length is between 10 μm to 200 μm, and most of them are concentrated between 50 μm to 150 μm.

Fig. 6. Scanning pattern of cracks in sample 1

Through scanning electron microscope analysis, we can see that there are obvious cracks in the metal structure of the water-cooled tube wall. When the pipeline is in working condition, the water vapor in the pipeline will exert pressure on the pipe wall, causing the concentration of stress at the crack, accelerating the expansion of the crack, and also causing the anisotropy of the metal structure, making the metal tissue there highly active, thus accelerating the corrosion of the steel.

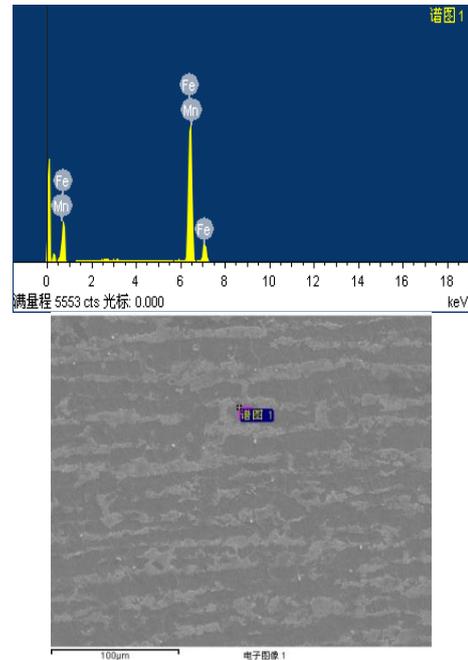
The EDS was performed near the cracks of the water-cooled tube wall. The composition is shown in Tables 1 and 2. The results of EDS showed that the tissue composition near the cracks of the water-walled tube is normal, and no other elements are found.

element	weight (%)	atom (%)
Mn K	0.97	0.98
Fe K	99.03	99.02
total	100.00

Fig. 7. Scanning matrix of the crack (spectrum 1)

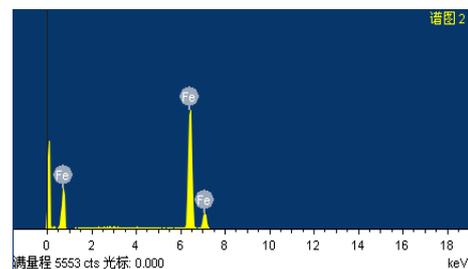
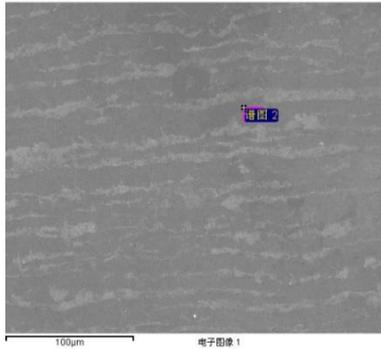
element	weight (%)	atom (%)
Fe K	100.00	100.00
total	100.00

Fig. 8. Scanning matrix of the crack (spectrum 2)
