Analysis on Corrosion Fracture of Guyed Rod of Cable Stayed Iron Tower in 110 kV Transmission Line

Hao Chen*, Xuechao Zhang, Xiao Liu, and Xin Qiao

Inner Mongolia Electric Power Science & Research Institute, Hohhot, Inner Mongolia, 010020, China

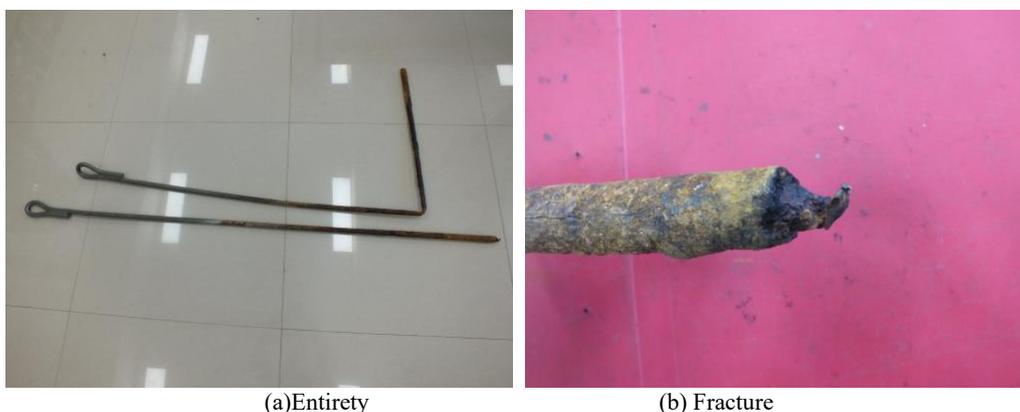
The 110kV guyed tower is located in the pastoral area without any industrial pollution. The guyed rod is made of Q235B with the diameter of 18mm and hot dip galvanizing layer is adopted as anticorrosive coating. Through excavation inspection, it is found that the underground part of guyed rod has fractured and corroded seriously, without obvious elongated deformation. Meanwhile its surface has been completely

covered with brown corrosion products, which illustrates that the zinc coating has totally depleted, as shown in figure 1. Additionally, the cross-section area of the stay guyed rod near the fracture is reduced by 70% due to soil corrosion, leading to a significant decrease in the bearing capacity. However, the above ground part of the guyed rod is almost free of corrosion, and the galvanized layer is relatively intact.

Figure 1 The macro morphology of the corroded guyed rod.

3) The method of nesting the guyed rod into a PVC pipe could effectively isolate it from corrosive substances in air and soil, which would play a good anti-corrosion role. Moreover, epoxy resin and zinc aluminum alloy with stronger corrosion resistance could be considered as anticorrosive coating, in order to ensure the safety and stability of transmission line.

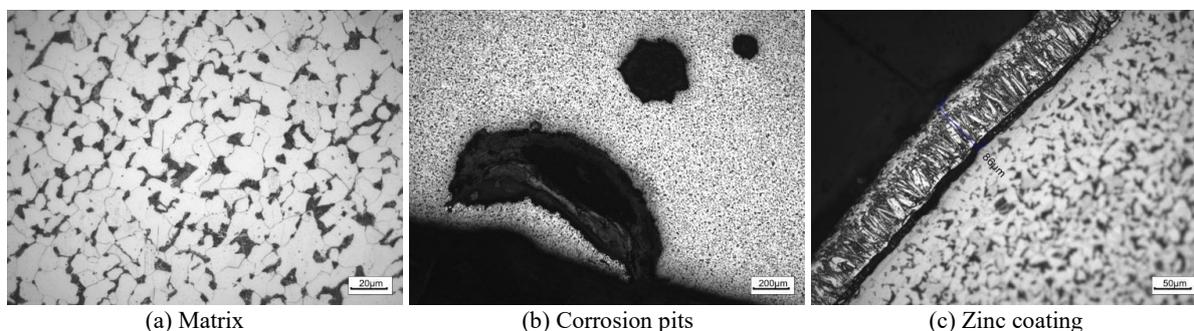
Figure 2 shows the metallographic microstructure of the corroded guyed rod. In the cross section near the fracture, the metallographic structure of the guyed rod is mainly polygonal ferrite and equiaxed pearlite, without

abnormal microstructure. Meanwhile, there are many corrosion pits in different sizes and depths on the surface of the corroded guyed rod. In addition, the thickness of zinc coating on the above ground part of the guyed rod is determined as 86μm by metallographic method.

Figure 2. The metallographic structure of the guyed rod.

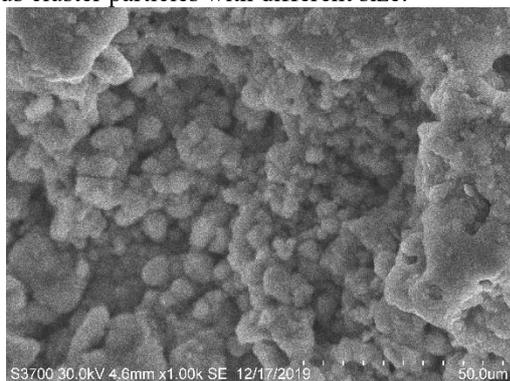
The micro morphology of the corrosion products sampled from the corroded guyed rod is investigated by means of scanning electron microscope (SEM) and the result is shown in Figure 3. It is clearly observed that the

surface of the corroded guyed rod is covered with a large number of corrosion products, which are loose and porous cluster particles with different size.

Figure 3. The SEM morphology of corrosion products.

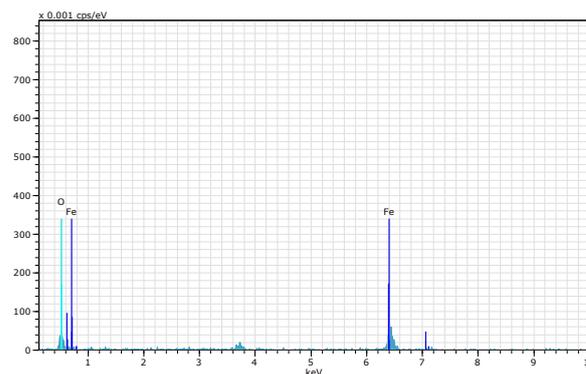
The chemical compositions of the corrosion product on the surface of the corroded guyed rod are analysed by energy spectrum analyser, and the testing result is shown in Figure 4. The result illustrates that the corrosion product mainly contains iron and oxygen without other elements, which should be iron oxide.

Figure 4. Energy spectrum analysis chart for corrosion product.
