Typical failure forms and improvement measures of power grid fasteners

Abstract. By investigating the fastening defects of power grid components, it was concluded that unreasonable design, insufficient corrosion protection, improper assembly and insufficient fastening were the four typical forms of bolt failure. In response to the above problems, improvement measures such as design review, material sampling inspection, construction supervision, and operation and maintenance inspection were proposed.

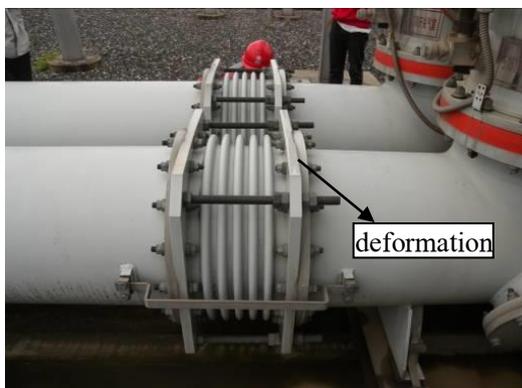
Fig. 1. Morphology of flange deformation.

The A leakage leakage defect occurred in the 126kV GIS bellows of a 110kV substation, and its model was ZF4-

110MGIS. Leakage was located at the joint between the bellows and the bus. The flange of the expansion joint of

GIS equipment had been deformed, as shown in Figure 1.

This type of bellows was an elastic element. It required a certain compensation bus bar sleeve expansion requirements during the design. The installation instructions indicated the clearance between the inner bolt (bellows side) and the flange plate to be 3-5mm, and the outer bolt (the tube side) didn't leave gaps to partially compensate for the axial expansion and contraction of the aluminum alloy cylinder. The on-site inspection of the fastening gaps between the bolts on both sides of the bellows flange plate and the flange plate found that the both-side bolts and the flange plate were locked and there was no clearance, as shown in Figure 2. By checking the installation information of the substation, the GIS equipment was installed and tested in summer. At that time, the temperature was high, and the aluminum alloy cylinder was in a thermal expansion

state. The bellows was under compression, and the maximum difference in the annual temperature of the substation was about 40°C. When the temperature was

low, the aluminum alloy cylinder shrunk and the screw directly distorted the flange plate through the outer bolts. The GIS bellows was under tensile stress. After the long-term operation, the weld between the bellows and the flange welds leaked.

1) In the design liaison meeting, the design drawings of the sealing parts and expansion parts of the main transformer and GIS and other important equipment were reviewed to avoid the problems of poor sealing and poor expansion.

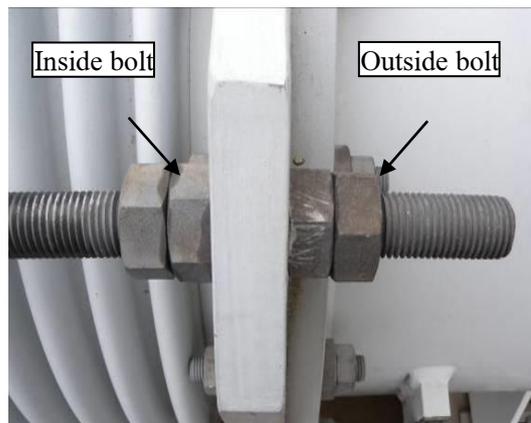
Fig. 2. Morphology of flange bolt fastening clearance.

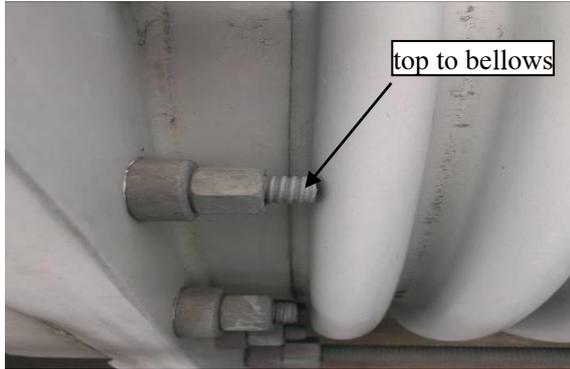
Fig. 3. Metallographic structure of thin walls of the flange.

In addition, there were also problems with the design of the fasteners on the inner side of the expansion joint. The screws of some fasteners were too long and had been pushed onto the body of the expansion joint, which would damage the outer surface when the expansion joint contracts, as shown in Figure 3.

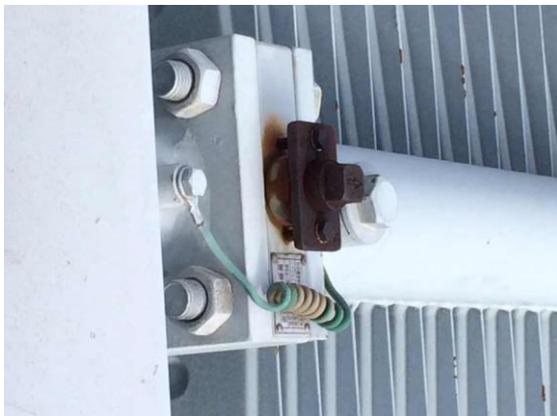
Fig. 4. Corrosion morphology of butterfly valve bolts.

A 220kV substation had been in operation for only 2 years. During the maintenance, it was found that the

fasteners of the main transformer butterfly valve were severely rusted, as shown in Figure 4. The bolting process used was cold galvanized, and the anti-corrosion performance was not suitable for outdoor wet environments.

2) In the material procurement stage, the quality of galvanized coatings of stainless steel bolts and the quality of stainless steel bolts should be tested to ensure their anticorrosive performance.

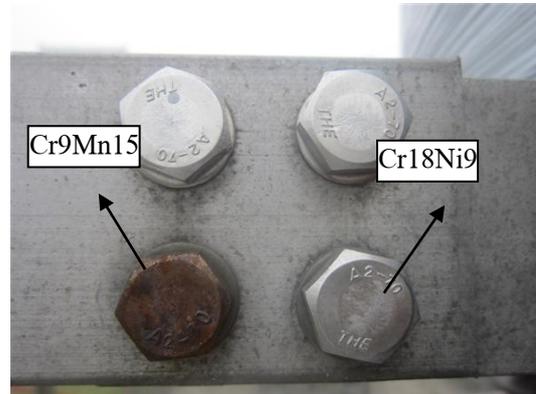
Fig. 5. Comparative appearance of stainless steel bolts of capacitor shunts.

In addition, the fastening bolts on the capacitor deflector of a 220 kV substation were made of stainless steel, but the corrosion of the stainless steel bolts of the same component was in sharp contrast, as shown in Figure 5. The composition was tested with a hand-held alloy analyzer, as shown in Table 1. The main component of the rusted bolt was Cr9Mn15. Ni element was not found in the composition, but the Mn content was as high as 15%. According to GB3098.6-2000 "Mechanical properties of fasteners, stainless steel bolts, screws, and studs" [3], rusted bolt was unqualified. The kind of high Mn stainless steel bolt was widely used in the power grid [4]. The unrusted stainless steel bolt was made of Cr18Ni9, which belonged to the typical austenitic stainless steel composition with excellent corrosion resistance.

Element	non-rusted bolt/%	rusted bolt/%	Standard/%
Si	0.87	0.95	≤1.00
Mn	1.06	15.04	≤2.00
Cr	18.60	9.28	18.00~20.00
Ni	9.79	-	8.00~11.00
Fe	Remain	Remain	Remain

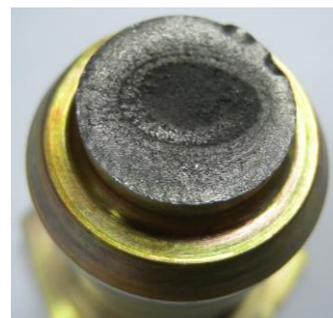
Fig. 6. Morphology of macro fracture of the bolt.

Fasteners could also be used as load-bearing connections in power grid switching equipment, such as closing spring energy storage connecting rod bolts. In the event of improper bolt assembly, the force was significantly different from normal conditions. A 220kV circuit breaker A-phase closing spring energy storage connecting rod bolt broke during spring energy storage, as shown in Figure 6, causing the spring and the energy storage connecting rod and bolts to punch out of the circuit breaker back cover. The circuit breaker was operated in 2009 and the bolt design material was 42CrMo steel.

3) During the construction phase, the gaskets, assembly methods, and tightening torques in the bolt assembly should be tested to ensure the installation quality. It is recommended to use a torque wrench to check the tightening force. At the same time, it is necessary to strengthen the training of field personnel for the importance of bolt installation to improve quality awareness.

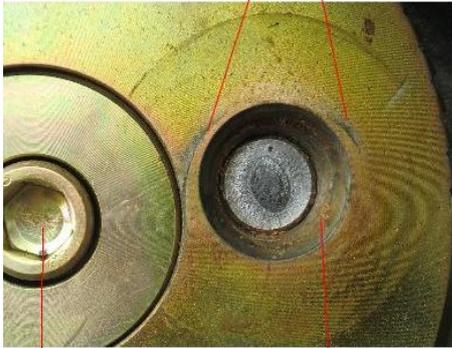
Fig. 7. Morphology of ratchet connected with the bolt.

Fig. 7 had shown the photos of the accidental fault bolts left in the ratchet wheel. It could be clearly seen that the thrust bearing pad had a more obvious indentation left on the surface of the ratchet wheel, which could be inferred that the connecting rod bolt was incorrectly assembled. The correct assembly was shown in Figure 8. The gasket was sleeved on the shaft sleeve. It was in free contact with the surface of the ratchet and it was impossible to leave a residual indentation. In this case, the 45°bevel of the bolt was tightly coupled to the 45°bevel of the ratchet internal thread, which could effectively cushion the impact of the bolt root during the switch operation. However, the actual assembly was shown in Figure 9. The gasket was pressed under the sleeve, so that the 45°slope of the bolt could not be coupled with the ratchet. In this way, the root of the bolt would be subjected to a large impact of additional bending moment stress when the switch was opened and closed, and eventually the root of the thread undercut would have a relatively rapid early low-cycle fatigue fracture.

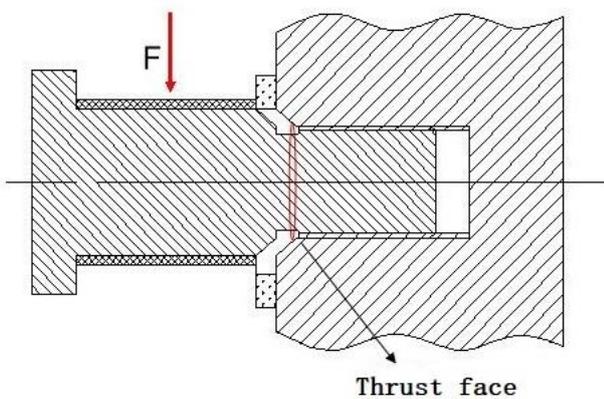
Fig. 9. Schematic diagram of incorrect assembly of bolts.

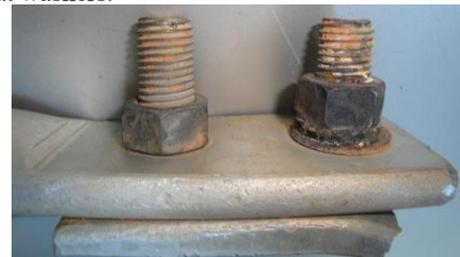
The tightness of the bolts of the grid deflection components directly affects the contact resistance of the connection parts, which results in different operating temperatures. The two sets of high-frequency protection channels of a 220kV line are abnormal. During the inspection, it was found that the drainage plate on the rear side of Phase A of Tower 107 of the line was burned out, as shown in Figure 10. The failure clamp drainage aluminum plate was connected by two bolts, and the fracture position was at the bolt connection. Obviously high temperature burns and melting deformations can be seen at the clip fracture and both bolts. In addition, the bolts and nuts was significantly rusted without spring and flat washers.

Fig. 10. Morphology of the failed clamp bolt.

Due to the above-mentioned quality defects in the installation process of the failed clamp, the bolt connection was loose and the local contact with the diversion caused the diversion area of the drainage plate to decrease during the operation. The temperature rose accordingly. Under the condition of a certain load, the clamp would gradually deform at high temperature until it melted. Because the melting point of aluminum is 660°C[5], which is much higher than the melting point of zinc, the corrosion-resistant galvanized layer of the connecting bolts has been melted before the aluminum plate is melted, causing serious corrosion of the bolts.

4) In the operation and maintenance phase, infrared temperature measurement should be performed on the fastening bolts of the high current part during the peak load period, and important bearing forces and seals should be monitored to avoid heating, corrosion and leakage.
