Failure analysis of isolation switch in transformer substation

Abstract. To analyze the fault cause of metal parts of isolation switch, a series of tests including macro check, penetrate testing, hardness measurement, composition tests and metallographic observation have been carried out. The experimental results showed that the failure of connecting lever was caused by improper processing, which resulted in the limitation of cracking and stress corrosion cracking. Based on this, the corresponding noteworthy key points were put forward to avoid similar accidents.

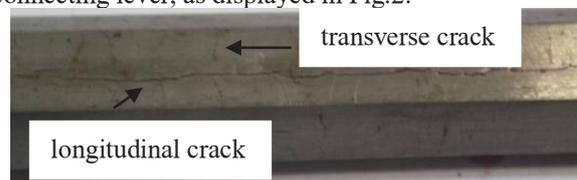
The connecting lever of isolation switch was severely cracked as shown in Fig.1. Massive cracks extend on the surface of connecting lever which was composed of 0Cr18Ni9 austenite steel with hexagonal profile. Further penetrant testing results revealed that the longitudinal crack was as long as 300mm, accounting for about 72% of the total length of the connecting lever. There are also many transverse cracks on the middle surface of the connecting lever, as displayed in Fig.2.

Fig. 1. Macroscopic feature of connecting lever.

Fig. 2. Penetrant inspection of connecting lever.

The austenitic stainless steel material is prone to aging cracking (also called delayed cracking) when the residual stress is not eliminated after processing. The processing of hexagonal connecting rod adopts the drawing technique, and the hardness exceeds the standard requirements which implying that the internal stress is large and the longitudinal crack conforms to the aging cracking characteristics.

Austenitic stainless steel is prone to stress corrosion under the condition of tensile stress corrosion. The connecting lever is in service condition of tensile stress, and contact with the external environment can provide corrosion medium. Considering that the transverse crack is densely distributed in the stress region (middle part of the connecting lever), it can be judged that the transverse crack is a stress corrosion crack. In addition, due to the low content of Cr and Ni of the connecting lever, the material composition does not meet the standard requirements of GB/1220-2007 Stainless Steel. It also has a great impact on the failure and cracking of the connecting lever.

The chemical elements, hardness, tensile strength, elongation of failed connecting lever do not meet the standard requirements which indicating the material is not qualified. The immediate cause of failure is aging crack and stress corrosion crack which is caused by improper processing.

1) The main reasons for cracking of connecting lever are aging cracking and stress corrosion cracking caused by improper processing technology. It is suggested to replace hexagonal connecting lever with round steel connecting rod and strengthen the quality inspection of stainless steel parts.

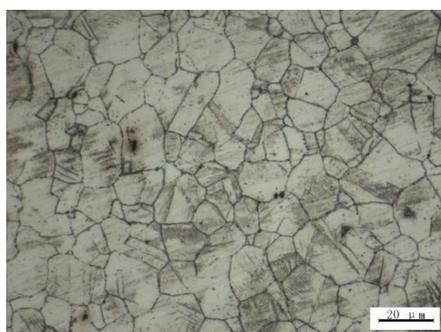
Fig. 3. The metallographic structure of connecting lever.

The microstructure of the connecting lever is combination of austenitic and carbide as shown in Fig.3, which conforms to the microstructure requirements of austenitic stainless steel. The microstructure of the

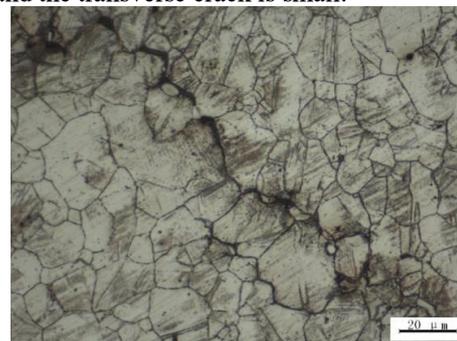
longitudinal crack is shown in figure 4. The crack extends along the grain boundary and extends inward from the surface of the sample. The longitudinal crack is large and the transverse crack is small.

Fig. 4. The longitudinal crack picture of connecting lever.

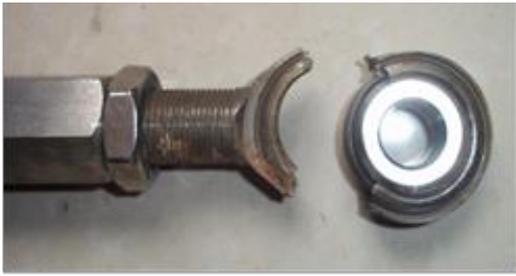
The two failed universal joint of isolation switch were shown in Fig.5 and Fig 6, respectively. There is corrosion on the surface of both samples, and the cracks are located in the directions of four o'clock and eight o'clock of the outer ring. Observed from the side of disconnected universal joint, distortion occurs from the ball head to the part above the crack, as shown in Fig.5 Further inspection revealed that the fracture exhibits no deformation.

Fig. 5. The macroscopic feature of disconnected universal joint.

According to the microstructure analysis, the actual material of universal joint is ZG0Cr18Ni9. In addition, the design requirements are forgings, the actual use is castings, the material is inconsistent with the design. The microstructure of cast steel is not uniform, there are structural defects such as element segregation, and its performance is much lower than that of machined stainless steel.

2) The main reason for the damage of the universal joint is the wrong use of the material. The design material is forged 0Cr18Ni9, while the actual use material is cast ZG0Cr18Ni9 which makes the mechanical properties of the part lower than the design requirements. It is recommended to replace all the universal joints in the same batch, and to strengthen the inspection of not replacing in time.

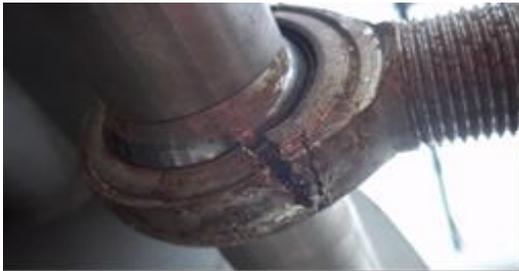
Fig. 6. The macroscopic feature of undisconnected universal joint.

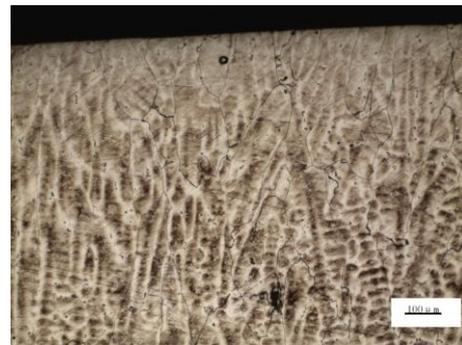
Fig.7. The metallographic structure of universal joint.

The microstructure of the sample is austenite with coarse structure, as shown in Fig.7. There is equiaxed crystal at the edge, obvious columnar crystal inside. The dendrite solidification trace could be identified, as well as immaterial twins. typical as-cast austenitic structure, as shown in Fig.8 and Fig.9.

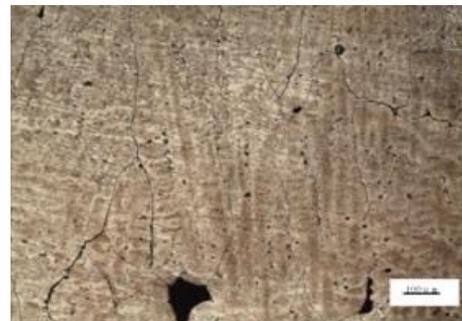
Fig.8. The picture of thick columnar crystal.

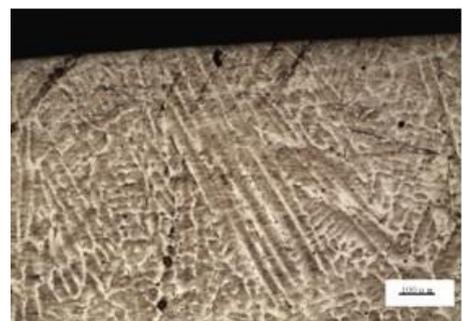
Fig.9. The picture of dendritic crystal.

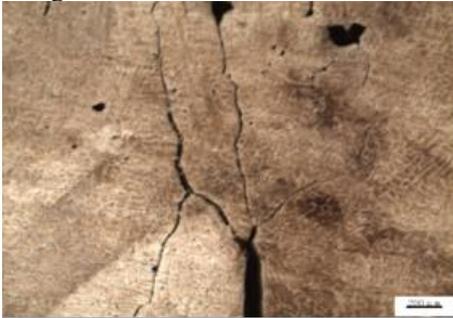
At the same time, there are multiple cracks in the microstructure. The cracks are generated from the edge and gradually grow into the tissue along the grain boundary, which is a typical intergranular crack, as shown in Fig. 10.

Fig.10. The picture of the intergranular crack in sample.
