# Analysis on three typical abnormal microstructures of overhead power line suspension clamps

**Abstract.** This article lists three typical abnormal microstructures of overhead power line suspension clamps, including inclusion, flake graphite and cementite network. A series of tests including macro check, hardness measurement, composition tests, Energy-dispersive x-ray analysis and metallographic observation have been carried out. The experimental results showed that the causes of abnormal microstructures mainly include: high content of impurities, flake graphite blank and unfulfilled annealing heat treatment. It is suggested to strengthen the supervision on suspension clamps before using, and focus on the quality inspection of metallographic structure and composition.

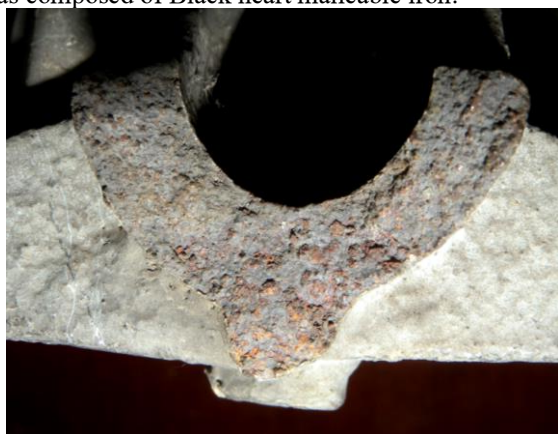
The suspension clamp A broke in the groove where the u-screw was assembled, with a straight fracture, no obvious wear and plastic deformation, and a typical brittle fracture, as shown in Fig. 2. The suspension clamp was composed of Black heart malleable iron.

Fig. 2. The fracture morphology of suspension clamp A

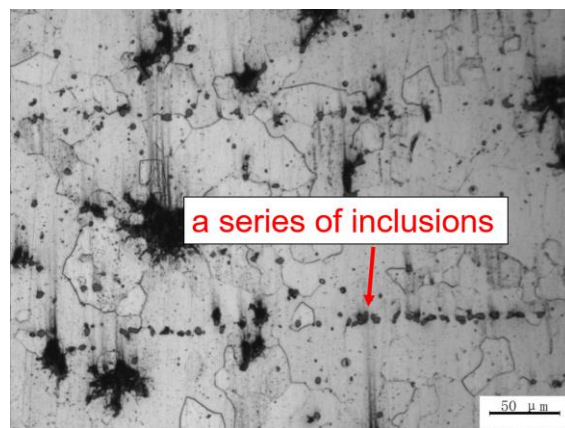
Fig. 3. The metallographic structure of suspension clamp A containing a series of inclusions.

The metallographic structure of suspension clamp A is consist of ferrite and tempered graphite, which meets the requirements of black heart malleable iron in the standard of GB/T 9440-2010 Malleable Iron [4].However, there are many inclusion of light gray particles in the metallographic structure, and they are connected into strings, as shown in Fig. 3.

S is an anti-graphitized element in malleable iron that forms a compound with Mn. Due to the excessive S element content in suspension clamp A, too much sulphur-manganese compound was formed, and these inclusions were distributed in the matrix in the form of chain, which segmented the continuity of malleable iron matrix, resulting in brittle fracture along the chain inclusions of suspension clamp A.

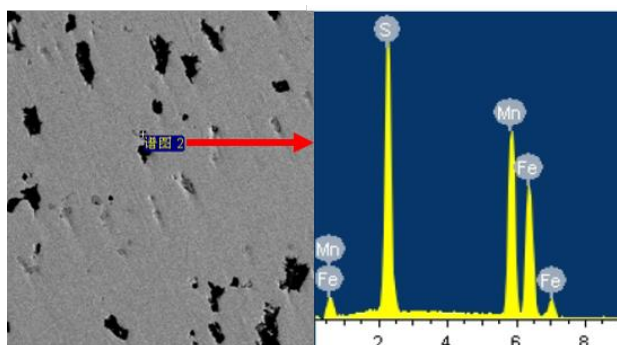
**Fig. 4.** SEM morphology and EDS spectrum of inclusion

Further observation by scanning electron microscope and semi-quantitative analysis of the series-shaped inclusions by matched energy-dispersive X-ray spectroscopy showed that the composition of the small-particle inclusions was mainly sulphur-manganese compounds, in which the atomic percentage of S reached 34.9%, as shown in Fig. 4 and Table 3.

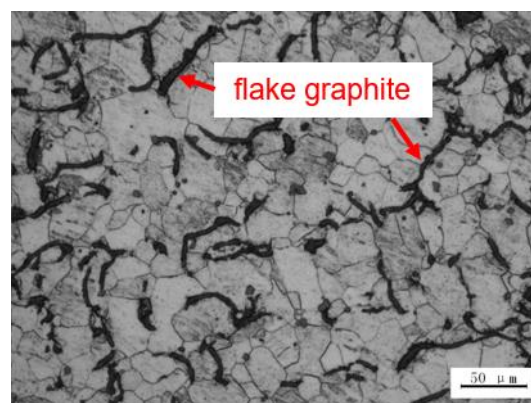
**Fig. 5.** The metallographic structure of suspension clamp B with flake graphite.

As we can see from Fig. 5, the metallographic structure of suspension clamp B was composed of ferrite and flake graphite, and flake graphite was distributed on the grain boundary of the matrix, showing a reticular structure. It did not meet the requirements of black heart malleable iron in GB/T 9440-2010.

blank is generally in the form of cementite, and there is no free graphite. After graphitization annealing at high and low temperature, the cementite in the metastable state of the structure was decomposed and transformed into a stable tempered graphite structure. Therefore, the presence of flake graphite in suspension clamp B indicates that white cast iron blank was not completely annealed and there was still a large amount of free carbon. Even if the subsequent annealing treatment was carried out normally, normal metallographic structure could not be obtained. The microstructure of suspension clamp B does not meet the standard requirements of GB/T 9440-2010 Black Heart Malleable Iron, and its mechanical properties deteriorate, resulting in fracture.

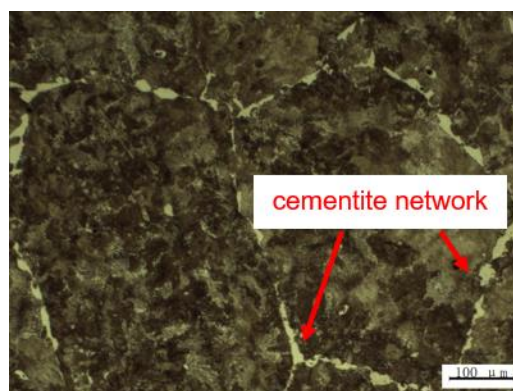
**Fig. 6.** The metallographic structure of suspension clamp C with cementite network.

The microstructure of suspension clamp C is a combination of ferrite and cementite network as shown in Fig. 6.

The cementite in the suspension clamp C are distributed in a network, which divides the continuity of the matrix and leads to the fracture of the clip.

Normally, most or all of the matrix of black heart malleable iron should be ferrite. However, when the annealing temperature is too low or the annealing holding time is too short, there may be residual pearlite or cementite in the matrix. According to *Metallographic Atlas of Metal Materials*, the first stage (high temperature stage, 920-980°C) will have eutectic cementite in the matrix if the annealing temperature is low or the insulation is insufficient. In the intermediate cooling stage, the secondary cementite will be precipitated in the matrix if the cooling speed is too fast. If the residence time is too long in the process of low temperature cooling, the tertiary cementite will be further precipitated in the matrix. So, the emergence of cementite network in suspension clamp C indicates that the annealing treatment has not been strictly carried out.
