Investigating the presence of mold in wood treated with chlorophenol

Olle Ekberg¹, Johnny C. Lorentzen², and Lars-Erik Harderup¹

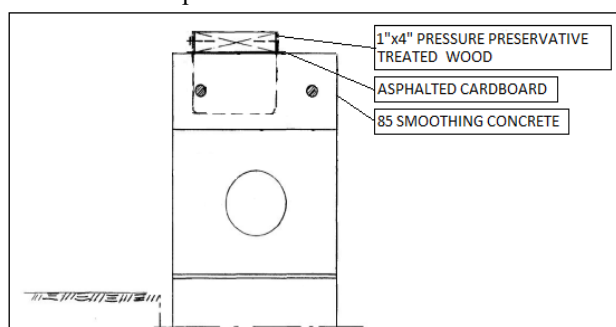
Inspection of the blueprints and technical descriptions for the school show that wood preservatives were in fact ordained for use in the sill plates. The image in Fig. 1 show one of the blueprint details of the crawl space wall and the PPT sill plate.

Fig. 1: Construction detail of the crawl space wall with ordained use of wood preservatives. The text is translated from the original Swedish.

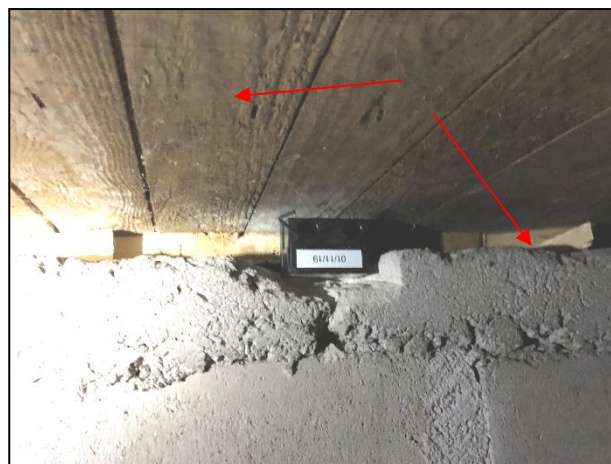
Fig. 2. Sample collection points from the sill plate and the crawl space ceiling in the northern facade. A wireless sensor is installed in the middle.

When inspecting the crawl space for signs of mold growth, no spots of visual growth were found on the sill plates. The crawl space ceiling showed patchy signs of a thin white substance in certain parts, which could be either white mold or efflorescence (salt residue) [14]. The bottom half of the concrete walls were covered in efflorescence.

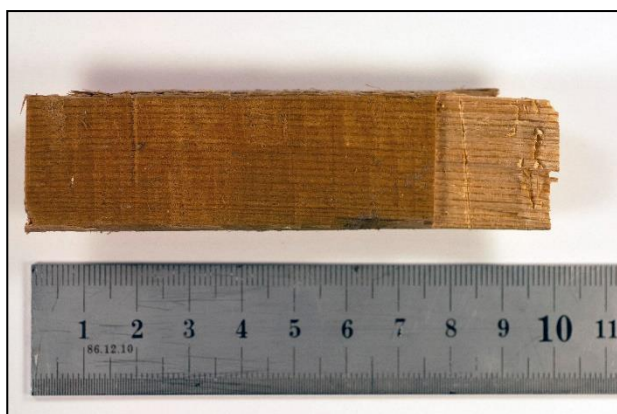
Ocular inspection of the samples did not identify mold growth. The sample from the sill plate looks like a fresh piece of wood with a smooth surface of a slightly brownish color compared to the inner parts. An odor is faint but noticeable. The crawl space ceiling sample has a smooth surface of a dark brown color with some darker spots, most likely from the coloration of the wood preservatives. This sample has a much stronger smell compared to the sill plate sample. Sample photos of the ocular assessment can be seen in Fig. 3 and Fig. 5.

Fig. 3. Sill plate sample. No magnification. MI 2.

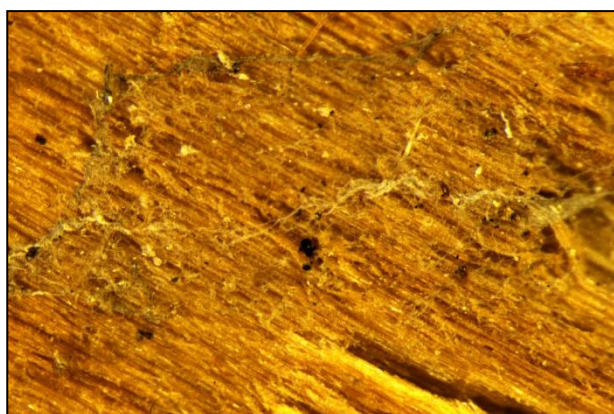
Analysis of the samples using a microscope show that there was some mold growth on the samples. The sill plate sample had MI 2 whereas the crawl space ceiling had MI 3, using the 0-4 scale. Both samples show hyaline hyphae. The sample photos at 40x magnification is presented in Fig. 4 and Fig. 6.

Fig. 4. Sill plate sample. 40x magnification. MI 2.

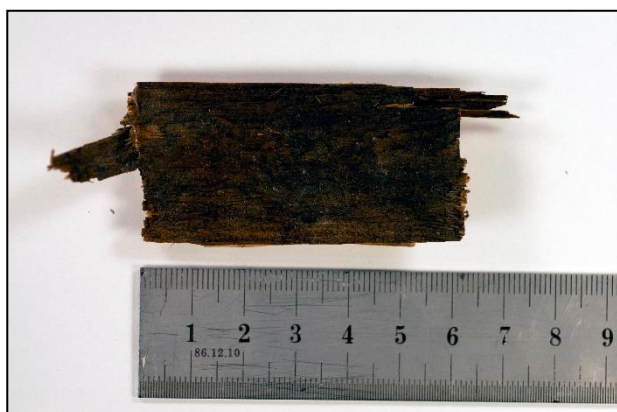
Fig. 5. Crawl space ceiling sample. No magnification. MI3.

The sample of the crawl space ceiling is considerably darker than the sill plate sample, making it harder to distinguish any growth at an ocular level. However, the examining conditions for all samples were the same with equal viewing distance and lighting to make the assessment consistent and comparable.

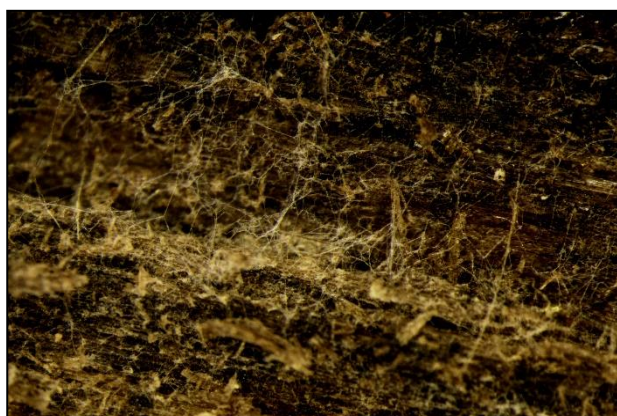
Fig. 6. Crawl space ceiling sample. 40x magnification. MI3.

The microscope analysis both indicated a MI 2 or higher, thus having stated mold growth according to the 0-4 scale [12]. However, the ocular assessment did not identify any clearly visible mold growth but a distinct odor could still be noticed from the samples.
