Analysis of rainfall-triggered landslide in Baleagung Village, Magelang Regency, Central Java

Abstract. The majority of Magelang Regency is considered as intermediate and high susceptible areas against landslide. As happened in Baleagung Village in January 2018, a landslide has damaged local residency buildings. The landslide occurred because of high-intensity rainfall on the day before. Meanwhile, cracks formed in several areas that were indicated by the slope around the village were still actively moving. Therefore, mitigation is urgently needed to minimize the risk of further landslide movement. This study aimed to analyze the mechanism of ground movement at Baleagung Village which was affected by rainfall. This research was conducted by using back-analysis method to determine the initial groundwater level conditions and its effect on the slope stability. Soil parameters were obtained by laboratory testing and permeability tests in the field. Subsequently, rainfall data was collected from Himawari-8 satellite and used as the data input parameter for numerical analysis using SEEP/W and SLOPE/W. The results obtained from back-analysis showed that rainfall infiltration into the so

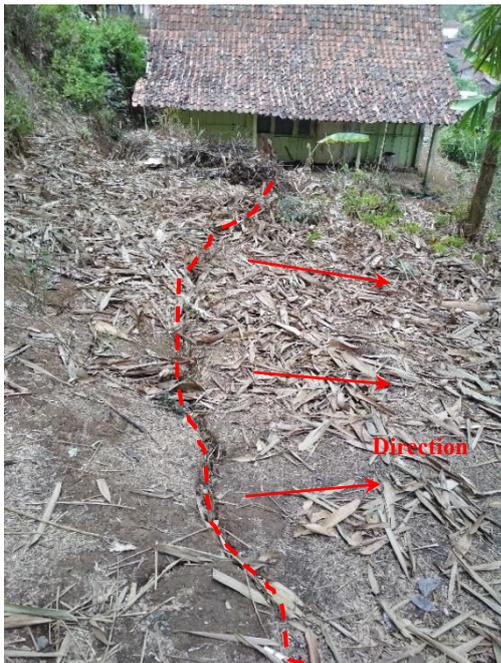
During the field observation, the slope movement can be located by the indications of cracks surrounding the slope (Figure 2) and several buildings. Therefore, mitigation is needed to minimize the risk of further landslide movement. Mitigation effort or disaster countermeasure is divided into two parts, structural and non-structural mitigation [3]. Structural mitigation could be conducted in the form of structural reinforcement, slope protection, drainage system, sabo dam construction, etc. Meanwhile, one of non-structural mitigation effort is by designing a monitoring and early warning system in the susceptible area.

Fig. 2. Crack surrounding Kupen Sub-village

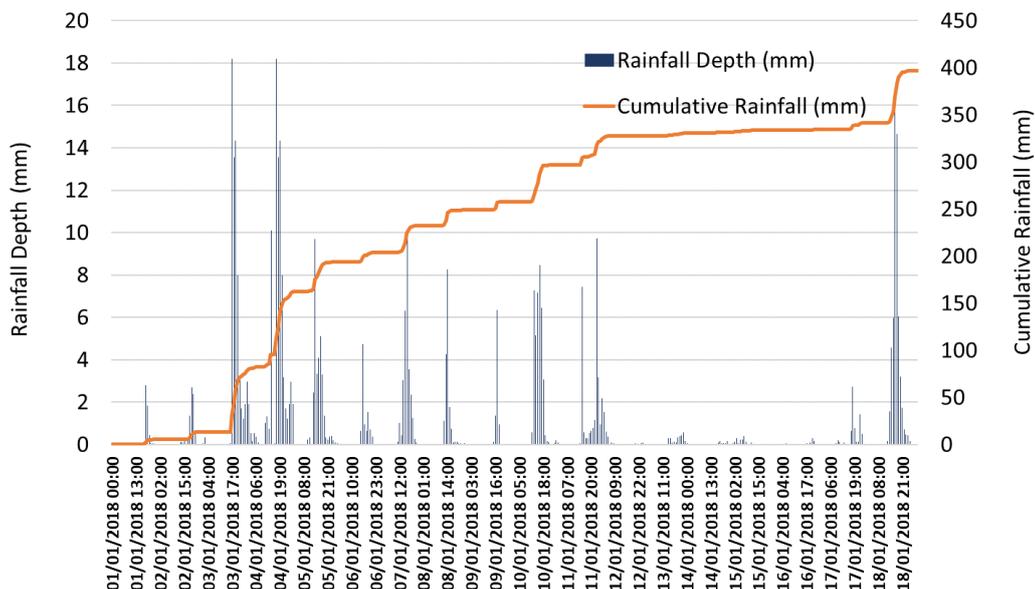
According to Figure 4, it is clarified that the rainfall level was quite high before the landslide occurred. As shown in Table 6, that at a day before the landslide, daily rainfall accumulation reached 54.81 mm. A few days before the event, on January 3rd and 4th January, daily rainfall accumulation reached 60.69 mm and 82.03, and it was categorized as heavy rain.

Fig. 4. Rainfall at Baleagung Village on 1-19 January 2018

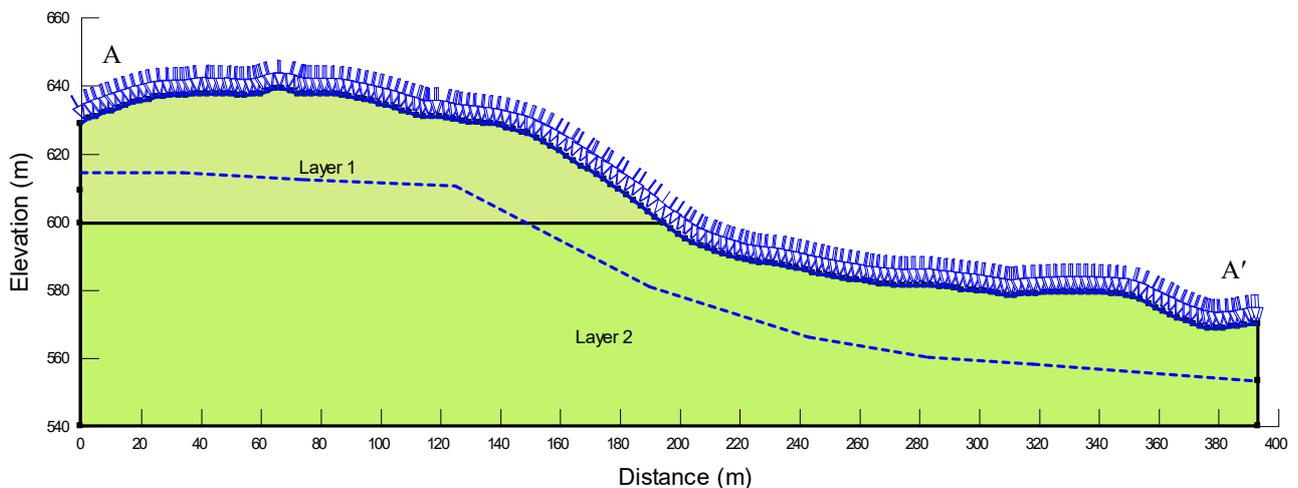
Landslide simulation was started with the slope geometrics determination at the most critical cross-section, as shown in Figure 3 (cross-section A-A'). The model analysis of this study was SEEP/W and SLOPE/W. Each material parameter was defined according to its analysis (Table 7). SEEP/W with saturated/unsaturated material model was being used for infiltration and rainfall wetting effect analysis. Hydraulic properties and water content for each layer were inputted.

Fig. 5. Slope model scenario (Cross-section A-A')

As a structural mitigation effort, the recommendation to minimize the risk of the landslide is to adjust the slope geometry. A slope is classified as safe/stable from landslide occurrence if the safety factor value is above 1.25. Based on back analysis results, the current landslide condition was under 1.25, i.e., 1.099. The slope mass was not ‘sliding,’ yet it was critical and can move when a triggering factor presented. Transformation of the slope geometry to increase the safety factor is one of structural mitigation works. The suitable method is ‘cut and fill’, in which part of the slope is cut and used as the counterweight. This mitigation work is used as a recommendation that could be implemented by related institutions. Another

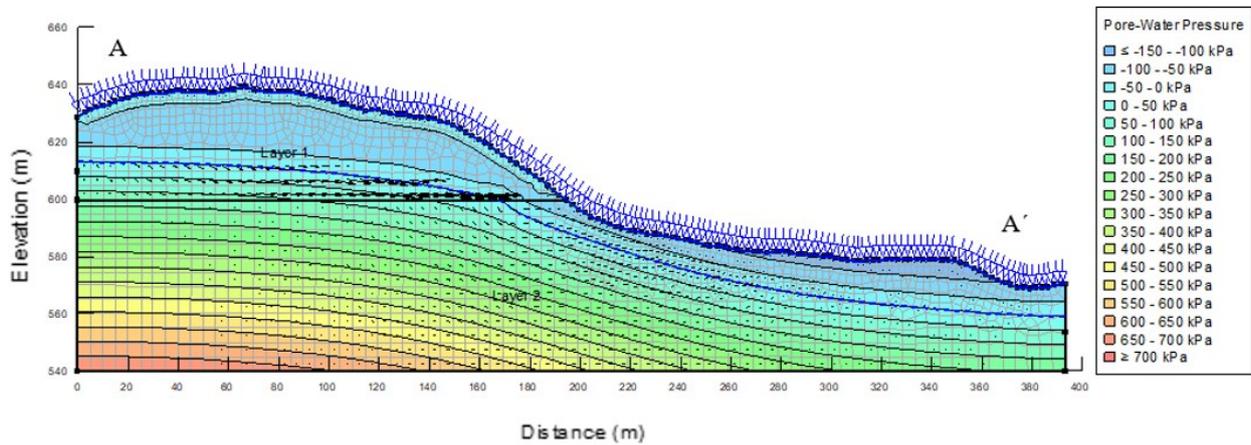
Based on the simulation results (Figure 6), pore pressure distribution for 19 days was obtained, and it increased the groundwater level. Pore-water pressure value distribution data was obtained from vertical section cut on the slope model from the ground surface until the lowest layer. The transformation is shown intuitively by the colors in Figure 6. Above the groundwater level (phreatic line), the pore water pressure was negative, shown in light blue color. Under the phreatic line, the pore water pressure was positive. The lower layer of soil, as well as the higher and more positive pore water pressure value, is shown in the color of blue, green, yellow, and red.

Fig. 6. Pore-water pressure condition on the 19th day (number show the value of pore-water pressure in kPa)

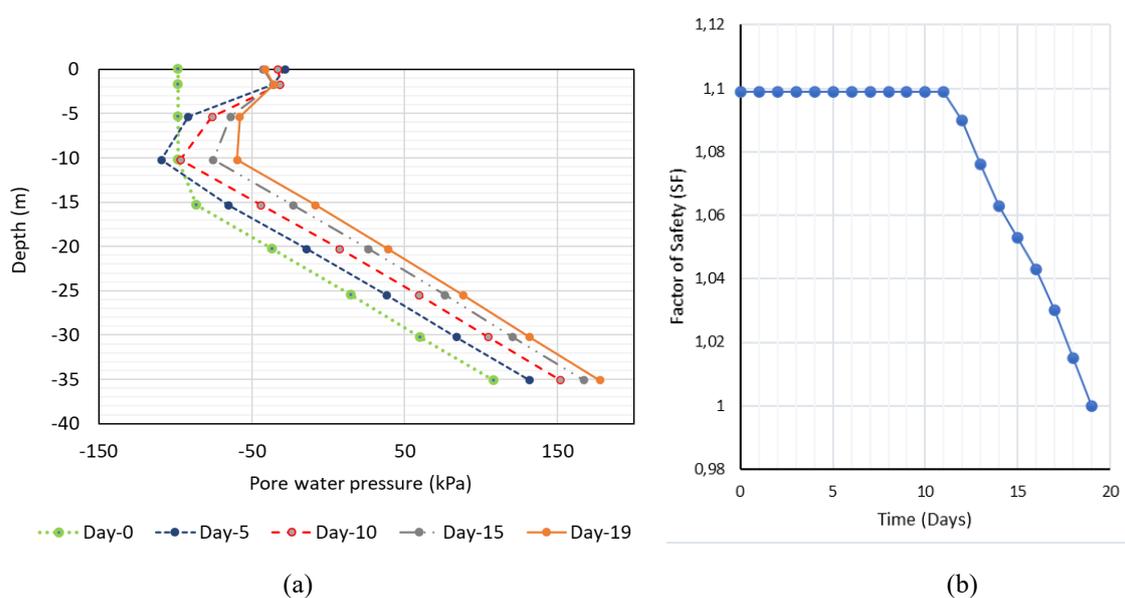
Pore-water pressure value distribution is illustrated in Figure 7a. Pore-water pressure value is changing due to rainfall infiltration into the soil. From the results, the pore-water pressure value decreased when it's approaching the groundwater surfaces.

The rise of groundwater-surface leads the SF value of the slope to decrease. According from the soil properties data, the safety factor of the initial condition of the slope was 1.099, and it was already unstable. The safety factor value did not change until day 11, and then it started to decrease. On the day when the landslide occurred, the SF value was 1.00. The rainfall effect made SF value decreased—hence triggering the landslide. Figure 7b illustrates the SF data from the groundwater-surface transformation in 19 days.

Fig. 7. (a) Pore-water pressure distribution (b) SF value distribution on 1 – 19 January 2018

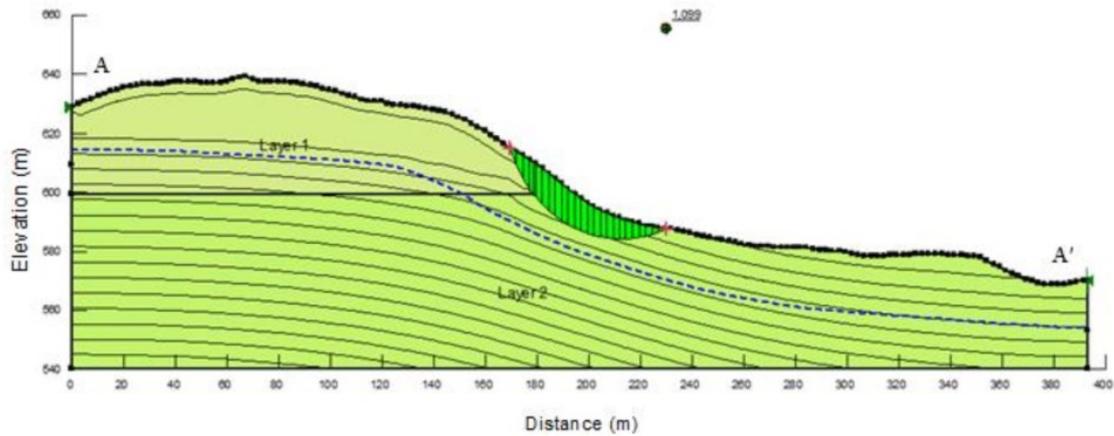
Fig. 8. SF value on the 1st day

Simulation results of the slope on the day 1 and 19 are presented in Figure 8 and Figure 9. The slip surface of both figure are used entry-exit point, which the entry point is assumed by the crack location in the field, and the exit point is got from back analysis result. In Figure 8, the groundwater has not reached the slip surface. The groundwater reached the slip surface on the day 12 and keep going up until the day 19 (Fig.9), and the slope can not hold the driving force and finally landslide occurred.

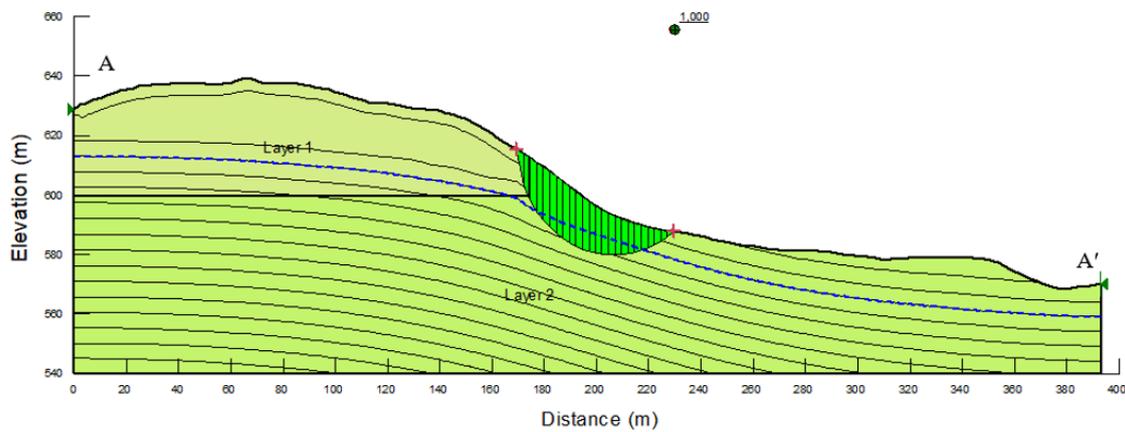
Fig. 9. SF value on the 19th day
