Possible in-service damages of steam generators at VVER-1000 and VVER-1200 NPP units and their impact on long-term operation

Abstract. Specific features of corrosion-mechanical damages of primary circuit header to steam generator vessel branch welds at VVER-1000 NPPs and their impact on safety and economic efficiency during long-term operation are analysed. Measures to avoid the damages for similar zones of VVER-1200 steam generators are discussed.

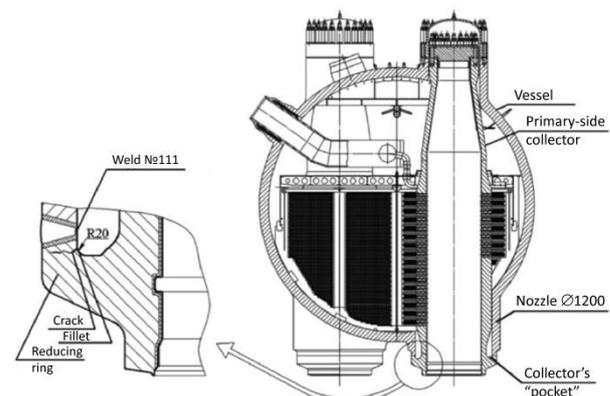
Specific design features of SS-111 zones under consideration are shown in Fig.1 [2]. SG branches connected to headers are oblique ones having long and short forming lines. A typical view of the SS-111 zone "pocket" is shown in the right part of Fig.1.

Fig.1. Steam generator PGV-1000M [2]

Damage of SS-111 starts on the inner surface from the "pockets" under corrosion impact of the secondary circuit coolant. Water chemistry parameters inside the "pockets" (Fig.1) may differ for the worse with accumulation of corrosion products and increased content of impurities.

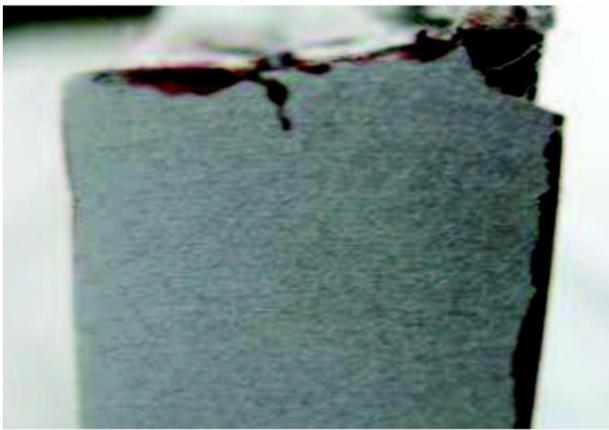
Damage in the SS-111 zone of cold SG collector of Kalinin NPP unit No.1 had specific features as long chains of pitting (Fig.2).

Fig.2. Pitting areas in the SS-111 zone of cold SG collector of Kalinin NPP unit No.1 [3]

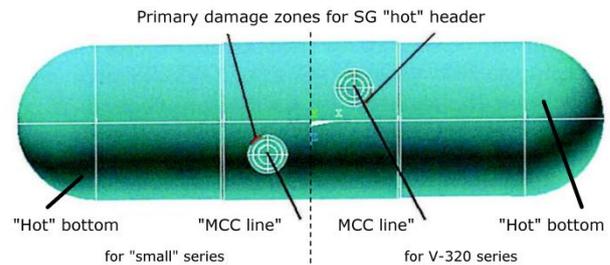
Characteristically, the position of the primary damages in the SS-111 zones of "cold" headers is also close to so-called "MCC line" as for "hot" headers (Fig.3) both on VVER NPP Units of "small" series, and on VVER NPP Units of the project V-320 (according to JSC NPO "CNIITMASH" reports [4, 7]).

Fig.3. Zones of primary damages for VVER-1000 of "small" series and V-320 series from [8]

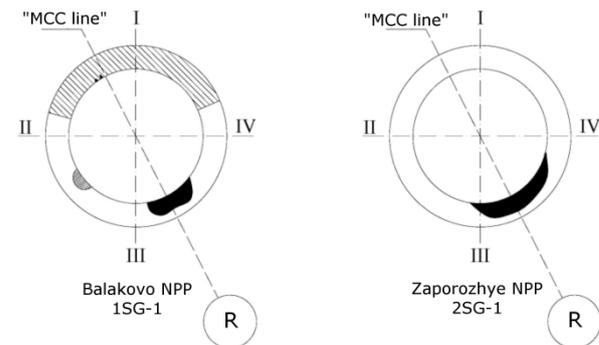
The results are consistent with the hypothesis that there is a directed mechanical impact of the MCC piping on the SS-111 zones, which should be considered as the main factor in the formation and growth of primary cracks in the direction of the "MCC line" (Fig.4-6). Fig.4 shows caption comments that are common to Fig.4-6.

- - primary damage (1st repair)
- ▨ - secondary damage (2nd and other repairs)
- ⊙ (R) - reactor

- I - long forming line (FL) of the Ø1200 SG branch
- II - FL of the Ø1200 SG branch near SG "cold" bottom (Figure 4)
- III - short FL of the Ø1200 SG branch
- IV - FL of the Ø1200 SG branch near SG "hot" bottom (Figure 4)
- "MCC line" connects centers of reactor and each SG header

Fig.4. Zones of primary and repeated defects in SS-111 of VVER NPP Units of the project V-320 ([2])

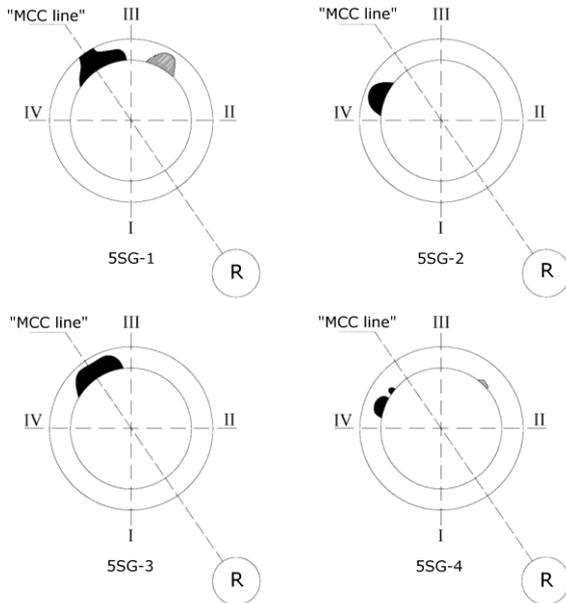
Fig.5. Zones of primary and repeated defects in SS-111 of the unit No. 5 of Novovoronezh NPP ([2])

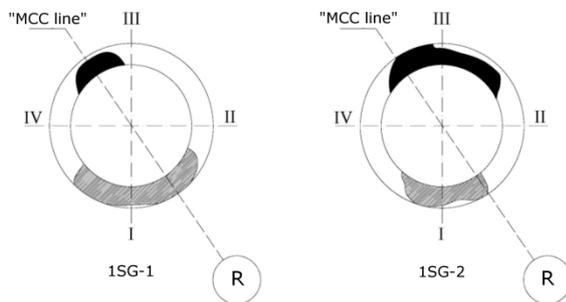
Fig.6. Zones of primary and repeated defects in SS-111 of the unit No. 1 of South Ukrainian NPP ([2])

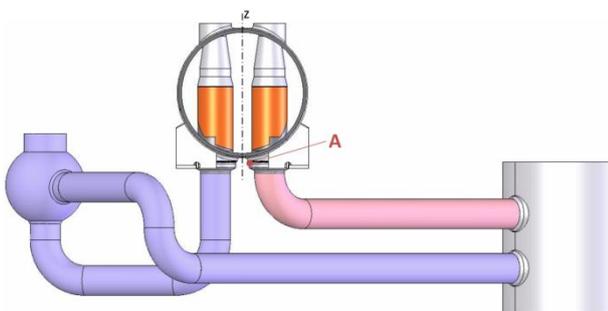
Fig.7. Layout of MCC piping of VVER NPP Units of "small" series ("hot" MCC piping in rose color)

Points A (Fig.7) and B (Fig.8) show maximum loaded zones located near short forming line of SG branches and "MCC line" (Fig.3).

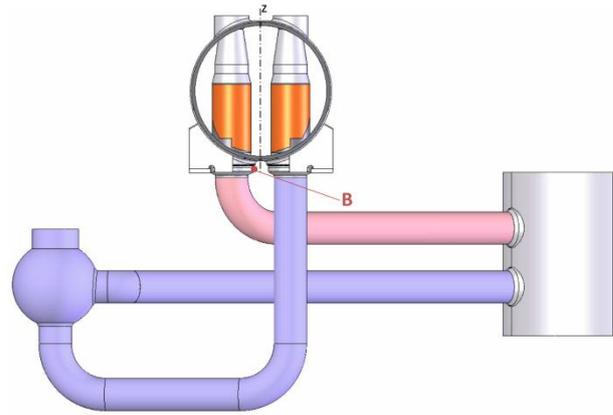
Fig.8. Layout of MCC piping of VVER NPP Units of the project V-320 series ("hot" MCC piping in rose color)
