Fracture failure analysis of the pump shaft

Abstract The failure reasons of the circulating pump shaft in the upper section of the quench tower were analyzed by means of chemical composition analysis, macroscopic observation, metallographic examination and fracture section analysis. The analysis result shows that the calcium-silicate inclusions in the surface of the pump shaft cause the microcracks and the parallel fatigue sources, which leads to the fatigue cracks propagation under alternating load and finally the shaft is fatigue fractured.

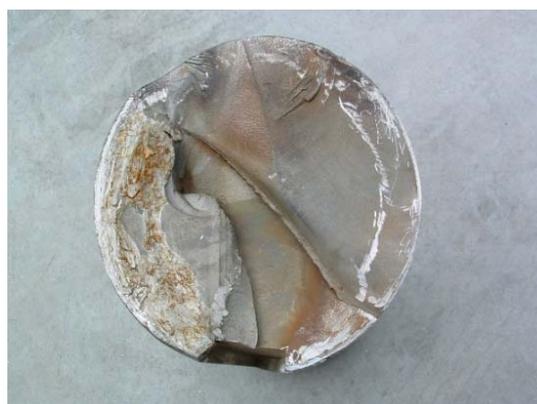
A sudden abnormal sound was detected in the circulating pump with the type of p-107S in the upper section of the quench tower of an acrylonitrile unit in Shanghai in 2019, and then the circulating pump was stopped and lift for inspection. The pump shaft was found fractured, and other parts were basically intact. The fractured part of the pump shaft was at the keyway of the shaft shoulder, where the structure of the pump shaft was discontinuous, as shown in Fig.1.

Fig.1 The fractured circulating pump shaft

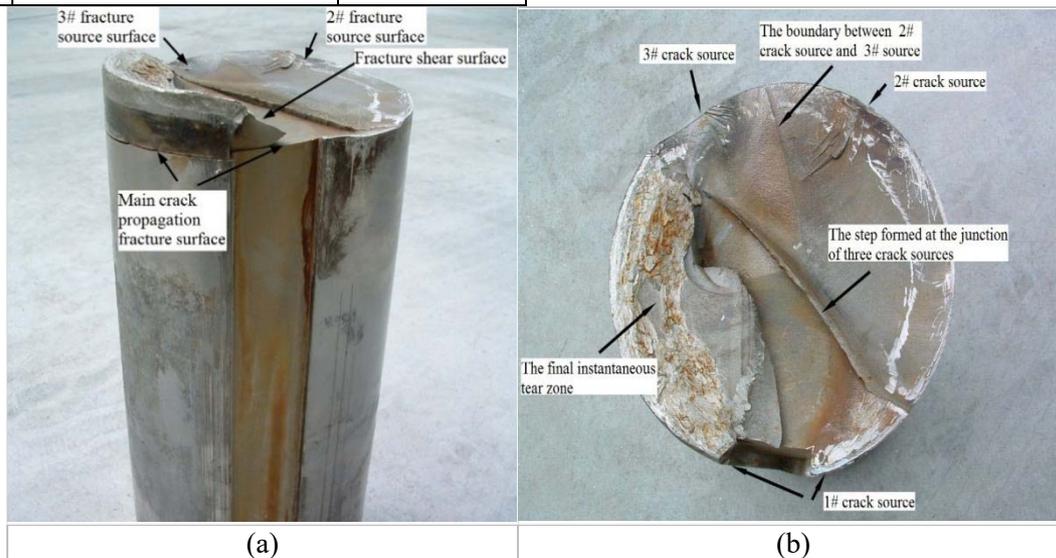
As shown in Fig.2(a), the fractured site of the pump shaft is located below the keyway of the combiner at the upper end of the pump shaft. The bottom of the pump shaft is machined thread, which is used to fix the axial position. The fractured section is at the keyway arc junction far away the bottom thread.

Fig.2 Macromorphology of the pump shaft fracture section

As shown in Fig.2(b), the whole fracture is divided into two main areas, one is the relatively smooth crack growth zone and the final uneven fracture zone. In the smooth crack growth zone, there are three parts where the black arrows point according to the crack growth steps. The parts are carefully observed that 1# crack is at the junction of the outer surface of the shaft and the machined surface of the keyway; 2# crack and 3# crack are at the axial fracture section. These three parts are the formed crack initiation parts as shown in Fig.2(b). The whole smooth crack propagation zone can be observed that the three crack sources are in different cross sections. Therefore, three steps are formed when the crack sources expand to the junctions. The middle step is the step formed by the interface of the three crack sources, while the lighter step on the fracture section is the step at the junction of 2# crack source and 3# crack source. The third step is the step formed by the crack growth zone and the final fracture zone, and the step finally tears rapidly in the form of shear layer at an angle of 45°.

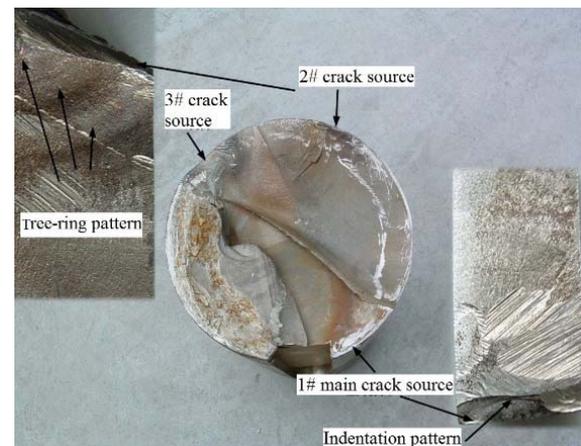
Fig.3 Partial appearance of the crack sources of the pump shaft

The features and patterns are found on the fracture section, such as the tree-rings and the indentation marks, which indicates that the fracture is a typical fatigue fracture, as shown in Fig.3. The characteristic of the features and patterns is often formed during circulating operation by the fatigue fracture propagation. When the friction between two matching fracture sections is very intense in the process of circulating operation, the mechanical polishing marks will appear in the smooth area, especially near the source area. In addition, the

surface of the fatigue crack growth zone is dark brown in color, while the surface of the final fracture zone is the fresh metallic luster in color in Fig.3[3]. The obvious difference in color between the fatigue crack growth zone and the final fracture zone is because the fatigue crack growth zone takes longer to form than the final fracture zone. The fatigue crack source is formed on the surface, and then the fatigue crack growth is connected with the external environment, so the surface of the fatigue crack growth zone is dark brown due to oxidation or corrosion, while the final fracture zone usually tears quickly and appears the color of metallic luster.

Through analysis of the fracture morphology characteristics of the pump shaft, it can be confirmed that the reason of the pump shaft fracture is the fatigue fracture failure caused by alternating load.

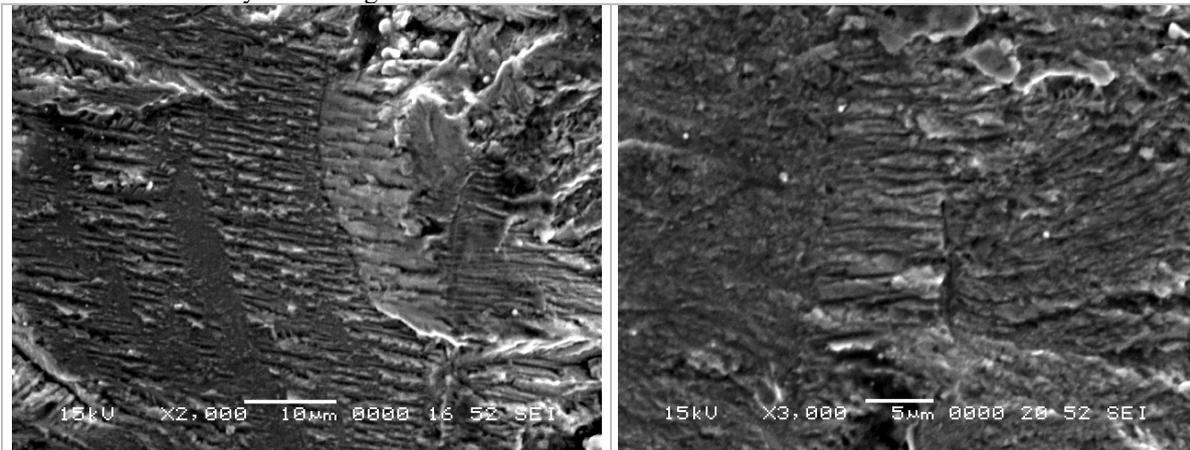
Fig.4 Micromorphology of the shaft fracture sections

The micromorphology pictures at 2000 and 3000 magnification is taken in the shaft fracture section, as shown in Fig.4. Fatigue striations are observed parallel to each other with equal spacing in the pictures, which is the most prominent feature of the fatigue fracture[3]. It can be judged that the striations belongs to the toughness fatigue striations. The crack propagation direction is the vertical direction of the striations.

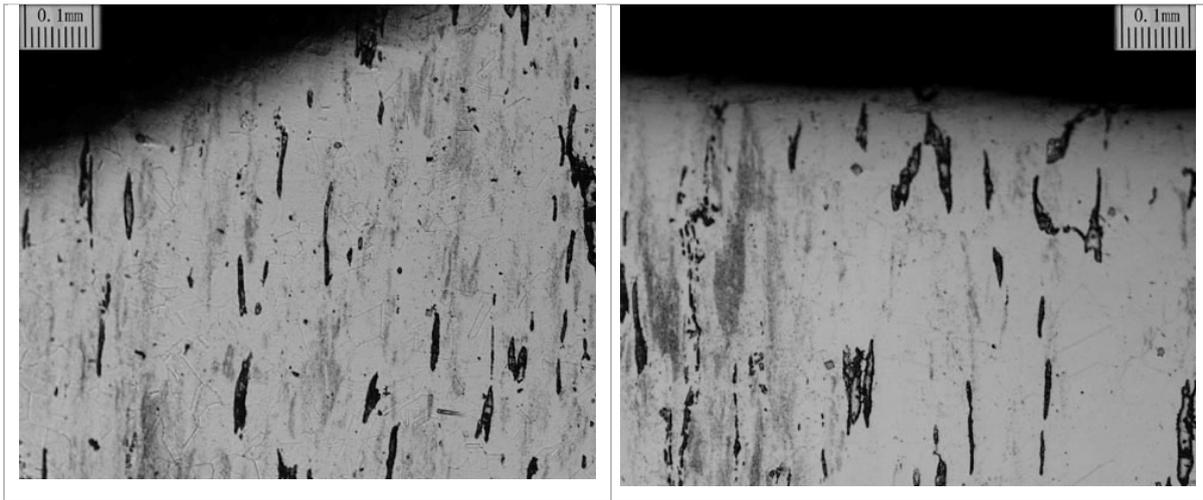
The metallographic structures was analyzed on the fracture sections of 1# crack source and 2# crack source, as shown in Fig.5. The material structure of the pump shaft are austenite plus strip ferrite, and the gray strip ferrite with different lengths is distributed in the white austenite matrix. There are twin crystals in the austenite matrix, indicating that the material has been processed by solid solution treatment[4]. In general, the normal austenite matrix contains a very small amount of ferrite, which is commonly in a single austenite phase or a phase of austenite plus carbide precipitation. A lot of ferrite was precipitated in the austenite matrix this time, indicating that the heat treatment temperature is too high or the heat treatment time is too long.

Fig.5 Metallographic structure pictures of the fracture sections of 1# (the left picture) & 2# (the right picture) crack sources ×100

Ferrite precipitation in austenite matrix can generally prevent the austenite grains coarsening, improve the yield point of the material and reduce the tendency of intercrystalline corrosion and stress corrosion. The disadvantage is that it promotes the transition from Cr in ferrite to σ -brittle phase and the formation of σ -phase, and increases the brittleness of materials and the tendency of point corrosion[5]. According to the metallographic structure photos, it can be observed that the strip ferrite precipitation is mainly distributed along the axial direction of the pump shaft, and the fracture sections of the pump shaft is perpendicular to the distribution direction of strip ferrite. Therefore, the ferrite contained in the material can be considered taking little influence on the fatigue fracture of the pump shaft.

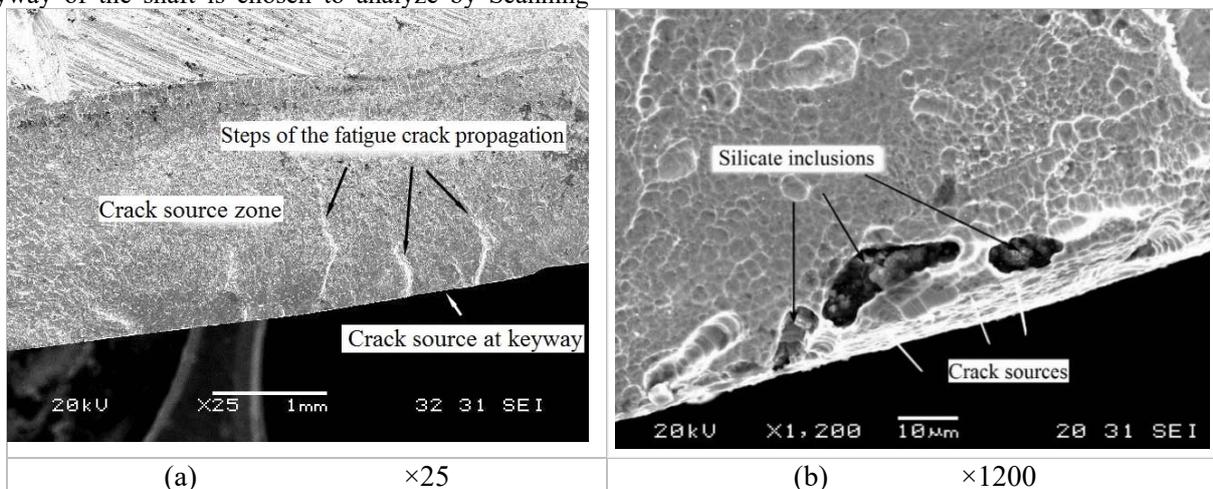
Electron Microscope (SEM), as shown in Fig.6(a). There is no induction factor of the pitting corrosion at the edge of the crack source, and the steps of the fatigue crack propagation are clearly visible.

The micromorphology of the crack source at the keyway of the shaft magnified by 1200 times locally is shown in Fig.6(b). The crack at the edge of the crack source can be observed containing a lot of inclusions, which are mainly composed of O, C, Si, Ca and Fe by elemental energy spectrum analysis as shown in Fig.7. The content of Ca was 3.11%, Fe was 26.9%, Si was 1.09%. Therefore, these inclusions are confirmed as calcium-silicate ($\text{CaO} \cdot \text{SiO}_2$). In the solidification process of steel material, liquid calcium-silicate has no time to crystallize due to the fast cooling speed of steel, and thus the calcium-silicate is retained in the steel in the form of inclusions at last. These calcium-silicate inclusions will not be deformed and brittle at room temperature, and keep their original shape[6]. According to GB10561-89 "Steel-determination of content of non-metallic inclusions: Micrographic method using standard diagrams", the calcium-silicate inclusions of the material shall be rated as 1.5.

Fig.6 The fracture section pictures of 1# crack source at the keyway

At the same time, it can be observed in Fig.6(b) that the fracture section at the crack origin is generally dimpled and ductile as same as the characteristic of the ductile fracture. This indicates that the austenitic material has good toughness and plasticity. It is certain that the inclusions are the source of crack initiation according to Fig.6(b). The microstructure of precipitated phase of strip ferrite in austenite matrix is shown in Fig.8. There is a

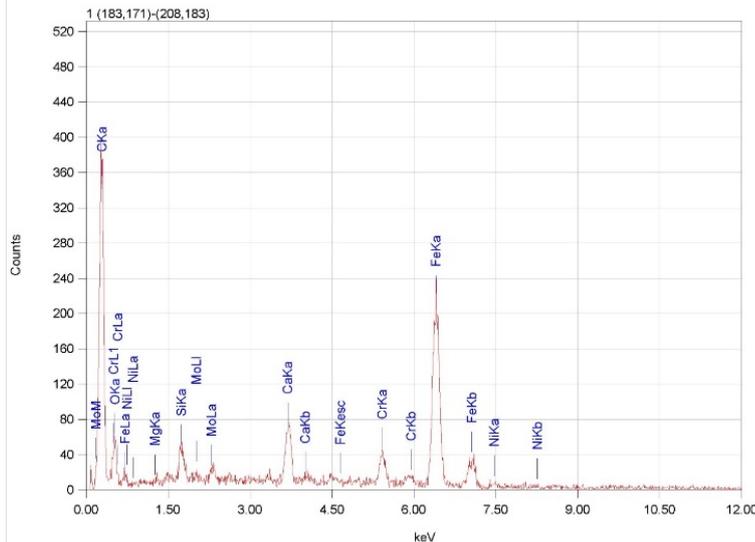
Fig.7 Power spectrum analysis of the crack surface inclusions at the keyway

(2) The chemical compositions of the pump shaft material shall be strictly controlled in the standard range, especially the elements of sulfur, phosphorus, silicon. In addition, the calcium-silicate inclusions in the pump shaft material must be well controlled.

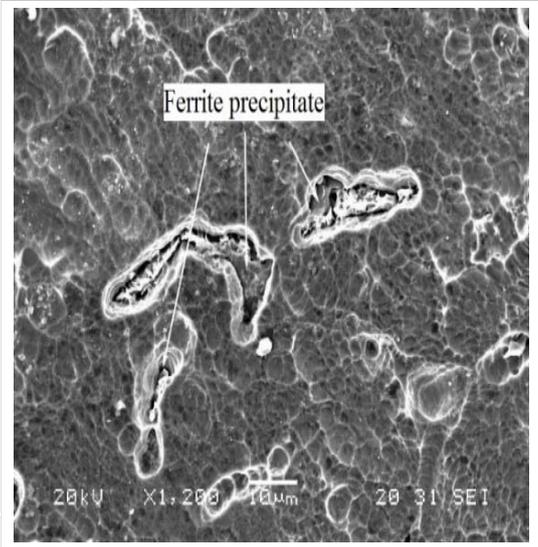
Fig.8 Precipitated phase of ferrite in austenite matrix of the fracture section

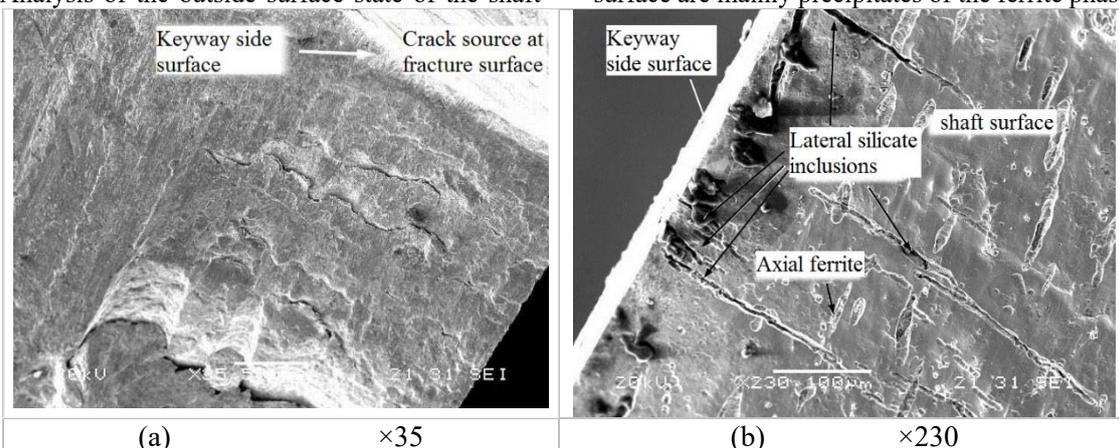
The outside surface state of the vertical axis of the fracture section at the keyway of pump shaft is shown in Fig.9. There are several parallel transverse microcracks on the outside surface tightly below the main fracture section, accompanied by the characteristics of deformation damage. Also there are calcium-silicate inclusions between these microcracks, and the stripe structures distributed along the axial direction on the surface are mainly precipitates of the ferrite phase.

Fig.9 Outside surface state at the keyway of the shaft

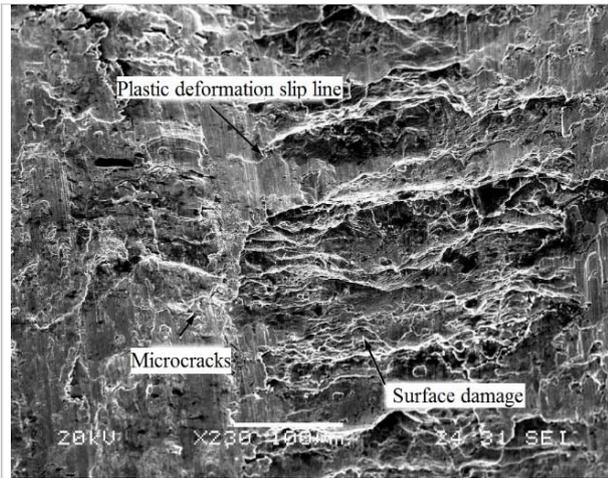
The outside surface state of 1# crack source below the keyway is shown in Fig.10. There are obvious slip lines of plastic deformation on the outer surface of the shaft, and the outer surface of the middle part is damaged due to plastic deformation, which leads to microcracks

on the outer surface.

Fig.10 Outside surface state of 1# crack source below the keyway ×230

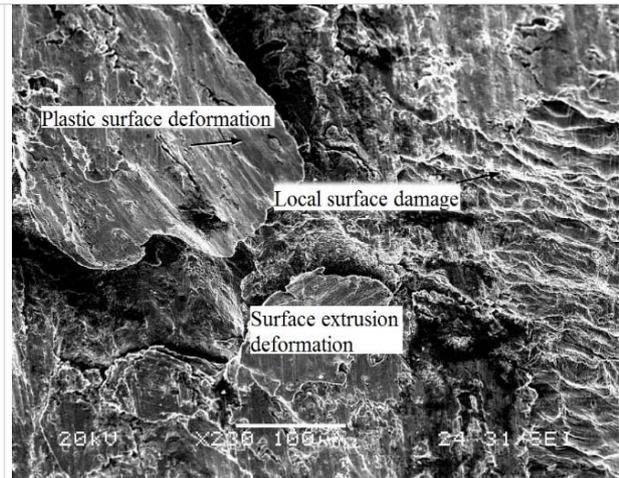
The outside surface state of 2# crack source also has the characteristics of plastic deformation and local surface damage, which is similar to the outside surface state of 1# crack source, as shown in Fig.11.

Fig.11 Outside surface state of 2# crack source ×230

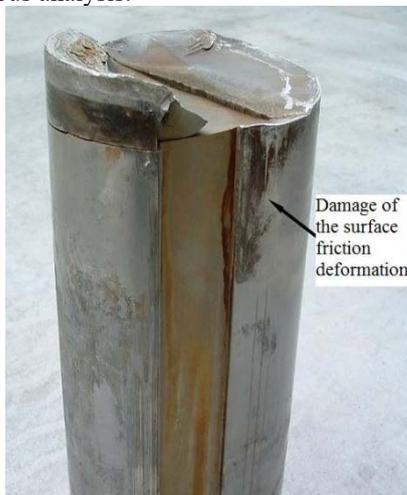
According to the macromorphology of the machined surface of the keyway shown in Fig.12, the machined surface of the keyway side sections and the circular arc area is in normal condition, but the characteristics of local deformation damage on the outside surface near 1# crack source can be observed, which is consistent with the previous analysis.

Fig.12 Outside surface macromorphology of the keyway

(1) When installing the pump shaft, forced assembly shall be prohibited according to the technical regulations to avoid surface damage at the keyway of the shaft. The outside surface of the keyway must be kept intact after the manufacture and installation of the pump shaft.
