# Analysis of Leakage Cause of L415M Spiral Submerged Arc Welding Pipe

Yan Xu\*, Yinglai Liu, Xianghui Nie, Zhenjun Feng, Liang Li, Fengping Yang

Tubular Goods Research Center of CNPC, Xi'an, Shaanxi, 710077, China

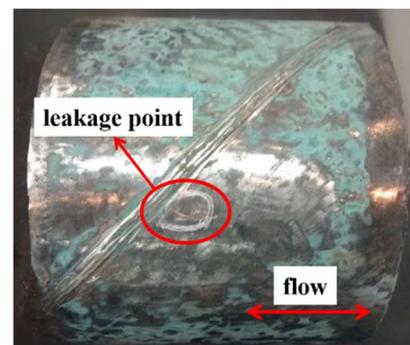
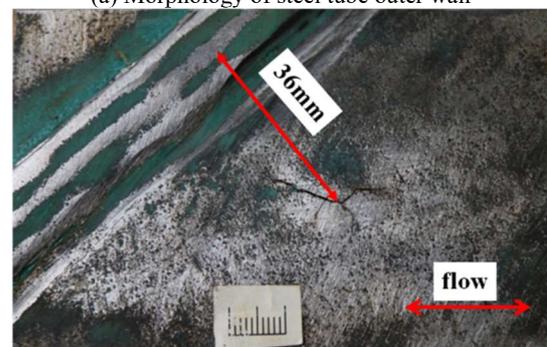
**Fig 1.** Macroscopic appearance of leakage steel pipe

The sample is the pipe section at the leakage site cut by a flame, and the leakage point is about one meter from the nearest pipe end. The morphology of the steel pipe after stripping the external coating is shown in Fig. 1. There are obvious cracks in the inner and outer walls of the steel pipe at the leakage point, and the cracks are distributed

along the longitudinal direction of the pipe body. The crack center is 36 mm away from the center of the spiral weld, as shown in Fig. 1(b).

(a) Morphology of steel tube outer wall

(b) Morphology of steel tube outer wall leakage point

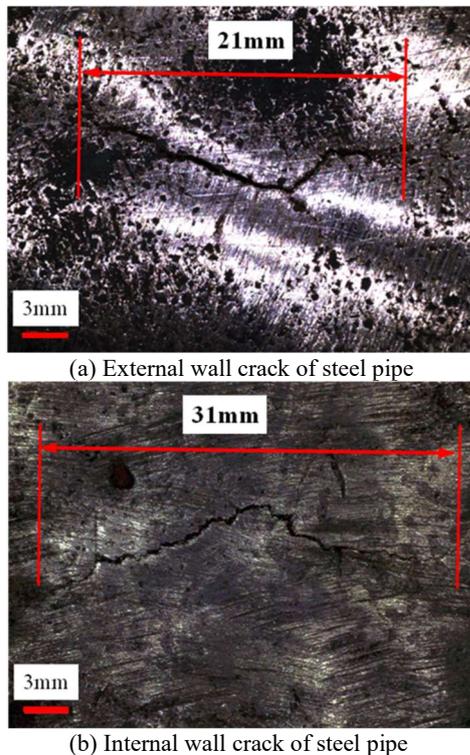
**Fig 2.** Macromorphology of cracks

The Smartzoom5 super-depth digital microscope was used to observe the cracks at the leakage, and the results are shown in Fig 2. The length of the outer wall crack is 21 mm, and the length of the inner wall crack is 31 mm. Fig. 2 (b) shows that there is a pit in the inner wall of the

steel pipe, 6 mm from the crack, and the maximum diameter is 2.4 mm. The wall thickness of the steel pipe near the crack was measured by ultrasonic thickness gauge. The wall thickness of the pipe at the pit was 5.9 mm, and that at other locations was about 7.1 mm.

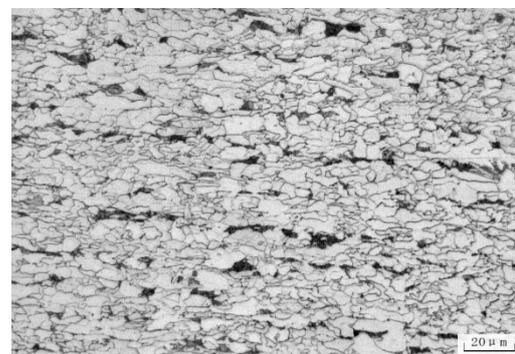
**Fig 3.** Tube structure away from leakage point

The microstructure of the tube far from the defect position is shown in Fig. 3, which is ferrite and a small amount of pearlite. The grain size is 11.0, and there is no obvious abnormality.

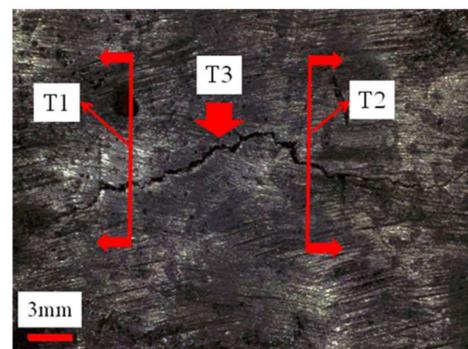
**Fig 4.** Sampling position of steel pipe leakage point

In order to understand the causes of cracks at the leakage of steel pipe, the T1 and T2 sections are intercepted along the direction perpendicular to the crack, as shown in Fig. 4. The full-thickness metallographic specimens are processed and observed by Smartzoom5 ultra-depth digital microscope and OLS 4100 laser confocal microscope.

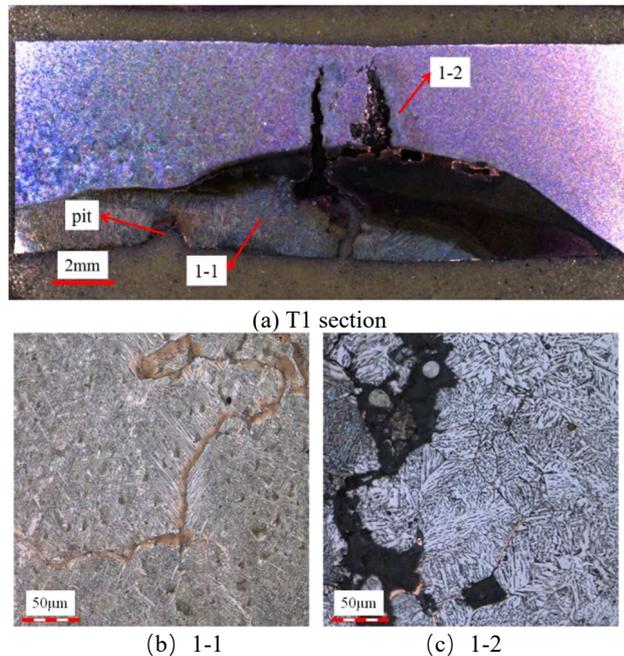
**Fig 5.** T1 section metallographic examination results

Fig 5 (a) is a photograph of the T1 section. The pit in the lower left corner corresponds to the inner wall pit found by the macroscopic inspection. The depth of the pit is about 1.2 mm, and the color of the pit and its adjacent cross section is abnormal, and the local color is purple yellow. The abnormal area is semi-elliptical, and the deepest part is close to the central position of the steel tube

wall thickness. There are holes at the interface between the color abnormal area and the tube matrix. The crack originates from the color abnormal area and extends to the outer wall. The microstructure at 1-1 is shown in Fig. 5 (b). The grains are abnormally coarse, and the color is different from the normal microstructure of the steel pipe, especially at the grain boundary. Fig. 5 (c) is 1-2 metallographic photographs. The grains near the main crack are coarse, the fine cracks propagate along the grain boundaries, and some purple inclusions exist in the grain boundaries.

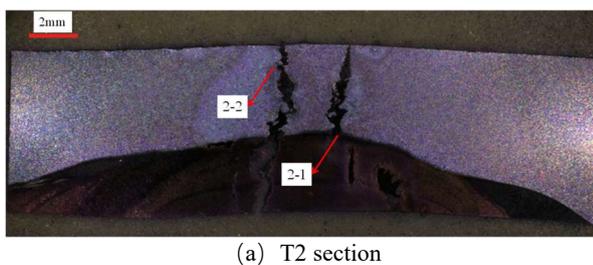
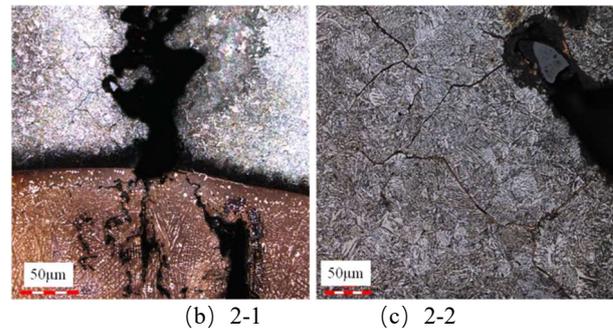
**Fig 6.** T2 section metallographic examination results

Fig. 6 (a) shows the photograph of T2 section, and there is still an abnormal area in the cross section of steel pipe. Fig 6 (b) is 2-1 metallographic photographs of the tube, which is located at the interface between the abnormal area and the normal tissue of the tube. The interface gap is obvious, and there are holes near the inner wall. The microstructure near the crack of the tube near the outer wall is overburned. Fig. 6 (c) in 2-2 metallographic photos, visible part of the grain boundary cracking, there are purple foreign bodies between grain boundaries, microstructure is overheating.

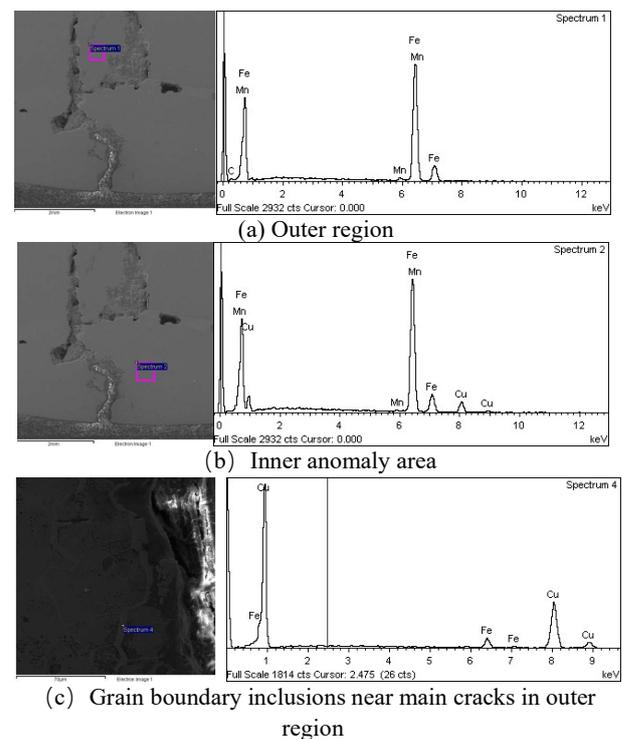
**Fig 7.** T1 section morphology and energy spectrum analysis

The INCA 350 spectrometer was used to analyze the energy spectrum at different positions of the T1 section. The results are shown in Fig. 7. The main elements in the outer region are Fe, C and Mn, while the main elements in the inner color anomaly region are Fe, Cu and Mn. Among them, the copper element is abnormally high.

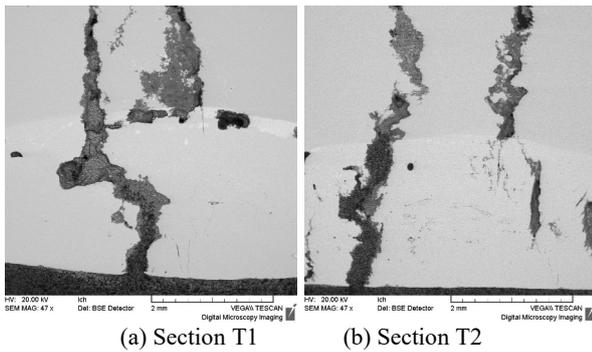
**Fig 8.** Backscattered electron imaging morphology

In order to better understand the distribution of Cu element, the T1 section and T2 section were analyzed by backscattered electron imaging. The results are shown in Fig 8. The contrast of backscattered electron imaging is caused by the difference in atomic number, so the distribution area of Cu element can be clearly distinguished. The area is consistent with the cross-sectional abnormal area found in metallographic observation, and it is semi-elliptical. In backscattered electron imaging, the contrast between the inner abnormal area and the outer tube interface area is higher, reflecting the higher content of Cu element.

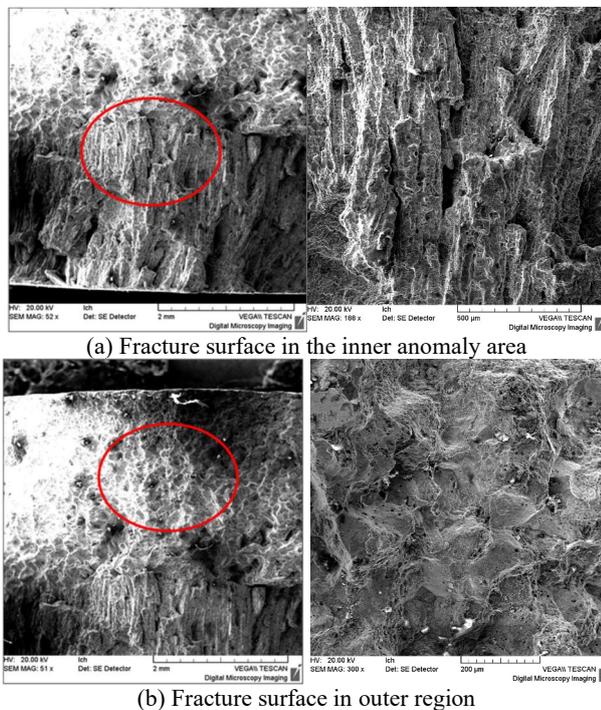
**Fig 9.** T3 Fracture Surface Morphology

The cracks between T1 and T2 sections in Fig 7 were broken off, and the morphology of T3 fracture surface was observed, as shown in Fig 9. The fracture surface is obviously oxidized at high temperature. Fig 9 (a) is the fracture surface morphology of the inner layer, and Fig 9 (b) is the fracture surface morphology of the outer layer.

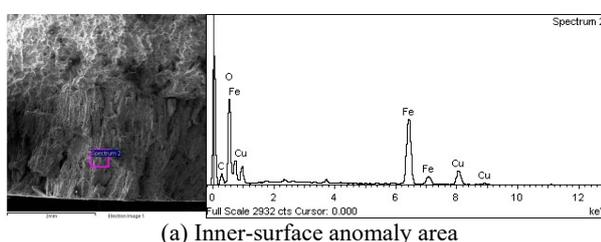
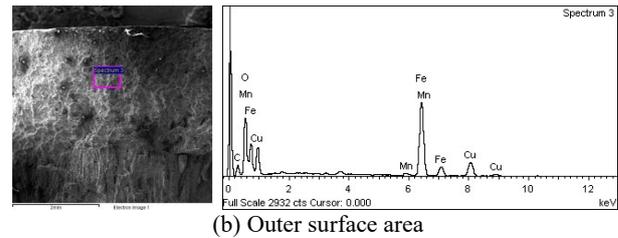
**Fig 10.** T3 fracture surface energy spectrum analysis

The energy spectrum analysis of the inner and outer layers of the T3 fracture surface is carried out. The results are shown in Fig. 10. There are Cu elements in the abnormal area of the inner layer and the outer layer of the fracture surface, indicating that Cu elements are enriched in the crack area.

(a) Inner-surface anomaly area

(b) Outer surface area

The above results show that the main reason for the leakage of the steel pipe is that the leakage site experienced an abnormal high temperature process. When the working environment or heating temperature is abnormally increased, the low melting point metal Cu is melted into liquid, and part of the metal on the inner wall of the steel pipe is melted. The liquid Cu diffuses into the molten steel pipe matrix, resulting in abnormal Cu content in the inner layer of the pipe wall, and the color of the burning area is different from that of the normal part. However, part of the grain boundary of the steel pipe near the burnt part melts, and Cu diffuses along the grain boundary. The Cu element is enriched at the normal grain boundary, that is, the molten metal at the burnt part, the molten grain boundary and the crack jointly constitute the diffusion channel of Cu element, which further deteriorates the material strength and reduces the effective bearing capacity of the steel pipe. When the hydraulic test is carried out on the site, the crack propagates along the weak grain boundary, and finally leads to the leakage of the steel pipe.

According to the characteristics of high temperature burn and Cu pollution at the leakage site, it is speculated that the cause should be due to improper operation and contact between the grounding Cu electrode and the pipe body in the process of pipemaking or field pipeline laying. When the contact between the two is not good, the resistance becomes larger and the arc is generated. The high temperature arc leads to the burning of the pipe body and the melting of the Cu electrode, which leads to Cu pollution and cracking in the part.
