Determination of roof rock weakening zones in extraction columns based on seismic exploration

Sergei Sokolov^{1*}, Anastasiya Kolmakova¹, Gennady Rout², and Peet-Mati Sööt³

Abstract. This article highlights the difficulties that arise in coal mining when roof areas have fractures with an opening of up to 0.2 - 0.5 m. Such situations may cause roof collapse. The seismic exploration method used by the authors to assess the geomechanical characteristics of extraction columns is described. The results of work on identification and registration of unstable roof areas are presented.

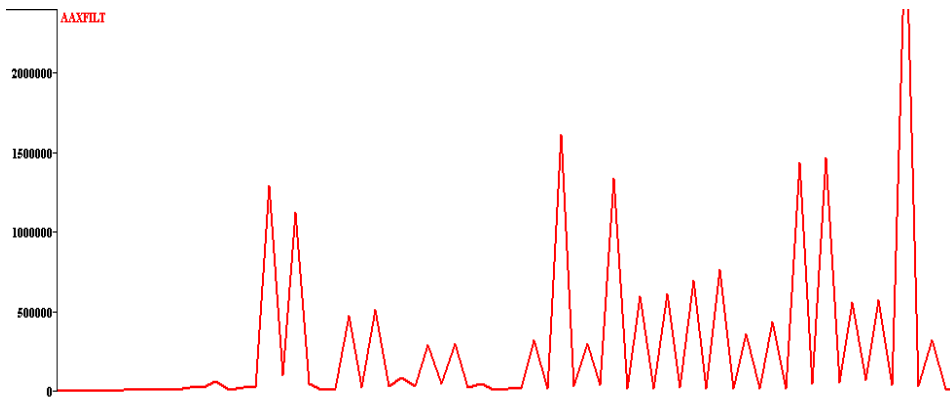
Fig. 2. Amplitude analysis of the active roof area within the geophysical profile No. 1.

Differentiation of various wave parameters was observed within the considered waveguide, which is the Vladimirovskiy Coal Seam, where the greatest contrast, ensuring the reliability of the research results, was recorded when analyzing the change in seismic vibrations amplitudes (Fig. 2).

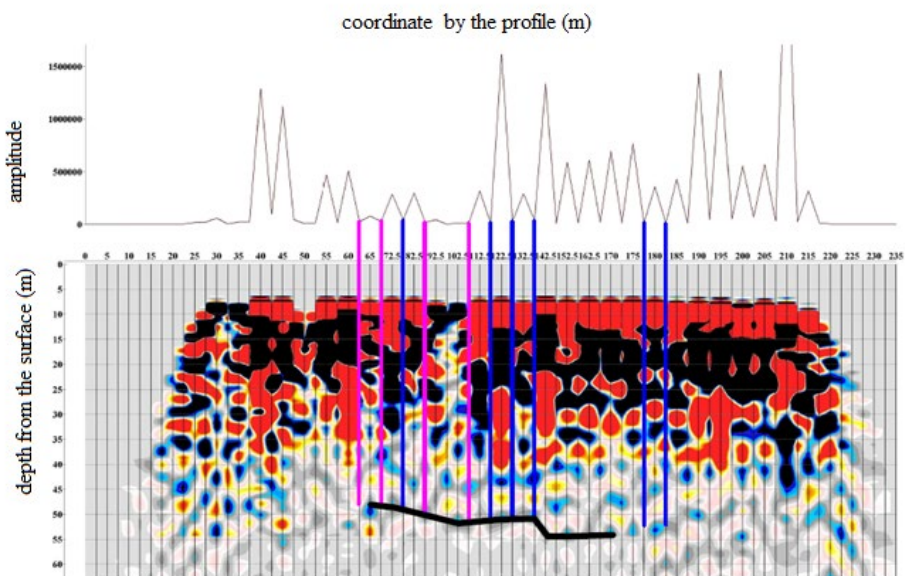
Fig. 3. The results of geophysical measurements of the area of the extraction column No. 11.

Based on the study results of the space between the recorded reflections of coal seams, the areas of concentration of rocks with the least connectivity were determined along geophysical profiles 1-4. On the generated seismic sections, the following elements of the massif structure were identified (Fig. 3): Vladimirovsky Coal Seam with an average burial depth of about 50 meters (black color); boundaries of areas characterized by minimum amplitudes values (purple color); boundaries of areas characterized by small values of amplitudes, which, under certain conditions, can also be areas of unstable roof (blue color).

Subsequently, within the areas identified according to the results of seismic exploration, the measures for the immediate roof strengthening with the resin injection were implemented. As a result of their implementation, mining operations in the zone of hydraulic dump influence were carried out without forced stops. The success of mining in the studied section of longwall No. 11 after resin injection reinforcement indicates high efficiency of seismic exploration use as a tool for registering zones of fractured rocks in the roof area of extraction column.

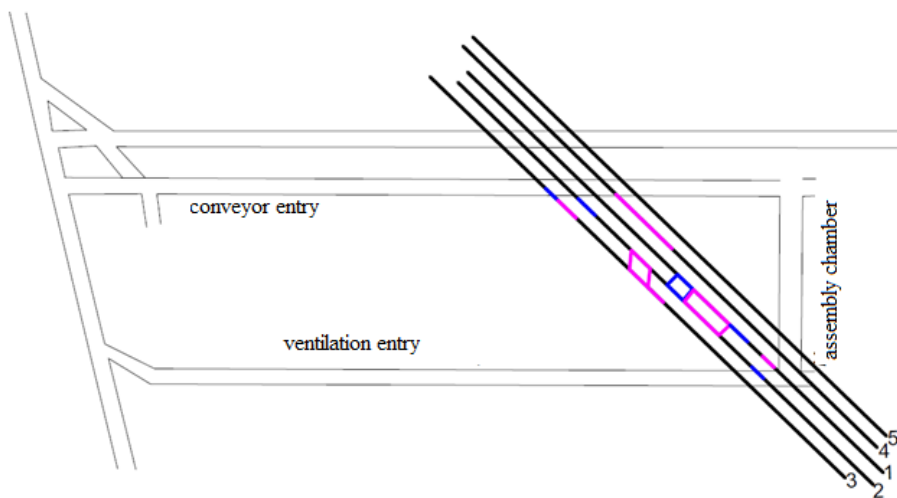
Fig. 4. The results of geophysical measurements plotted on the mining work plan of “Vladimirovskaya” mine.

Based on the geophysical measurements results comparing with the actual position of the functioning objects of Vladimirovskaya mine, zones, characterized by the minimum values of amplitudes and small values of amplitudes, were placed on the mining plan in the contour of the EC No. 11 (Fig. 4).
