# Understanding of subsurface conditions controlling flow liquefaction occurrence during the 2018 Palu earthquake based on resistivity profiles

**Abstract.** The 7.4 Mw earthquake on 28<sup>th</sup> September 2018 in Palu City triggered a flow liquefaction phenomenon in the Balaroa and Petobo areas, contributing to significant casualties and building damage. This paper presents the results of a liquefaction study to map subsurface conditions in these areas using the multi-electrode resistivity method with the dipole-dipole configuration. The objective of this study is to understand factors controlling the flow liquefaction phenomenon. Based on the interpretation of 2-D resistivity images, the liquefied soil layers are characterized by lower resistivity values than the non-liquefied layers. These contrasts of resistivity values form a gently sloping boundary between the liquefied and non-liquefied soil layers. The resistivity image perpendicular to the flow direction indicates the presence of a subsurface basal morphology in the Balaroa area, suggesting that a shallow groundwater zone is present within the liquefiable soil layer. Thus, the subsurface topographical condition is the

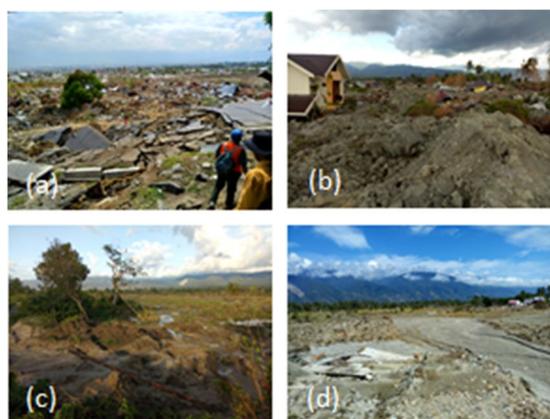
**Fig. 1.** Flow liquefaction phenomena in (a) Balaroa, (b) Petobo, (c) Ojo Oge and (d) South Sibalaya.

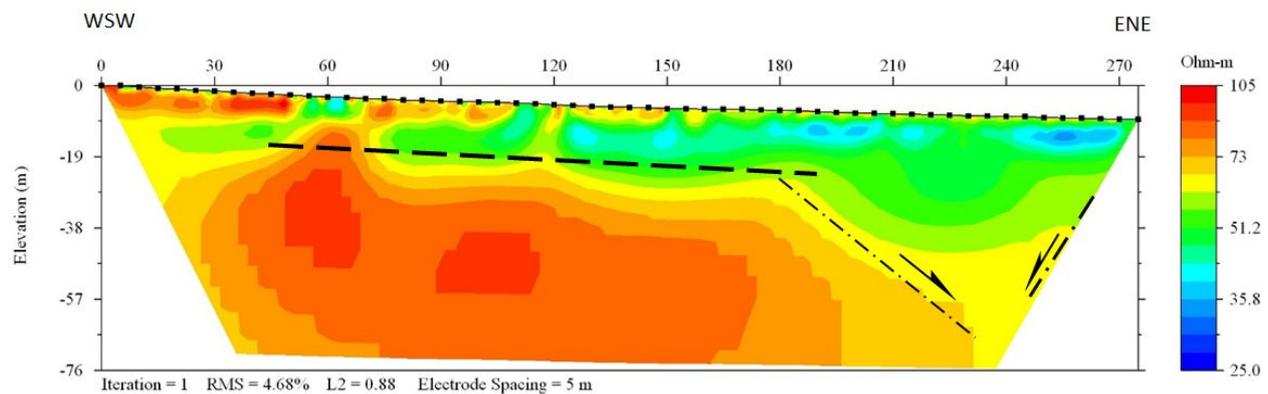
**Fig. 5.** Resistivity profile for WSW-ENE direction at the Balaroa site. The black dotted line indicates the inclined plane at the boundary between the soil layer with low resistivity and the soil/rock layer with high resistivity. Dashed-dotted lines and arrows indicate the normal faulting. The profile map view is shown on Fig. 4a.

As shown in Fig. 5, the boundary between alluvial deposits and the old alluvial fan layer forms an inclined plane at a very gentle angle from west to east. Thus, this subsurface topography is likely to govern the initiation of movement of liquefied soil mass to turn into flow liquefaction during the earthquake. Fig. 5 also indicates the thickening of alluvial deposits to the east due to the existence of a basinal structure associated with the normal

faulting component of the Palu-Koro Fault. [18] also found this basin geometry from the analysis of microtremor measurement data in this area.

Furthermore, the examination of Fig. 5 and 6 clearly shows that the boundaries between alluvial deposits and alluvial fan deposits are still intact after the flow liquefaction event. It implies that the flow liquefaction only involved the alluvial deposits. The presence of high

resistivity layers at the ground surface is associated with the remnants of alluvial fan deposits being displaced during the earthquake.

It is also evident that the alluvial deposits indicated by low resistivity of less than 30  $\Omega\text{m}$  at a depth of shallower than 10 m were locally developed after the liquefaction event. This finding suggests that the highly saturated soil layers are still present within the liquefied soils. Hence, the area is still prone to a liquefaction hazard in the future.

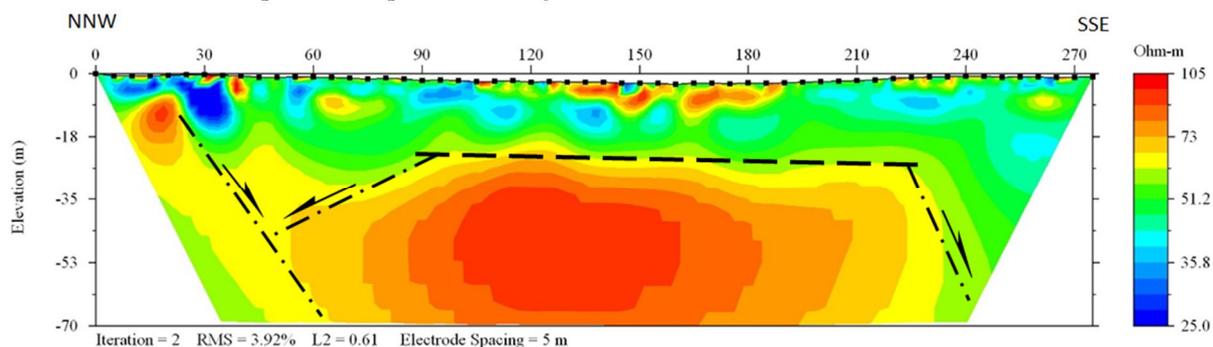
Meanwhile, Fig. 6 indicates that the boundary between low and high resistivity seems to form a basin geometry associated with normal faulting components of the Palu-Koro Fault. This basin geometry will control groundwater flow to this liquefied area. Consequently, shallow

groundwater levels will easily develop in this area to cause the soil mass to liquefy during the earthquake. The old alluvial fan deposits seem to disappear, and the alluvial deposits become thicker in the southeast direction. Consequently, this area experienced less intense flow liquefaction than the main area during the earthquake, as evidenced in Fig. 4(a).

**Fig. 6.** Resistivity profile for NNW-SSE direction at the Balaroa site. The black dotted line indicates the inclined plane at the boundary between the soil layer with low resistivity and the soil/rock layer with high resistivity. Dashed-dotted lines and arrows indicate the normal faulting. The profile map view is shown on Fig. 4a.

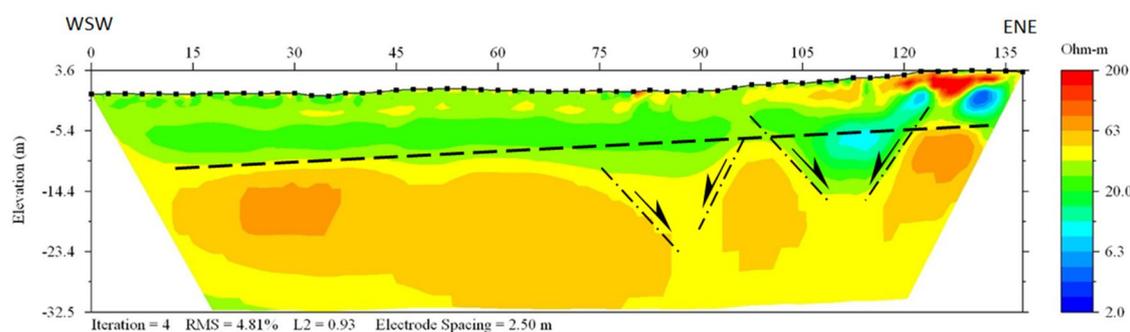
Fig. 7 presents the results of the geoelectric survey for the east-west direction at the flow liquefaction location in the Petobo area. The resistivity profile shows that the resistivity values range between 2 and 200  $\Omega\text{m}$  with a coverage depth of 36 m. The soil layer with a low resistivity profile (less than 40  $\Omega\text{m}$ ) is probably associated with the alluvial deposits. In contrast, the high resistivity layers (>40  $\Omega\text{m}$ ) are probably associated with the old alluvial fan deposits. Some fragments of alluvial fan deposits can also be found near the surface, as indicated by higher resistivity values, in most parts of the slope profile. The boundary between these different deposits forms an inclined plane at a gentle angle from east to west that controls the generation of flow liquefaction. Close

examination of Fig 5 and 7 suggests that the inclined boundary in the Petobo site is steeper than in the Balaroa site. Consequently, the liquefied soils in the former flowed at a greater distance than in the latter.

Fig. 7 also shows the presence of basinal structures within the alluvial fan deposits, probably due to normal faulting associated with the movement of the Palu-Koro Fault. This basin geometry may control groundwater accumulation within the alluvial deposits, which leads this sediment mass to be highly saturated, and thus, highly liquefiable during the earthquake. Localized very low resistivity layers are still detected within the alluvial deposits, indicating saturated alluvial deposits are still present near the ground surface in the upper part of the slope profile. These pieces of evidence indicate that the Petobo liquefied area is still prone to flow liquefaction in the presence of a strong earthquake in the future.

**Fig. 7.** Resistivity profile for WSW-ENE direction at the Petobo site. The black dotted line indicates the inclined plane at the boundary between the soil layer with low resistivity and the soil/rock layer with high resistivity. Dashed-dotted lines and arrows indicate the normal faulting. The profile map view is shown on Fig. 4b.
