# Implementation of earthquake mitigation at the engineering faculty, university of mataram

**Abstract.** After the 2018 Lombok earthquakes, buildings within the Engineering Faculty of the University of Mataram (FT Unram), were severely damaged and there have been no comprehensive treatments. Facilities to support earthquake mitigation, such as signs for evacuation routes and assembly points (temporary evacuation sites), are still minimal, and even if they are available many of them are not designed and placed properly. Some parts of the buildings have been partially renovated, meanwhile, there are new buildings constructions that have not been investigated related to disaster mitigation. Anticipating the re-occurrence of big earthquakes in Lombok, it is very necessary to carry out activities for implementing earthquake mitigation at FT Unram. The activities are divided into three stages, namely *first*: conducting direct reviews for inventory and documentation of all vulnerable points, followed by making of maps and building plans; *second*: determining the proper locations of assembly points, creating labels and signs for evacuation routes and assembly points, and making tutoria

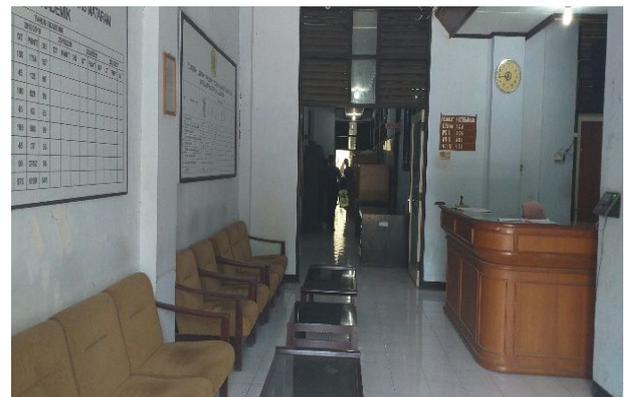
Fig. 3 shows the atmosphere on the 1<sup>st</sup> floor, where a corridor is narrow and blocked with several piles of goods because there is a warehouse at the end of the

**Fig. 3.** Daily situations of the 1<sup>st</sup> floor of Building A.

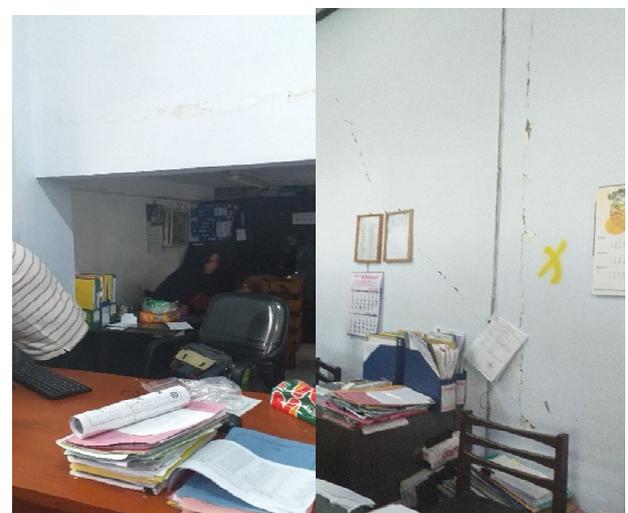
corridor. In Fig. 4 some staff occupied a narrow place under the stair, due to the lack of available spaces, while the condition of the walls in that room was quite dangerous. Fig. 5 shows the library with several reading shelves (some of them are made of glasses) are placed very closely together. Fig. 6 shows some cracks in the outside walls of the 3<sup>rd</sup> floor of the building. Since current renovations are only inside the building, these cracks will not be treated, because they can only be observed by seeing carefully through a window in the corner of the 3<sup>rd</sup> floor.

**Fig. 4.** Staff is working on a narrow place under stairs, and conditions of walls on the 1<sup>st</sup> floor of Building A.

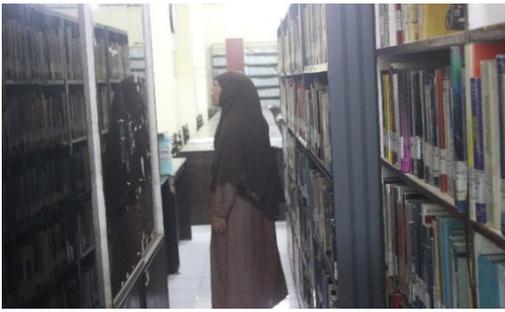
**Fig. 5.** The library with several reading shelves (some of them are made of glasses) is placed very closely together on the 2<sup>nd</sup> floor of Building A.

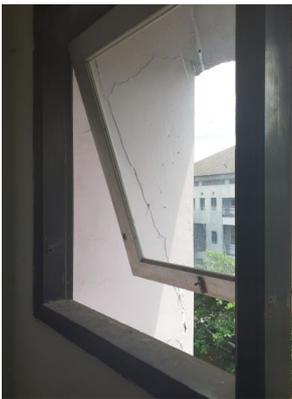
**Fig. 6.** Cracks in the outside walls of the 3<sup>rd</sup> floor of Building A.

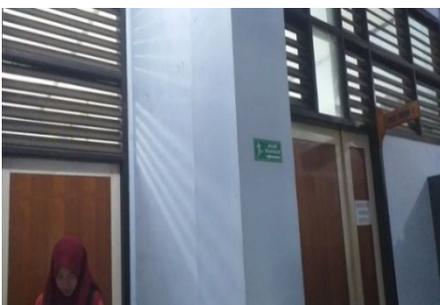
**Fig. 7.** For an example of a misplaced and misused evacuation symbol on Building A, here a ladder symbol was used on a straight path.

In this building, there were evacuation signs, but often installations and the symbols used are not correct. Fig. 7 is an example of an evacuation sign with a ladder symbol was placed, even though what is meant is only going straight. Fig. 8 shows a symbol that commonly resembles an evacuation sign, even though what is meant is showing the direction to reach the Informatic Engineering study program. In a panic situation, this sign might be misinterpreted. The placements of these evacuation signs are higher than the standard, which should be between 120 – 160 cm above the level [6].

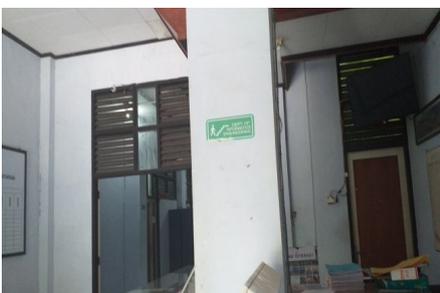
**Fig. 8.** Example of a misused symbol on Building A, here the same symbol as evacuation one was used to give information of direction to a study program, which on a panic situation it might be misinterpreted as an evacuation route.

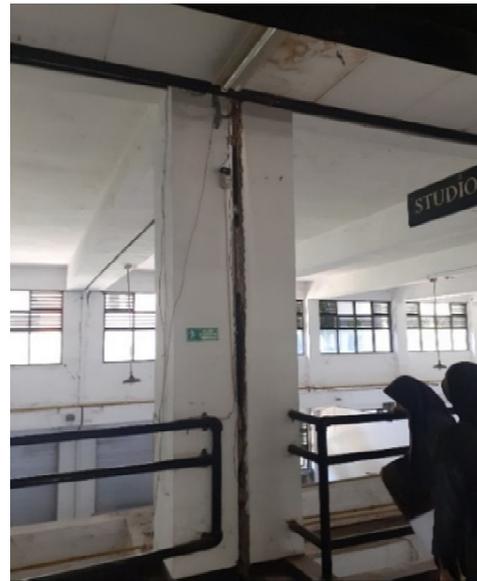
**Fig. 9.** A large crack between two columns was observed from the 2<sup>nd</sup> floor of Building B; the crack is initially from the ground floor.

This building is the administration room, lecture rooms, and laboratories of Mechanical Engineering and Electrical Engineering study programs. There are quite a large number of damages on this building, including heavy damage on the 1<sup>st</sup>, 2<sup>nd</sup>, and 3<sup>rd</sup> floors. Fig. 9 shows a large crack that can be observed on the 2<sup>nd</sup> floor. It is a connection between two columns, that are heavily fractured already from the ground floor. Some of the walls including one beside the hanging stair Fig. 10 had large cracks, and the ceiling of the laboratory on the 3<sup>rd</sup> floor was also broken in Fig. 11.

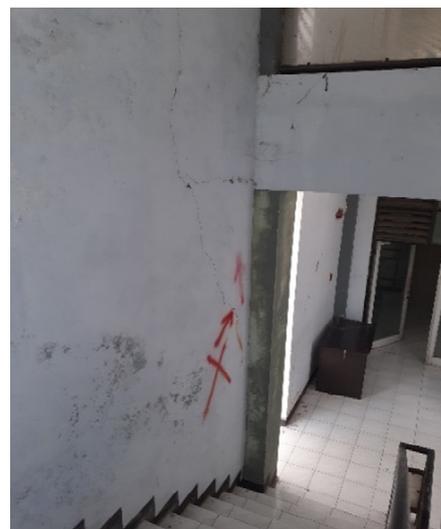
**Fig. 10.** A large crack in the wall beside the hanging stair, connecting the 2<sup>nd</sup> and the 3<sup>rd</sup> floor of Building B.

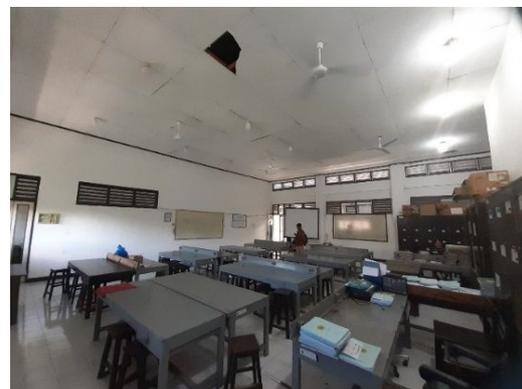
**Fig. 11.** A large crack on the ceiling of the electrical laboratory on the 3<sup>rd</sup> floor of Building B.

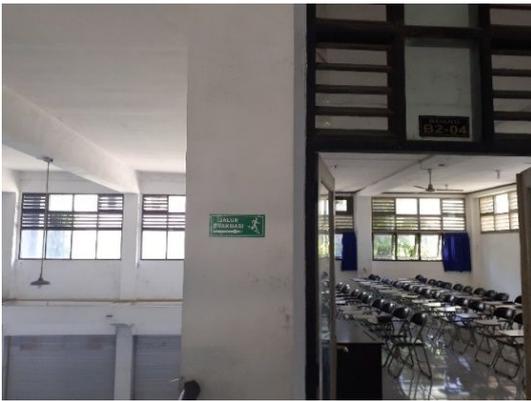
**Fig. 12.** Example of a misplaced evacuation symbol on Building B, which is quite impossible to be seen by the people who come out from the classroom.

Many evacuation symbols are installed incorrectly, for example, it placed on the wall in the direction of the classroom door in Fig. 12, which is quite impossible for the people who come out of the room to see the sign. Several symbols are placed on the glass windows or glass doors in Fig. 13, which will most probably be broken firstly on a large earthquake.

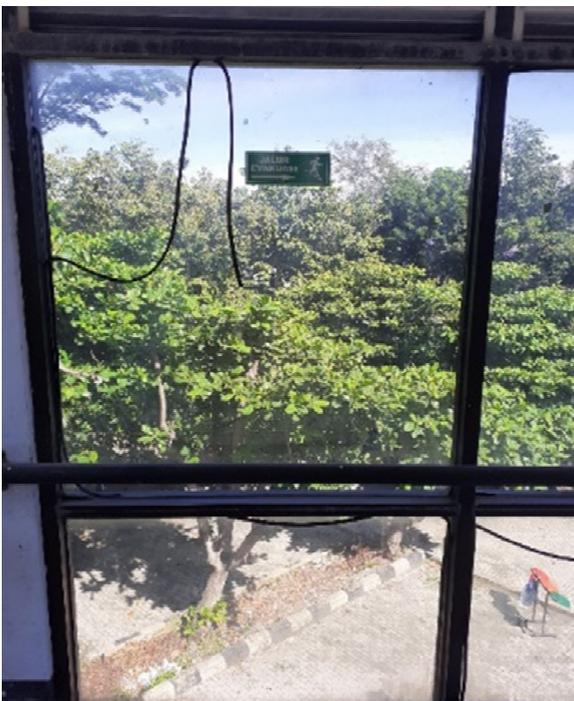
**Fig. 13.** An example of a misplaced evacuation symbol on Building B, placed on a glass window which is most probably broken firstly on a large earthquake.

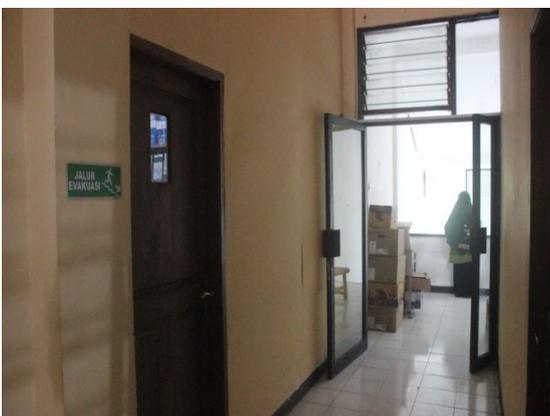
**Fig. 14.** A misplaced evacuation symbol on Building C1 might be misunderstood there is a staircase behind the door.

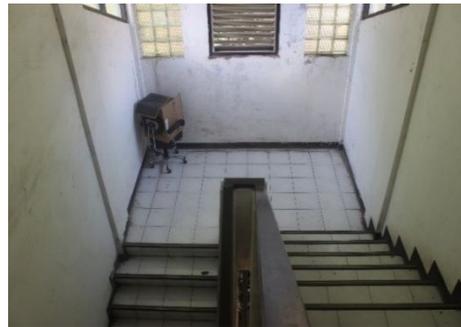
**Fig. 15.** Inaccessible evacuation route in Building C1, some items are placed in the stair and the next door is locked.

Compared to the other two previous buildings, damage to this building was quite minimal, especially in Building C1. While in Buildings C2 dan C3 there were some minor damages on the 2<sup>nd</sup> floor; but the exact number of vulnerabilities could not be identified yet. The evacuation symbols are also in good availability in all important places. However, there was a misplaced symbol as depicted in Fig. 14. The symbol with ladder sign placed next to a closed glass door, which might be misunderstood that there is a staircase behind the door by guests; even though what is meant is an evacuation route and the stair is in the next position route (just after a large glass door). If we try to follow the route through the stair, it was inaccessible because the next door was locked and there were some items placed in the middle of the stairs, as depicted in Fig. 15.

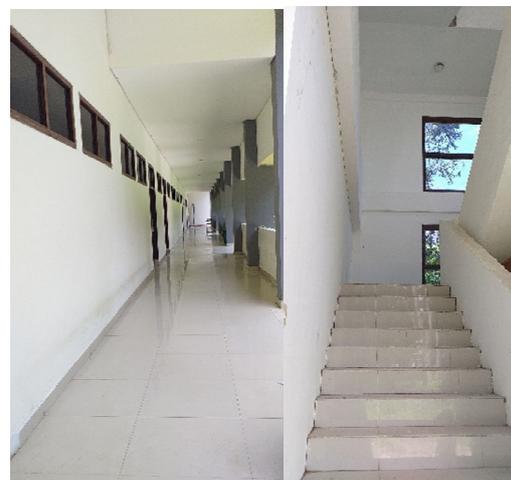
In this building damages are not so visible, because the finished construction before the 2018 Lombok earthquakes was only for the 1<sup>st</sup> floor; and the rest three floors were only completed in the middle year of 2021. However, the condition of the corridors and stairs is very narrow (Fig. 17), which raises difficulties for people to evacuate. The wooden doors of some classrooms (Fig. 18) are difficult to open, which might cause some other vulnerabilities. Careful inspections on this building construction during the last few months show that there seems to be a slight slope in the concrete columns starting from the 2<sup>nd</sup> floor. Because of this, we must continue more detailed investigations.

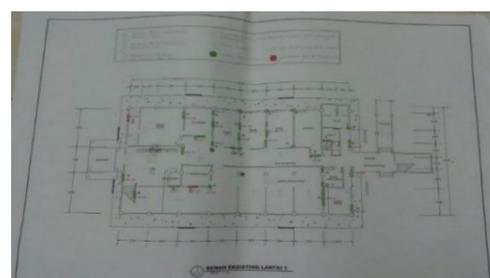
Fig. 18. Sketch of Building A, showing all vulnerable points.

Fig. 18 is an example of a building sketch that shows all vulnerable points and levels of vulnerability in detail. This drawing is equipped with point codes and an accompanying document that describe the vulnerability of each point, also documentation in the form of photos and videos of each vulnerable point.

Results of calculation of the number of vulnerable points and their categories for each building and each floor as shown in Table 1. It appears that Buildings A and B are the most vulnerable and need immediate attention, while Building C is relatively safer. Meanwhile, in Building D, we have not finished collecting data and must continue more detailed investigations.
