# Fracture analysis for lubricating oil pipe of compressor

Jun SI, Huating LV, Facai REN

Shanghai Institute of Special Equipment Inspection and Technical Research, Shanghai, 200062

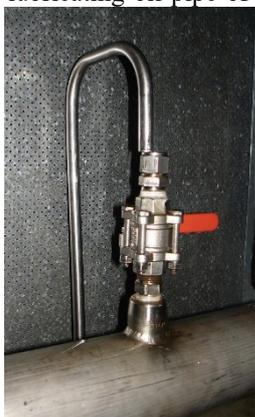
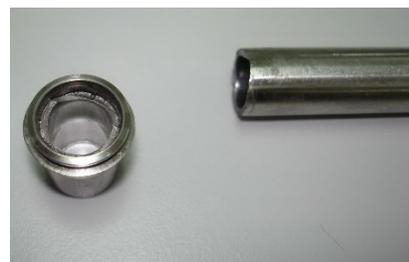
Fig 1. Fracture morphology of lubricating oil pipe

Fracture macroscopic morphology of lubricating oil pipe is shown in Fig. 1. Both ends of the oil pipe have the same structure, which are conical pipes. The fracture location of the lubricating oil pipe occurs within the clamp on one side and there is no significant plastic deformation at the fracture location.

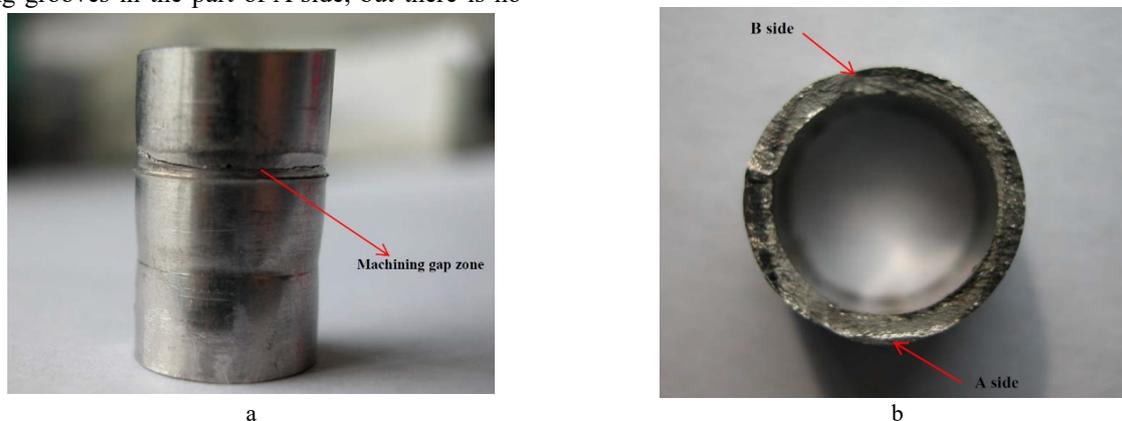
**Fig 2.** Macro morphology of the surface and section of the broken lubricating oil pipe

Overall macroscopic features of the fracture of lubricating oil pipe are shown in Fig.2. The external surface characters at the location of fracture is shown in the Fig.2a, and the origin of the crack is lie in the conical position constructed of the lubricating oil pipe. There are deep machining grooves in the part of A side, but there is no

trace of such redundant machining in other parts along the circumference direction. The macro morphology of the section of fracture is shown in the Fig.2b. It can be seen from Fig.2b that both sides of A and B are the initiation positions of crack growth, and the cracks propagate towards the centers of the section of the oil pipe. The direction of arrow in Fig.2b shows the direction of crack propagation.

It is suggested that the machining quality should be improved and measures should be taken to reduce fluid the induced vibration of fluid.

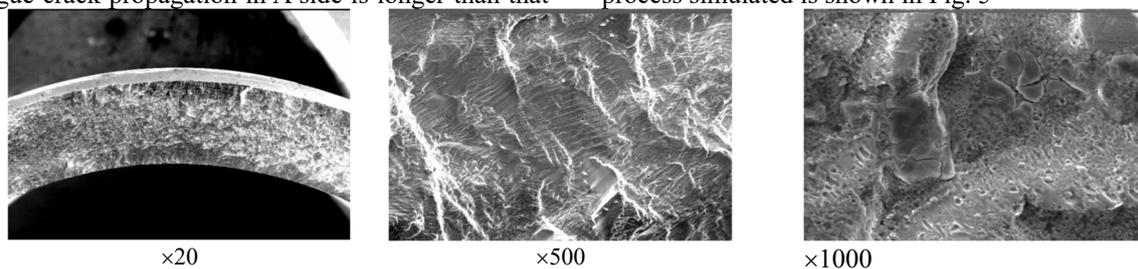
**Fig 3.** Scanning electron microscopy (SEM) of the fracture on A side

The section of fracture of A and B sides was analyzed by Scanning Electron Microscopy (SEM), as shown in Fig.3 and Fig.4. It can be seen from the Fig.3 and Fig.4 that there are obvious fatigue striations on the fracture surfaces on both sides of A and B, so the broken reason of the oil pipe can be judged as fatigue fracture. The length of fatigue crack propagation in A side is longer than that

in B side. With the propagation of fatigue crack, the material strength is not enough to bear the pressure and the instantaneous fracture occurs finally. Since there are two initiation zones in the section of oil pipe, it can be judged that there is bidirectional vibration for the oil pipe in the process of service. The schematic diagram of fracture process simulated is shown in Fig. 5

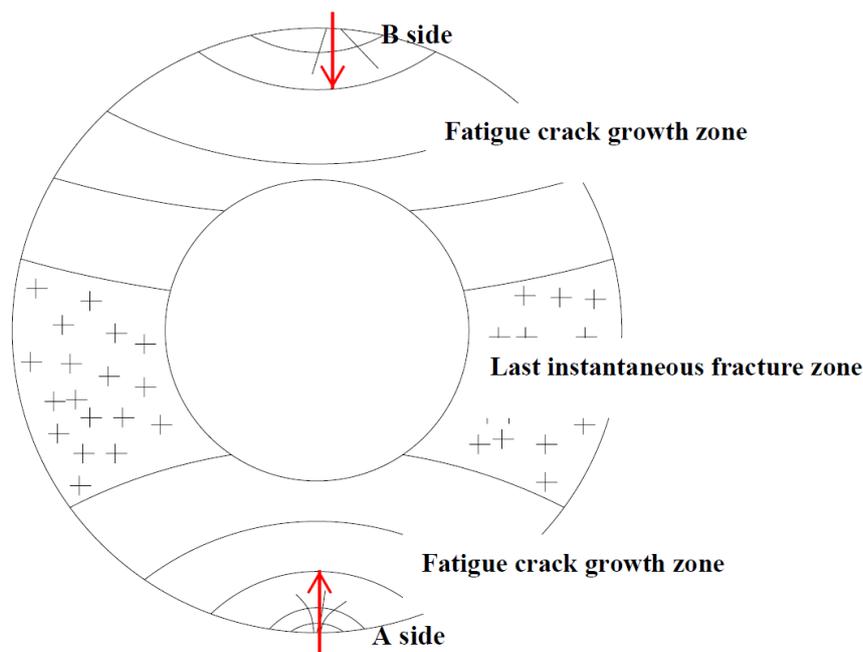
**Fig 5.** The schematic diagram of fracture process simulated

The analysis shows that the failure mode of the lubricating oil pipe is fatigue fracture. The conical structure of the lubricating oil pipe is over machined, which leads to discontinuity of structure and stress concentration at the position machined. At the same time, there is the bi-directional vibration phenomenon at the conical position of the oil pipe during operation. Under the action of vibration, cracks are firstly initiated at the over machined part of the conical position. With the initiation of the crack

here, the crack also occurs on the opposite side, and then the crack gradually expanded, and finally the instantaneous fracture occurs. Therefore, the fracture of lubricating oil pipe is mainly caused by fatigue under machining defects and external vibration conditions.

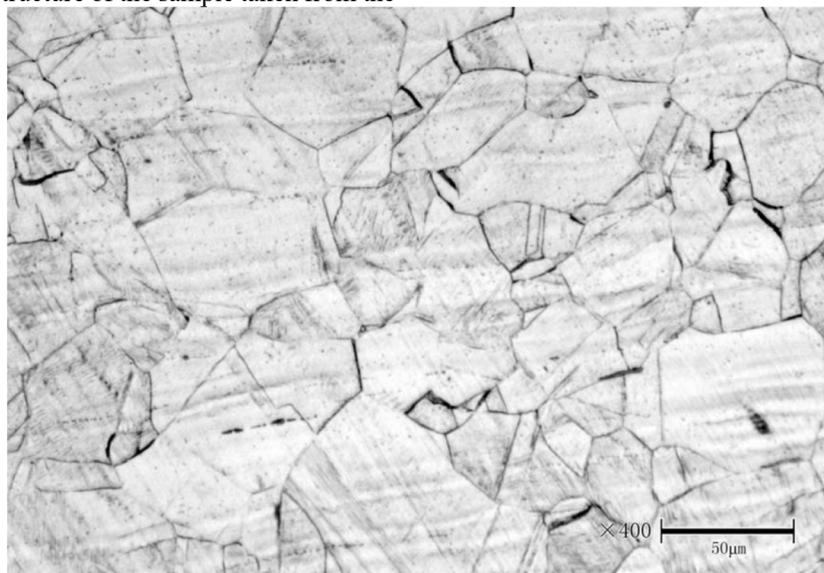
**Fig 6.** Metallographic structure of lubricating oil pipe

fracture location was analyzed. It can be seen from the figure that the metallographic structure of the oil pipe was normal, which was single-phase austenite structure, as shown in Fig. 6.
