Study on the damage analysis of 110kV cable structure

Zhitao HE, Wen HE, Haohui HE^{*}, Junxuan HONG

Dongguan Power Supply Bureau of Guangdong Power Grid co, LTD , 523000 Dongguan, China

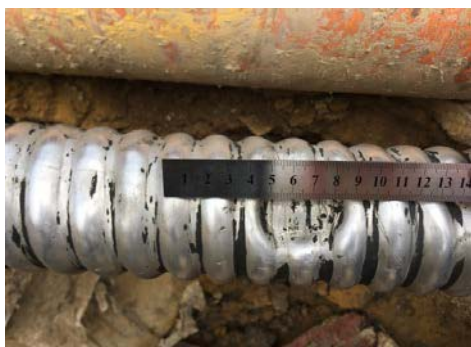
According to the “grading standard of transmission equipment defects”, the damage to the insulation shielding layer is classified as "major". As shown in Figure 3 and Figure 4, the aluminium sheath and insulation shield of 110kV cable line are damaged. The impact dent damage occurs at the body of the cable, and the metal sheath and internal insulation shield are damaged by the impact. The stress concentration generated by the depression reduces the fatigue life of the cable structure, and the existence of the depression also reduces the yield strength of the cable structure [7-13]. In summary, the static strength and fatigue life of the existing cable structure in the sag area have a significant impact on the power supply reliability of the cable. According to the standard, the defect and the insulation shield layer are rated as "significant" and should be locally strengthened for maintenance and replacement.

Fig. 3. Damaged aluminum sheath

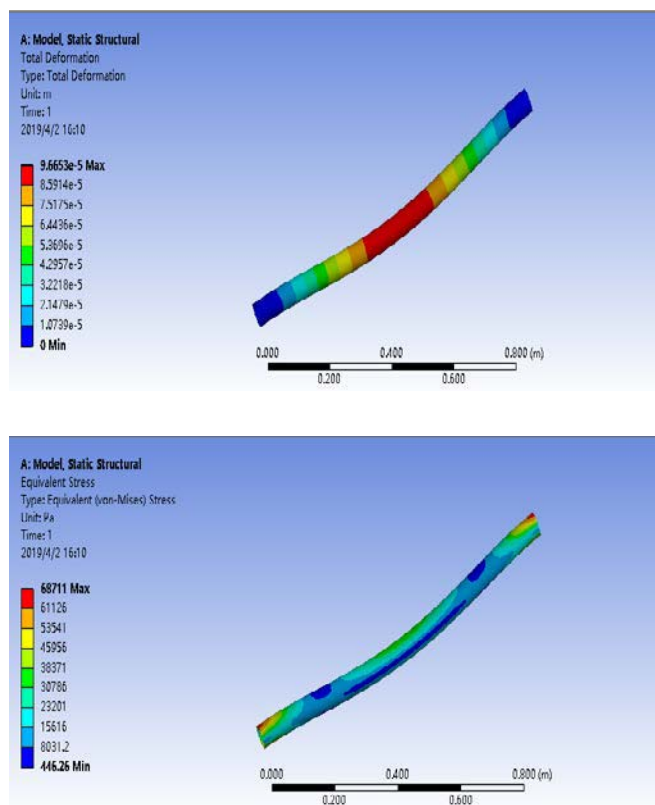
As the buried pipe section of the cable was damaged by water supply emergency repair construction machinery, the inspection found that a damaged cable buried pipe, about 1.1m long and about one third of the circumference, had a depression on the surface of the cable outer sheath. It can be inferred that the cable section is subject to external impact. This simulation simulates the steel ball with $M = 4\text{kg}$, releases the steel ball at the height of 0.5m, 1m, 1.5m, 2m, 2.5m and 3m, and observes the sag and stress of the cable under the impact of the steel ball. As shown in Figure 5, the sag and stress distribution of the cable under the height of 2m are shown.

Fig. 5. Cable depression and stress distribution at a height of 2m

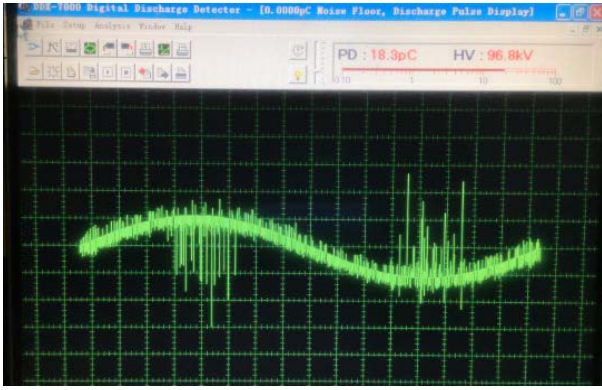
This test instrument adopts series resonance withstand voltage test system, model: MSR700-21000, DDX digital partial discharge detector, model: DDX-7000, to test 110kV cable line damaged by external force. Partial discharge is used to indicate the severity of partial discharge of high-voltage cable. To test the partial discharge of high-voltage cable, the test system must be calibrated first. After testing, the amplitude of partial discharge signal is compared with the calibration information, and the value of partial discharge is calculated to judge the damage degree of partial discharge. Among them, the background signal of not closing the cable is 1.6pC, and the background signal of closing with cable is 2pC. When the voltage is raised to 70kv, the partial discharge signal is 5pC, and when the voltage is increased to 96kV, the partial discharge signal is 18pC, as shown in Figure 6.

Fig. 6. 96kV partial discharge diagram

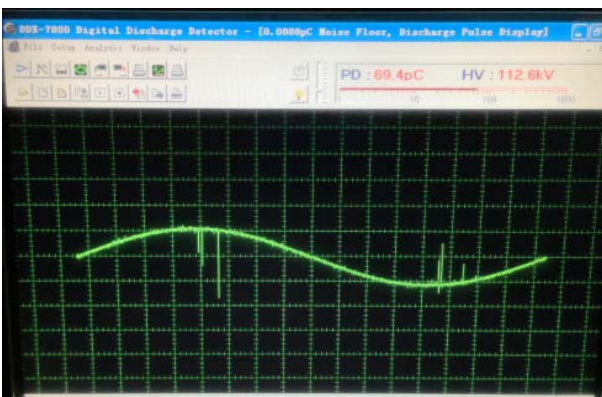
When the voltage is increased to 112 kV, the partial discharge signal is 50-70 pC. as shown in Figure 7, the partial discharge signal is 69.4 pC when the voltage is increased to 112.6 kV.

Fig. 7. 112kV partial discharge diagram

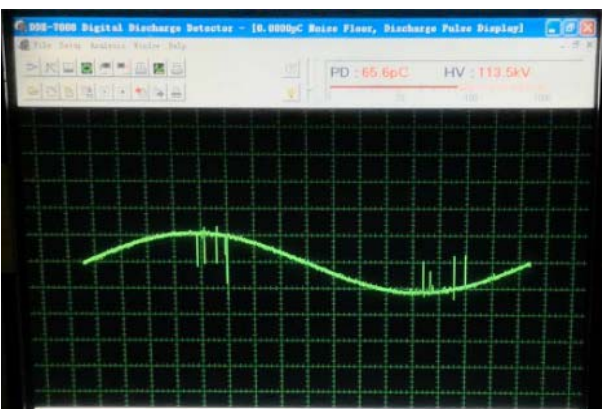
As shown in Figure 8, when the voltage is increased to 113.5kv, the partial discharge signal is 65.6pC.

Fig. 8. 112kV partial discharge diagram

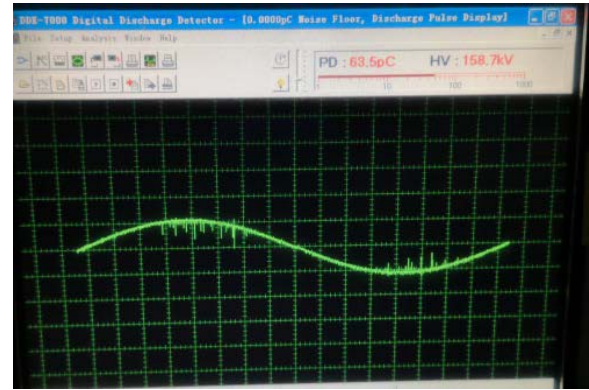
When the voltage is increased to 160kV, the partial discharge signal is between 53-70pC. As shown in Figure 9, when the voltage is increased to 158.7kV, the partial discharge signal is 63.5pC.

Fig. 9. 160kV partial discharge diagram

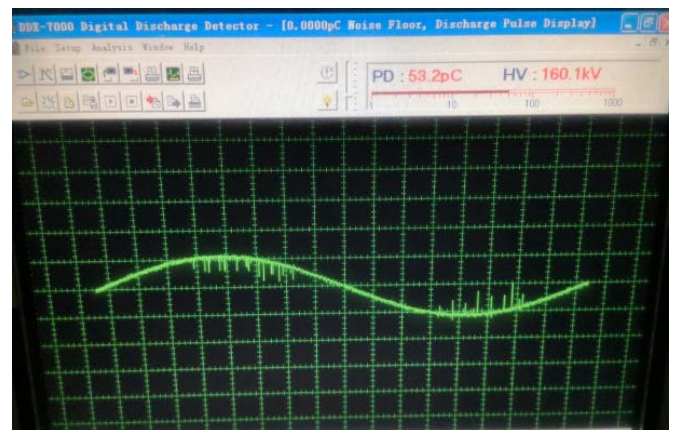
As shown in Figure 10, partial discharge signal of 53.2pC appears when the voltage is raised to 160.1kv.

Fig. 10. 160kV partial discharge diagram

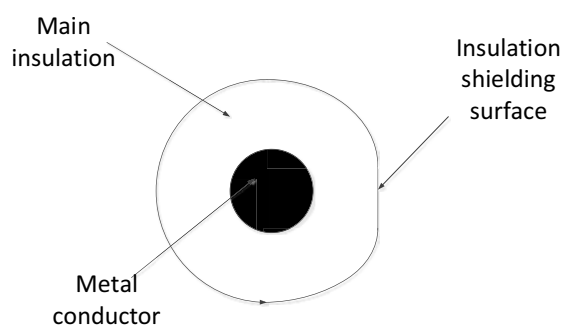
According to the laboratory measurement, the structural dimensions of the cable insulation core depression are as follows: the normal outer diameter of the insulated core is 65.2mm, the minimum outer diameter of the depression is 64.3mm, and the hollow area of the insulated core is 39×27 mm (length \times width). The average insulation thickness of cable is 17.8 mm, and the minimum insulation thickness at depression is 17.0 mm. It can be seen that the damage of insulation shield of 110kV cable is more than 0.8mm.

Fig. 11. Schematic diagram of the fault cable
