Failure Analysis of the Guyed-V Tower Link Plate Deformation of a 500 kV Transmission Line

Abstract. Component analysis, mechanical property test, field survey and finite element mechanical calculation were used to analyse and evaluate the deformation failure of the Guyed-V Tower link plate of a 500 kV transmission line. The results show that the main cause of the failure is the relaxation of the guy after right front guy or wire is subjected to a large impact towards the large side. The weak design of the link plate structure and the misfitting of angle steel are the indirect causes of the failure. The construction angle of anchor cable is larger than the design value, and the tension of anchor cable is low, which has a certain impact.

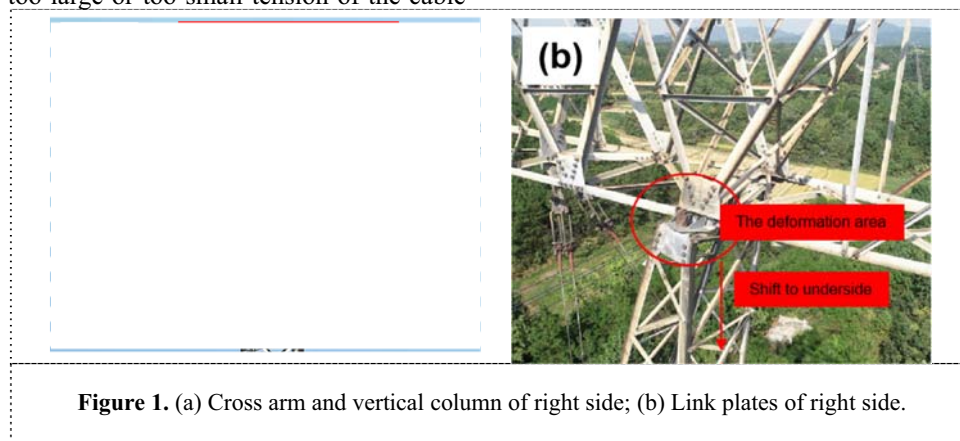
On September 23, 2019, during the maintenance of a 500kV transmission line power failure, it was found that link plates between the right cross arm and the right side of the vertical column were deformed and bent on #94 tower. The right cross arm was shifted to the large-number-side by about 300mm and to lower position. Cross arm and link plate of left side were not damaged, as shown in figure 1-2.

Figure 1. (a) Cross arm and vertical column of right side; (b) Link plates of right side.

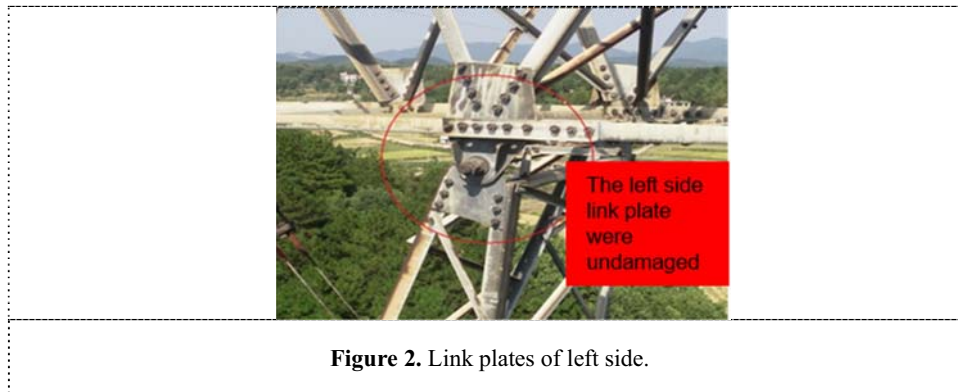
Figure 2. Link plates of left side.

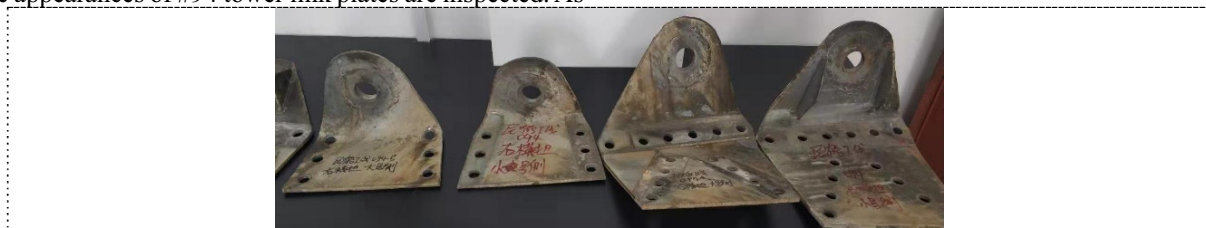
Figure 3. Deformed link plates of right cross arm of # 94 Tower.

we can see from figure 3-4, the damaged right side link plates are bent to nearly 90°, and there are fresh marks on the outside. No corrosion marks were found on the left and right side coupling plates, and no corrosion marks were found on the cracks. It is speculated that the bending time is relatively short and there is no serious corrosion on the surface of the coupling plate. Refer to Guidelines for Corrosion Safety Assessment of Steel Structures of Transmission Lines for light corrosion (grade C).

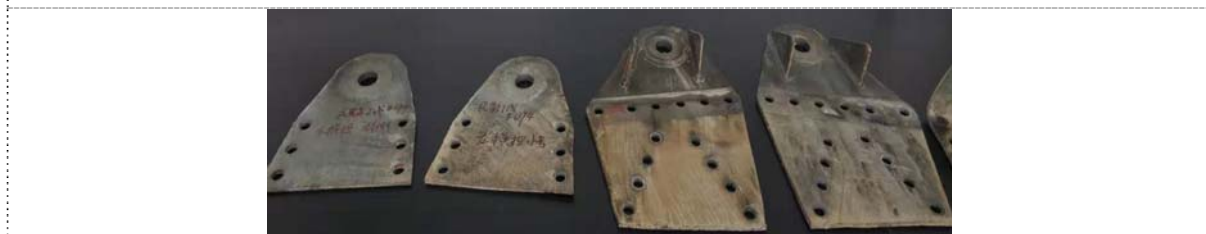
Figure 4. Undeformed link plates of the left cross arm of # 94 Tower.

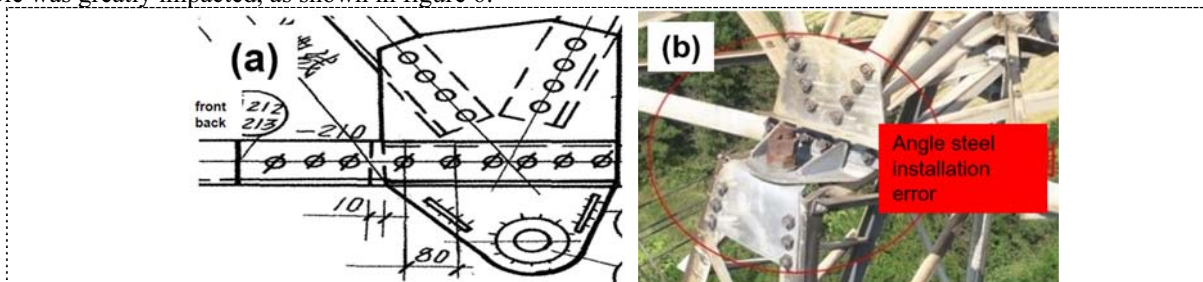
Field investigation found the angle steel installation error of right side link plates. On the small-number side of #94 tower, No.213 angle steel should be installed on right side link plates, but the actual installation was No.212 angle steel. When those link plates were slightly deformed, the lower part of the angle steel could not support them, as shown in figure 5, and the correct installation of angle steel is shown in figure 2.

Figure 5. (a) Angle steel installation on design drawing; (b) Angle steel incorrectly installed, unable to support reinforcement.

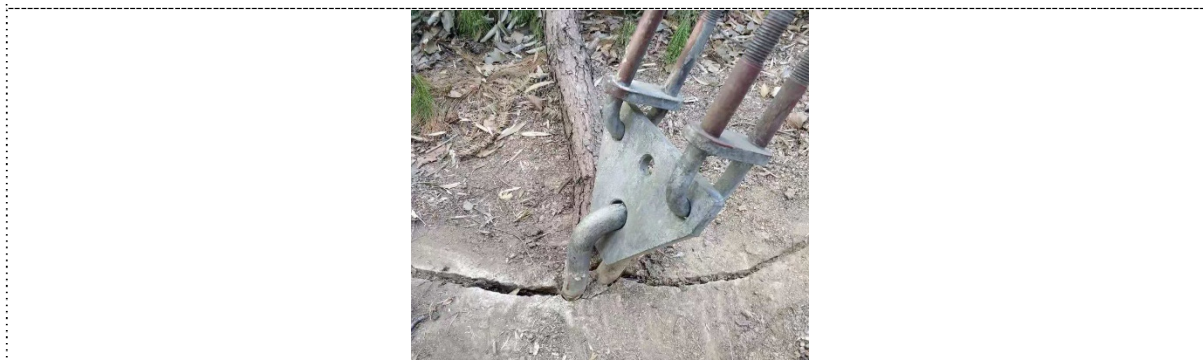
In addition, it was found that the left trailing cable of #94 tower was seriously slack, and the ground anchor on the right side of the small tower was pulled out 2 cm, and the ground cracked near the anchor, indicating that the

cable was greatly impacted, as shown in figure 6.

Figure 6. Cracks occur on the ground near the ground anchor on the right side of the small-number-side of #94 tower, and the degree between ground anchor and ground is larger than that of cable and ground.
