Failure Analysis of the Strain Clamp Steel Anchor Corrosion of a 500 kV Transmission Line

Abstract. By macroscopic observation, composition analysis, mechanical properties test, SEM, energy spectrum, overall grip tensile test and finite element mechanics calculation method, the strain clamp steel anchor corrosion failure of a 500 kV transmission line is analysed. The results show that the corrosion of steel anchor for 31 years are the result of the natural corrosion, steel anchor corrosion rate is accelerated due to the galvanic corrosion, crevice corrosion, stress and damaged surface of the galvanized layer, and achieve C4 environment (zinc 2.1-4.2 um per year, carbon steel 50-80 um per year). The hardware are qualified. It is suggested to replace the steel anchor with yellow rust on the surface after 5 years, and to reevaluate the next maintenance cycle of the gold fittings without yellow rust on the surface at present, and replace it when the corrosion depth reaches 10%. Before replacement, all fittings should be monitored, especially steel anchor.

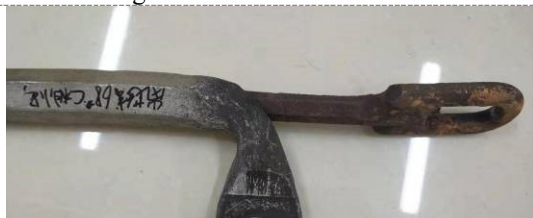
The exposed surfaces of three groups of strain clamp steel anchors of Tower No. 68, 109 and 292 are all seriously corroded and have complex shapes, which are not convenient for anticorrosion coating, as shown in figure 2. Steel anchor rings are welded.

Figure 2. Surface morphology of exposed steel anchor with no. 68 tower strain clamp.

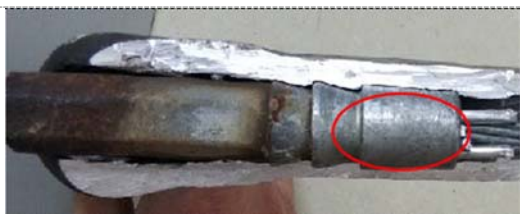
The steel anchor inside the aluminum bushing was found to be in good condition, and no traces of rust were found, as shown in figure 3. The thickness of galvanized layer of the uncorroded steel anchor was measured to meet the standard requirements. The steel core of the conductor in the strain clamp steel anchor is not corroded except at the point where the steel ring is inserted, and the steel core in the compression zone is not corroded, which will not affect the grasping strength performance of the compression zone, as shown in figure 4.

Figure 3. There is no rust on the surface of the steel anchor inside the aluminum casing.

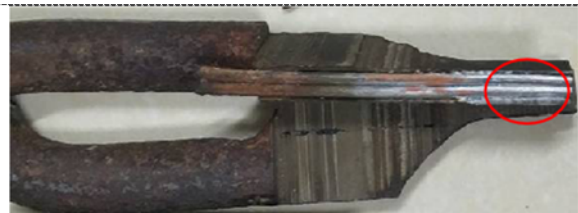
Figure 4. The steel core in the compression zone is not corroded.

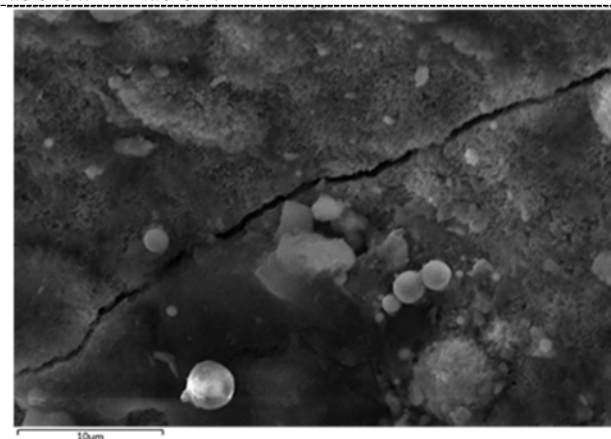
SEM analysis was conducted on the corrosion surface of the anchor steel ring zone of tower No. 109 Phase B strain clamp steel anchor, and it was found that the surface was cracked and porous, showing typical surface morphology of rust, as shown in figure 5. No S element was detected on the surface by energy spectrum, excluding the influence factor of environmental accelerated corrosion, as shown in table 1.

Figure 5. The surface cracks and porosity of the ring area of steel corroded by steel anchor in B phase of Tower No. 109.

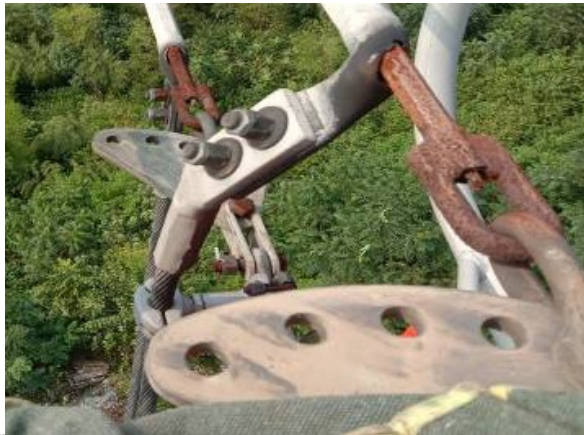
According to the corrosion map, it is located in C3 environment (Zinc 0.7-2.1 $\mu\text{m}/\text{year}$, carbon steel 25-50 $\mu\text{m}/\text{year}$) [3], but the corrosion of strain clamp steel anchor is more serious, and the corrosion rate is higher than that of other fittings, as shown in figure 6. The original padding of the steel anchor is 19mm, and the current padding is 17.8-18.4mm, and the corrosion rate reaches C4 environment (zinc 2.1-4.2 $\mu\text{m}/\text{year}$, carbon steel 50-80 $\mu\text{m}/\text{year}$). The reasons are as follows: (1) the steel anchor contacts with the aluminum casing, and there is the corrosion of the dissimilar metal couple. (2) Crack corrosion exists in the gap between steel anchor and aluminum casing, the weld at the end of steel anchor, and the gap between steel anchor and steel core. (3) Accelerated corrosion of steel anchor under tensile stress. (4) The galvanized layer on the hydraulic rear surface of

Based on the finite element analysis calculation of Abaqus, when the edge of steel anchor is reduced to 17.2mm, the force of steel anchor is greater than the material strength requirement, that is, the service of steel anchor should meet the requirement that the edge is larger than 17.2mm. At present, the thinnest part is 17.8mm. Based on the corrosion rate of low carbon steel in the C4 environment of 50-80 $\mu\text{m}/\text{year}$, it is recommended to replace the steel anchor covered with yellow rust after 5 years.

Figure 6. Comparison of corrosion of tensile steel anchor with other metal fittings.

(1) Based on the test and calculation of the steel anchor, it is suggested that the steel anchor covered with yellow rust should be replaced after 5 years, and the steel anchor with the rod transfer plan can be replaced in advance in combination with the renovation project. The current surface is not covered with yellow rust for the next maintenance cycle to re-evaluate. It should be replaced when the corrosion depth reached 10%. Before replacement, all fittings should be monitored and especially steel anchor corrosion should be closely monitored.

(2) The corrosion rate of steel anchor is higher than that of other fittings. The thickness of galvanized layer of newly replaced steel anchor should be increased to more than 120 μm . The metal detection of newly replaced fittings and bolts should be strengthened to ensure the quality of zinc plating. After the installation of new steel anchor, an anti-corrosion coating should be carried out immediately to strengthen the protection and meet the requirements of *DL/T 1453-2015 Anticorrosive Protection Coating of Transmission Line Tower* [4].
