Failure analysis of SA210-C steel pipe in power plant

Abstract: The reason and mechanism of the failure of SA210-C steel liquid wall were analyzed by means of macro morphology analysis, chemical composition analysis, microstructure analysis and XRD phase analysis. The test results show that the main reason for the failure of SA210-C steel water wall tube is the corrosion under the inner wall scale, and the long-term unqualified boiler water quality is the main factor causing the corrosion of water wall.

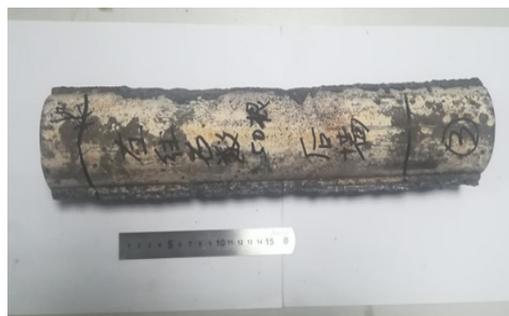
Fig. 1 is a macro photo of the back fire surface and the front fire surface of the water wall tube. It can be seen that the water wall tube diameter has no obvious expansion,

the outer wall of the tube has no cracks, damage and other macro defects, and there is no serious outer wall oxidation.

Fig. 1. Macroscopic appearance of water wall tube

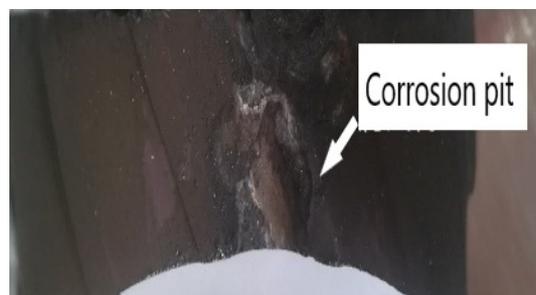
When the water wall tube is cut open, it is found that there is corrosion on the inner wall of the fire facing surface of the tube. The corrosion is multiple corrosion pits in a strip, and the black and dense scale layer is covered on the corrosion pits, as shown in Figure 2.

Fig. 2. Corrosion of inner wall of water wall tube

The corrosion part of water wall pipe analyzed in this test occurred in the inner wall of the pipe to the fire side, and formed multiple corrosion pits under the scale of the inner wall of the pipe, which is typical corrosion under the scale. Under scale corrosion is a common local corrosion phenomenon of thermal power boiler. When the inner surface of the pipe on the heating surface of boiler is attached with scale, serious corrosion will occur under it, which is called under scale corrosion or under sediment corrosion. There are many reasons for corrosion under

- (1) The results of the experiment can be used to judge that the corrosion of the water wall is under scale corrosion.
- (2) In order to avoid the corrosion aggravation and cause large area hydrogen corrosion, it is suggested to determine the area of the seriously corroded pipe row and replace it by nondestructive testing and pipe cutting test.
- (3) The power generation enterprises shall regularly guarantee the quality of boiler water supply and acid pickling according to the standard requirements.

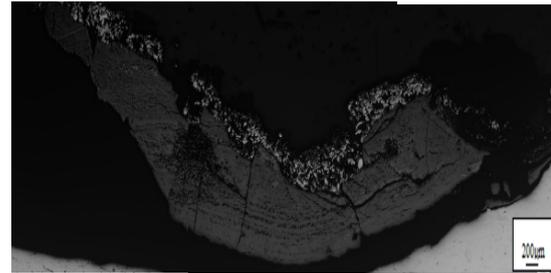
Figure 3 shows the micro morphology of the corrosion pit of the water wall tube. It is observed from the figure that the corrosion products and scale layers are successively covered above the base metal of the corrosion pit, and some of the corrosion products and scale have fallen off. The so-called scale refers to the solid attachment on the metal surface of the water side of the heating surface in the boiler with the water temperature rising or evaporation concentration after the impurities carried in the feed water enter the boiler^[3,6].

Fig. 3. Scale corrosion layer of sample

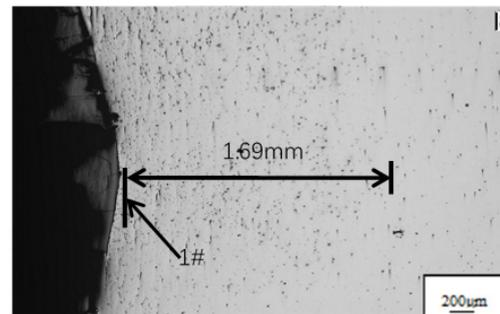
The metallographic specimen was prepared at the corrosion site of the pipe. Fig. 4 shows the micro morphology of the pipe section under the condition that the sample is not etched. The residual thickness of the pipe wall after corrosion is 4.88mm, and the wall thickness is reduced by 30.3%. The No.1 position in the figure is close to the corrosion pit, and there are dense microcracks within 1.69mm from the corrosion pit to the inside of the pipe.

Fig. 4. Micro morphology of sample

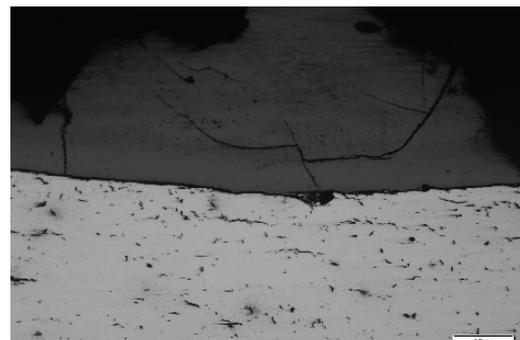
Continue to observe the position 1 in Fig. 4 at a higher multiple, where the microcrack is intergranular, and no defects are found at other positions (Fig. 5).

Fig. 5. 1#Micro morphology of sample

The corrosion under acid scale (hydrogen corrosion) is characterized by the corrosion under dense scale, the decarburization occurs locally in the pipe and micro cracks are formed along the grain boundary. Although the corrosion under acid scale occurs in the water wall pipe in this test, it is not yet to be judged from the decarburization degree, crack morphology and pipe mechanical properties data. However, attention should be paid to this stage. If the pipe is not replaced in time, the corrosion will make the wall of the pipe at the fire side seriously thinner, the effective area of the pipe will be reduced, the strength, toughness and plasticity of the metal will be reduced sharply, and then a large area of water wall explosion will occur.

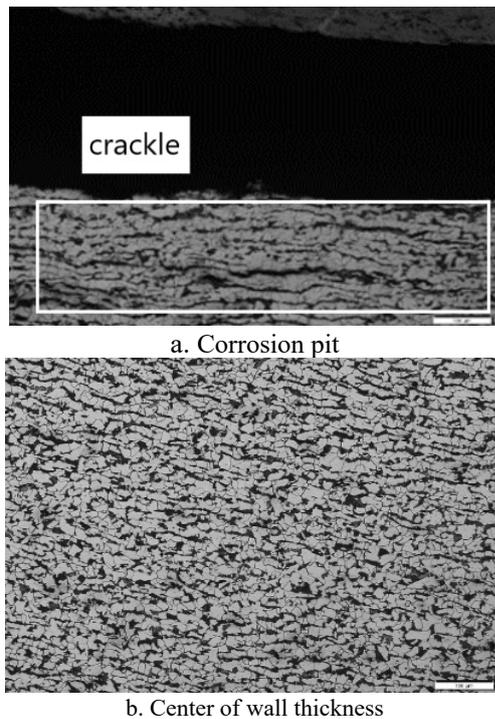
Fig. 6 shows the metallographic structure of each part of the sample after etching. The metallographic structure of the corrosion pit (inner wall) and the part far away from the corrosion pit are ferrite and pearlite, and there is no sign of serious spheroidization and other structural abnormalities^[7], but there are microcracks at the edge of the corrosion pit (Fig. 6a). Compared with the other two parts, the pearlite area is reduced, and there is obvious decarburization phenomenon.

Fig. 6. Metallographic structure of sample

The microstructure of the water wall tube was observed. It was found that the microstructure of the matrix was ferrite and pearlite, and no abnormality was found. However, there were decarburization phenomena in different degrees in the corrosion pit, i.e. the inner wall of the pipe, and a large number of microcracks were distributed along the grain boundary. The yield strength of the samples is lower than the standard requirements and is also related to the decarburization of the microstructure found in metallographic examination. Judging from the above characteristics, the corrosion of water wall pipe belongs to acid corrosion (hydrogen corrosion) under scale. Acid corrosion under scale is due to the metal surface scaling, because of their poor thermal conductivity, the temperature of the pipe wall under the scale will rise, the furnace water infiltrating under the scale will be concentrated sharply, and it cannot be mixed with the furnace water in the pipe. As a result, the concentration of impurities in the furnace water under the scale becomes higher, and the cathode generates atomic hydrogen, which makes the metal pipe wall and scale concentrate a lot Hydrogen, which occurs under scale, is usually on the fire side.
