Systematic monitoring of the deformed state of long-length reinforced concrete structures with an assessment of their reliability

Abstract. The article shows the method of systematic monitoring of the stress-strain state of reinforced concrete structures covering one of the operated public railway stations. The description of large-span structures of the building, their defects and damages acquired during the operation of the building is given. The article describes the methodology and methods used for long-term, more than 2 years, continuous monitoring of the deformed state of coating structures in operation. The most damaged structures are examined in detail with the help of installed devices to obtain accurate data. The features of measurements in different periods of time and time of year are described. Based on the results of the obtained measurements of the stress-strain state of the building coating structures, the possibility of their further operation is predicted, taking into account the defects and damages found during the survey.

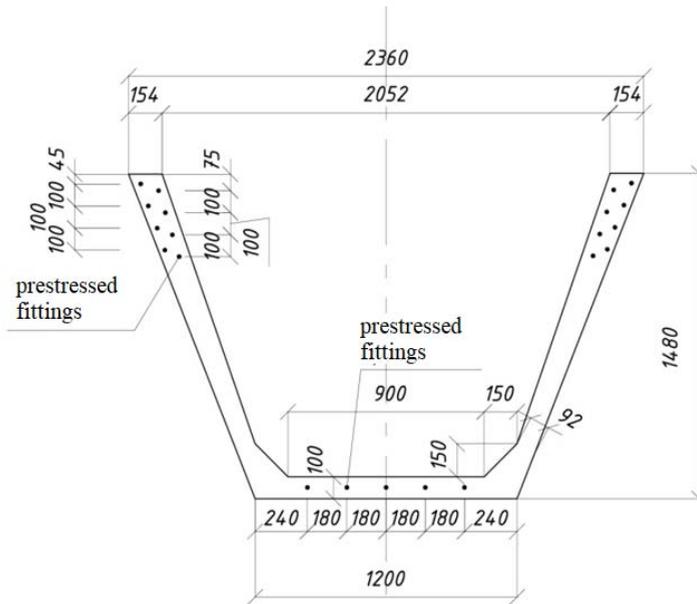
Fig. 5. Cross section of the U-shaped element of the coating structure.

During the operation of the building since 1972, many defects and damages have accumulated on the U-shaped elements of building structures. Basically, the defects are presented in the following form:

- the deflection of individual U-shaped elements of the cover is higher than the permissible standard values.

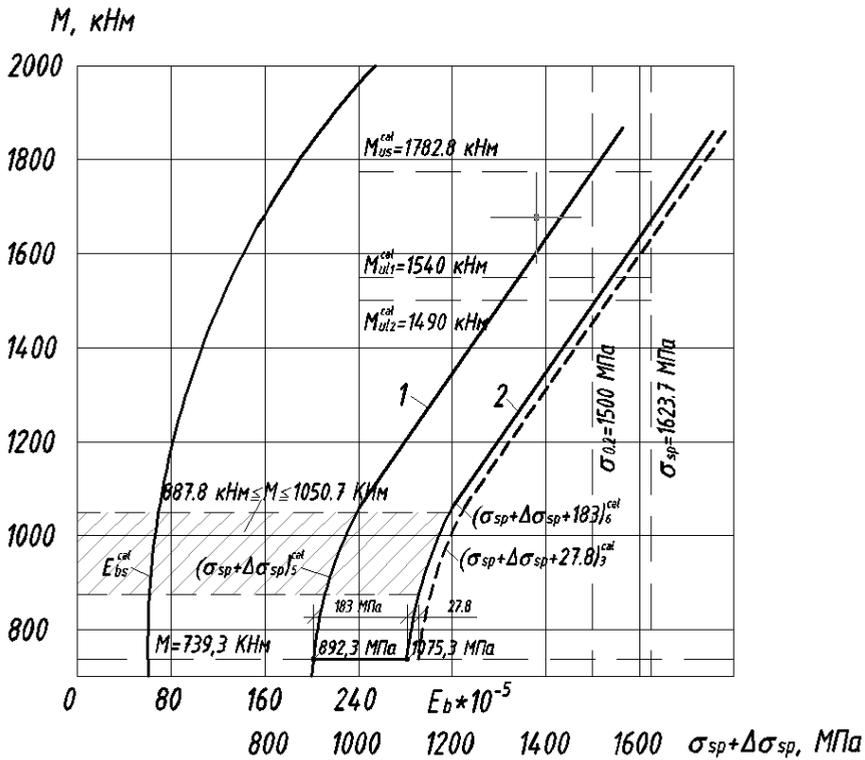
Fig. 7. Determination of the calculated breaking moment M_{ul2}^{cal} taking into account the stress increment $\Delta \sigma_{sp} = 27.8 \text{ MPa}$

From the results of the calculations, it follows that the stress increment in the prestressed armature of the bottom of element 21 reduces its calculated load-bearing capacity in the span normal section (M_{us2}^{cal}) to the value of 1490 kN*m. The minimum value of the margin coefficient in this case is

$$M_{util}^{cal}/M_2^P = 1490/1050.7 = 1.42 \quad (5)$$

Thus, even in the most unfavorable case, the minimum value of the reserve coefficient of element № 21 is not lower than the normalized value. At the same time, the reserves of increment of deformations and stresses in the pre-armature of the bottom for a long period of time practically did not remain.
