Failure analysis for tube bundle of methanol condensation recovery heat exchanger

Abstract: The S30408 tube bundle of methanol condensation recovery heat exchanger in a chemical company was found leaked during use. The cause of tube bundle leakage was analyzed by means of macroscopic inspection, chemical composition analysis, metallographic analysis, hardness test and leakage fracture analysis. The results show that formic acid and chloride condensate are formed by the exhaust gas in the shell side near the outlet of the shell side, which results in the spot corrosion and stress corrosion cracking of the tubes. Surface coating or replaced material is recommended to prevent such failure.

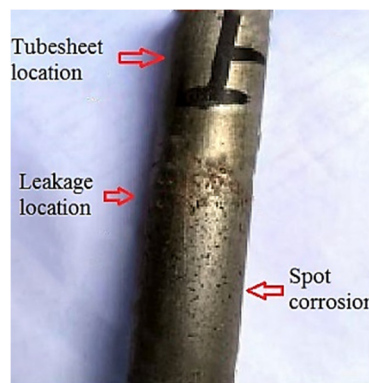
upper tubesheet after the leaked pipe section was cut down. The closer the tubes were to the tubesheet, the more serious the corrosion of the tubes were, as shown in Fig.2. There was basically no corrosion at the tubesheet position. The leaked tubes had no obvious plastic deformation and no thinning of wall thickness. The surface of the tubes was partially covered by corrosion products. The leakage points were rough and black with local yellow-brown and a little of dark red. After grinding the position of corrosion products covering, many corrosion holes were found in the tubes, as shown in Fig.3. Part of corrosion holes only occurred on the outer wall and did not penetrate to the inner wall of the tubes. In addition, a total of 32 corrosion holes penetrated the tubes by macroscopic inspection. Therefore, it can be confirmed that the corrosion leakage started from the outer wall of the pipe. In other words, the leakage started from the corrosion of the outer wall by the medium of shell side^[1].

Fig.2.Morphology of a leaked tube

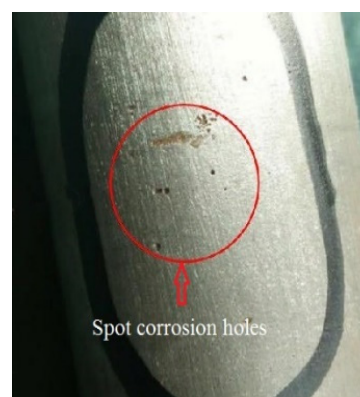
Fig.3 Spot corrosion after grinding

The cross-section metallographic sample were taken from the position shown in Fig.3. The metallographic examination was conducted in accordance with GB/T 13298-2015 "Methods for Examination of Metal Microstructure". The metallographic microstructure of the leaked tube was normal single-phase austenite. There were some spot corrosion pits on the outer wall of the tube, and there are cracks under the spot corrosion pits^[2].

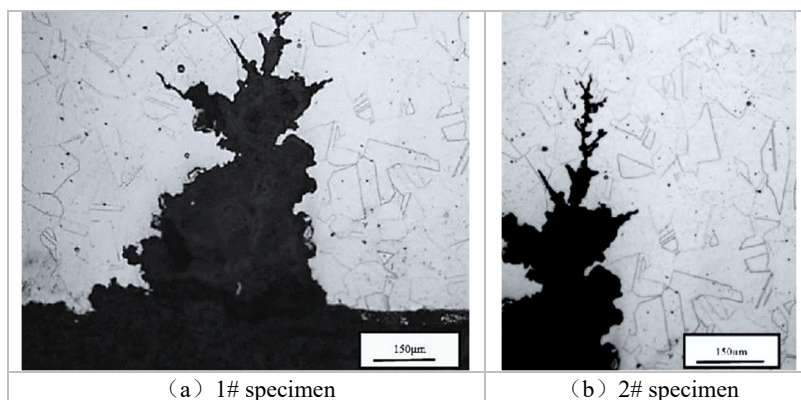
One of the spot corrosion pits penetrated the tube selected as 1# specimen and the other did not penetrated the tube selected as 2# specimen. No accumulation and growth of carbide was observed, as shown in Fig.4. A small range of plastic deformation could be seen at the edge of the leakage hole on the outer surface of the tube. The dislocation line of the slip step plug was found in the deformation area. All the main cracks and the secondary cracks showed the characteristics of transgranular propagation.

Fig.4 Metallographic structure of the leaked tube

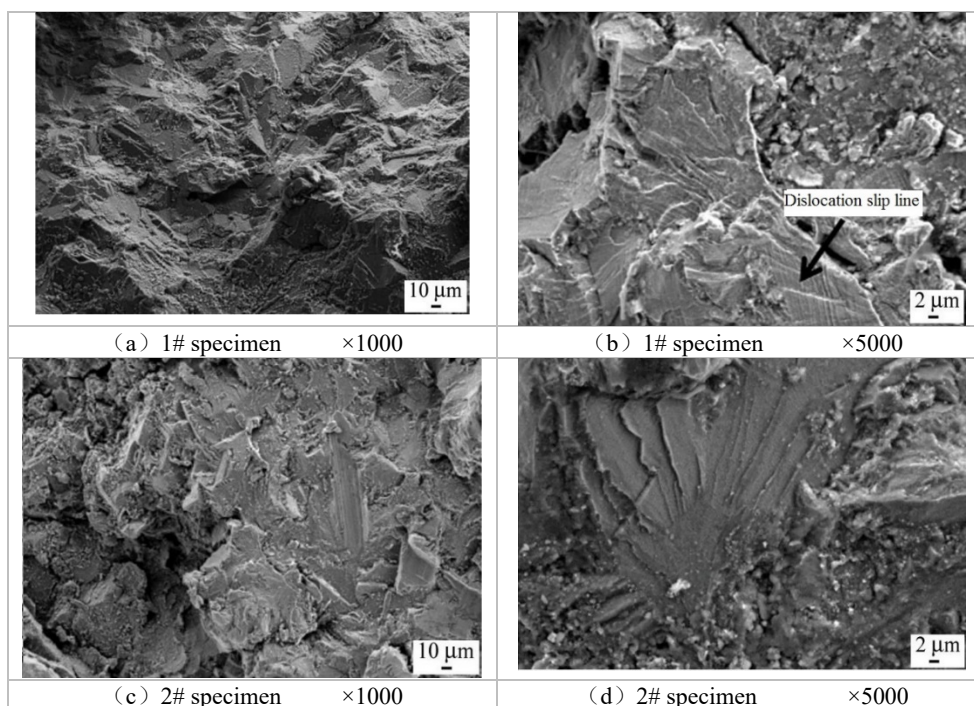
The specimens were processed, polished and cleaned with acetone. The microscopic morphologies of the samples were observed by Scanning Electron Microscopy (SEM). The river pattern and a small amount of fan pattern were found in the microscopic morphology of 1# specimen, which was a typical characteristic of cleavage fracture^[3], as shown in Fig.5(a) and (b). The surface of the leakage fracture was covered by corrosion products. The main leakage crack appeared at the leakage section, which was characterized by transgranular propagation. The secondary cracks and dislocation slip lines were visible on the leakage fracture. The river pattern and a small amount of fan pattern were also observed in the microscopic morphology of 2# specimen, as shown in Fig.5(c) and (d). The surface of the leakage fracture was also covered by corrosion products, but no cracks and dislocation slips were obviously found.

Fig.5 Microstructure of leakage fracture By SEM

When the medium sediment was gathered on the surface of tubes, the spot corrosion of formic acid was easily occurred under the sediment. S30408 was prone to stress concentration under pits^[5]. According to the results of energy spectrum analysis, there was a large content of chloride ion in the corrosion position of the leakage fracture. According to GB/T 30579-2014 "Damage modes identification for pressure equipments", when chloride ion is contained in the medium and the tubes was in the dry-wet, water-vapor alternated environment, the chloride is locally concentrated, and the sensitivity of stress corrosion cracking is significantly increased. The microstructure pattern of river and a small amount of fan in the leakage fracture indicates the stress corrosion cracking of the tubes^[6].

(1) There are many leakage positions in the tube bundle, so it is not feasible to block all the leaked tubes by welding which will directly affect the heat transfer efficiency. Therefore, the shell side with the tube-to-tubesheet part is recommended to be replaced.

(2) Chloride ion was found in the corrosion products by energy spectrum analysis, so the current tubes material of S30408 is suggested to change into a material with strong resistance to stress corrosion cracking by Chloride ions, such as S32205 (the brand is 022Cr23Ni5Mo3N). Another method is to apply a coating on the surface of the tube bundle to avoid direct contact with Chloride ions.
