# Study on early warning of rapid sinking of large land caisson in silt layer

<sup>1</sup>CCCC Second Harbour Engineering Co. Ltd, Wuhan

The south anchor caisson foundation of a suspension bridge is the first large-scale land caisson constructed with a deep silt layer. The plane size is 70×63meters (m) and the total height is 67.5m. There are 30 rectangular wells (10.84×10m) in total. Except for the steel shell concrete caisson in the first section, the rest are reinforced concrete caisson. The process of “three times of height connection, three times of sinking” was adopted to complete the height connection and sinking of the caisson.

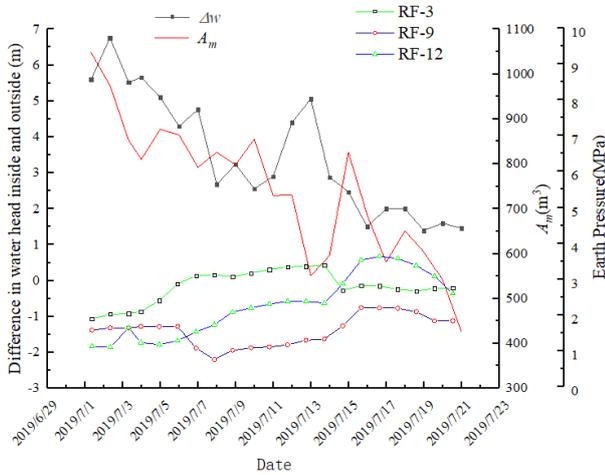
**Figure 2.** Change curve of supporting area, water level and earth pressure.

Figure 1 shows the arrangement of measuring points for earth pressure at the end. The change curve of water level (difference in water head inside and outside,  $\Delta w$ ), mud surface support area ( $A_m$ ) and earth pressure before the first rapid sinking is shown in figure 2, and the change of earth pressure before the second rapid sinking is shown in figure 3. In the stagnation stage before the first rapid subsidence, the average earth pressure at RF-3, RF-9, and RF-12 points was 2.19MPa, and the average ultimate earth pressure was 2.73MPa. Except for the monitoring points at the corner points (hereinafter referred to as the edge points), the average earth pressure in the stagnation stage was only 0.65MPa, and the average ultimate soil resistance was 0.68MPa. The average of earth pressure at the corner points before the

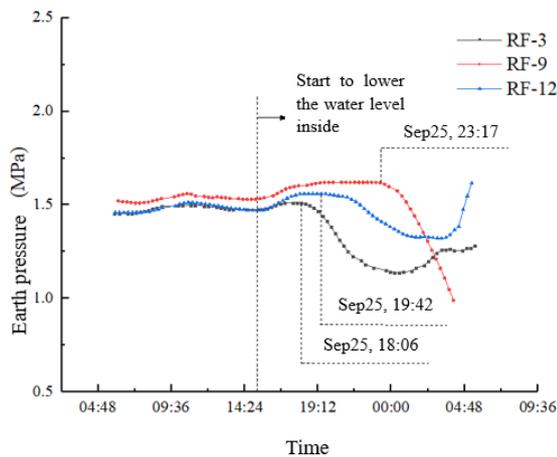
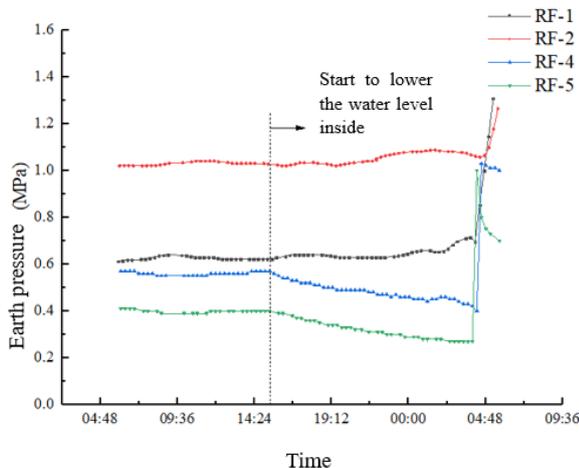
**Figure 3.** Earth pressure in the second rapid sinking.

second rapid subsidence was 1.53MPa, while the average pressure at the edge point soil was 0.66MPa. The limit soil resistance of corner points was obviously greater than that of edge points, the use of edge points for monitoring would underestimate the earth pressure and its changes.

(a) Change curve of earth pressure in corner point.

(b) Change curve of earth pressure in edge point.

When the support area decreased, the earth pressure first increased and then decreased, the corner soil was plastically extruded, and the end earth pressure reached the limit state and then began to decrease; When buoyancy decreased at the same time, the side resistance sharing ratio increased gradually to meet the stress balance of open caisson. RF-4 and RF-5 decreased as the water level decreased, and the amount of decrease was equivalent to the decreased water head. When the blade feet were partially empty, the reaction force monitored by the edge point was mainly buoyancy. The additional stress of the basement at the corner point was greater than that at the edge point, and the wrapping effect was more obvious; the use of corner earth pressure data could be more effectively reflect the force state of the caisson.

With the decrease of water level in the cabin, the soil was prone to plastic failure under the action of the earth pressure difference between the two sides of the blade end, and the surrounding soil had gushed into the cabin. In the process of rapid sinking, the corner earth pressure decreased gradually, which reflecting the process of plastic extrusion of soil at the edge. Due to the thixotropy of soft soil, the side friction and supporting force decreased rapidly, which led to the overbalance and downward movement of open caisson, resulting in rapid subsidence. The strain softening characteristics of high thixotropy and structural silt are the main reasons for the rapid sinking of open caisson [9]. After the rapid sinking, the soil support was re-established and gradually stabilized from the unstable state. From the change of the earth pressure at the edge point, it could be seen that the end earth pressure quickly recovered with the increase of the penetration depth of the caisson blade feet.

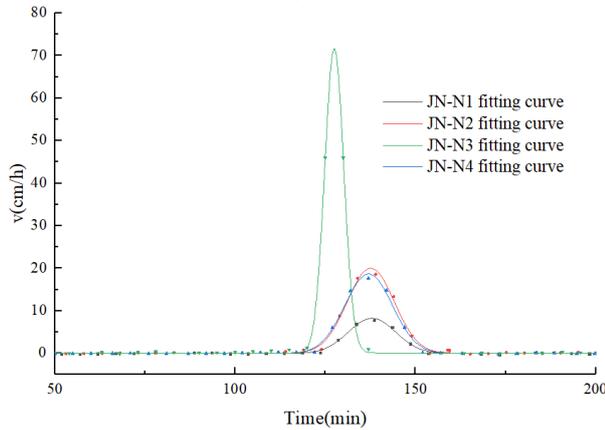
**Figure 5.** Sinking rate curve in the first rapid sinking.

increased. When the caisson was unstable,  $v$  increased rapidly and exceeded 2cm/min. The fitted sinking rate curve presents a "single peak shape". After the soil support was gradually established,  $v$  decayed rapidly and approached zero. The peak sinking rate of JN-N3 on the downstream side of the first rapid sinking was the largest, and JN-N1 on the upstream side was relatively the smallest. The downstream side lost stability first, and  $v$  decayed first; at that time, the other three monitoring points  $v$  hadn't reached the peak rate.

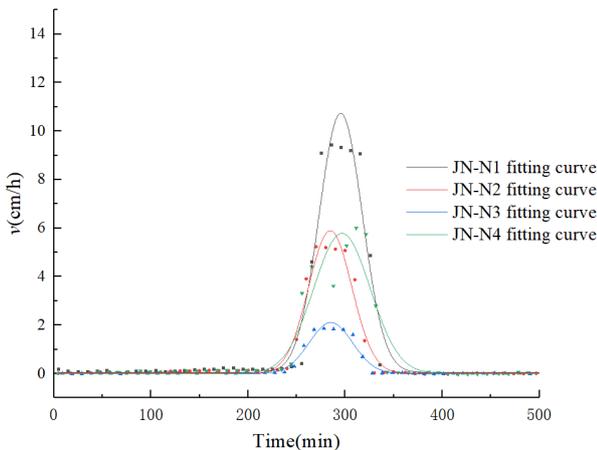
**Figure 6.** Sinking rate curve in second rapid sinking.

During the second subsidence, compared with JN-N3,  $v$  of JN-N1 and JN-N2 increased rapidly. The side with a large amount of sinking. In other words, the side with a small supporting area of the mud surface, would initiate the sinking first, and end the unstable state at the latest. The period of rapid sinking instability was about 90 minutes, and the  $v_{max}$  was 11 cm/min. The rapid sinking caused by precipitation, which  $v_{max}$  was smaller than the first time, and the instability time was longer. It had showed that only part of the plastic zone of the soil was destroyed during the precipitation process with reducing of the bearing capacity.

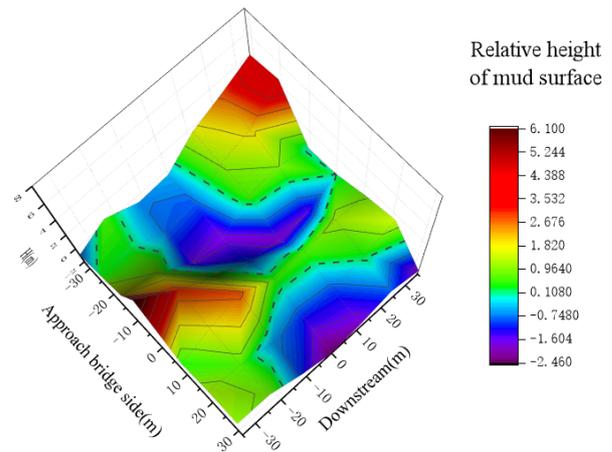
**Figure 7.** Depth of the blade feet buried before the first time rapid sinking.

Before the first rapid sinking, the blade feet of the three outermost continuous compartments in the downstream were in a void state. The supporting area of the mud surface was smaller than that on the upstream side, and the blade feet were located in a silt layer containing cohesive soil, which was more prone to gushing soil. The blade feet on the downstream side were squeezed and destroyed, and the connection of the plastic zone was led to the instability of the downstream

side of the influx of soil, inducing instability and failure of the soil in other locations.

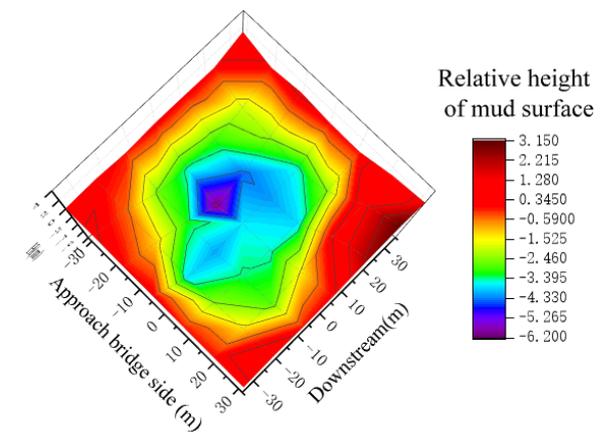
**Figure 8.** Embedded depth of blade feet before the second rapid sinking.

The depth of the blade feet before the first sinking and the second sinking is shown in figure 7 and figure 8. A positive value indicated the depth of the blade feet inserted into the mud surface, a negative value indicated that the blade feet was empty, and the absolute value was the distance from the mud surface to the blade feet.

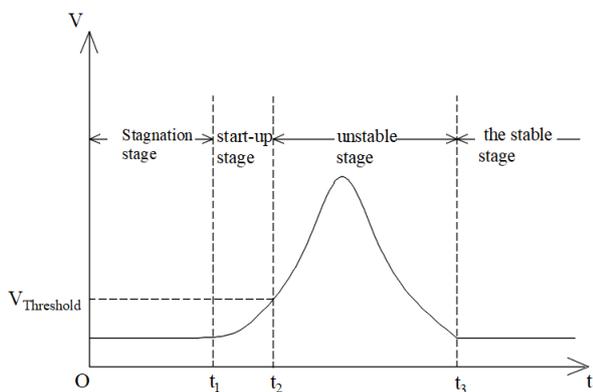
**Figure 9.** Division of rapid sinking stage.

The rapid subsidence can be divided into 4 stages. 1) The stagnation stage, the sinking of the caisson is difficult. 2) The start-up stage, the corner earth pressure decreases, and  $v$  gradually increases. 3) The unstable stage,  $v$  increases rapidly, and the side with small support area loses stability first. In the process of soil gushing, the support gradually establishes, and the subsidence rate decreases rapidly. 4) In the stable stage,  $v$  decays to zero and stagnates again. In the start-up stage, the rapid sinking early warning will have enough time to evacuate people, avoiding the loss of life and property.

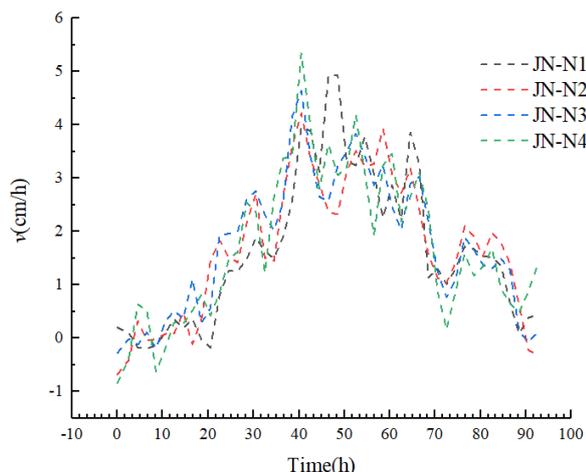
**Figure 10.** Sinking rate during dewatering.

The sinking rate from October 30 to November 2, 2019 is shown in figure 10. The curve during dewatering assisted sedimentation is "multi peak", and the  $v$  peak valley of each measuring point is not identical, and the sinking well sinks during the swing process.  $v$  is less than 5cm/h, and the sinking data analysis shows that when  $v$  exceeds the threshold value of 5cm/h and lasts for 2 hours, it will start the rapid sinking trend.

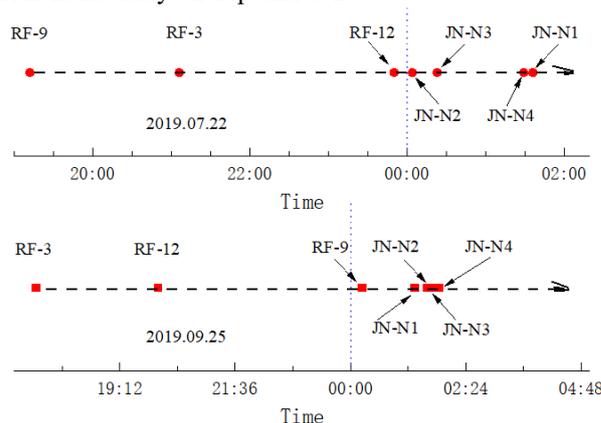
**Figure 11.** Warning time line of rapid sinking

The early warning timeline of rapid sinking is shown in figure 11. The settlement warning was later than the earth pressure warning at the corresponding point, and there was a time difference between them. The earth pressure warning time and settlement warning time of the side with a small supporting area were earlier than those on the other side, and it was more sensitive to dewatering. The above-mentioned early warning mechanism was established after the rapid sinking on July 22, and successfully issued a level three warning four hours early on September 26.
