Research on the building restoration engineering and materials of the Night Watch House in Macau - taking the Patane Night Watch House in Patane as an example

Abstract. As the only existing example of the Night Watch House building in Guangdong, Hong Kong and Macau, the Patane Night Watch House has become one of the common cultural relic building restoration methods and revitalization design ideas in Macau. Study and explore the restoration problems from four aspects: the historical development of the Macau Museum, the construction context, the Lingnan architectural characteristics, the methods and materials of the restoration project, and hope that this will be used as a follow-up of similar types of buildings in Macau and the Lingnan Cantonese area to provide some experience reference.

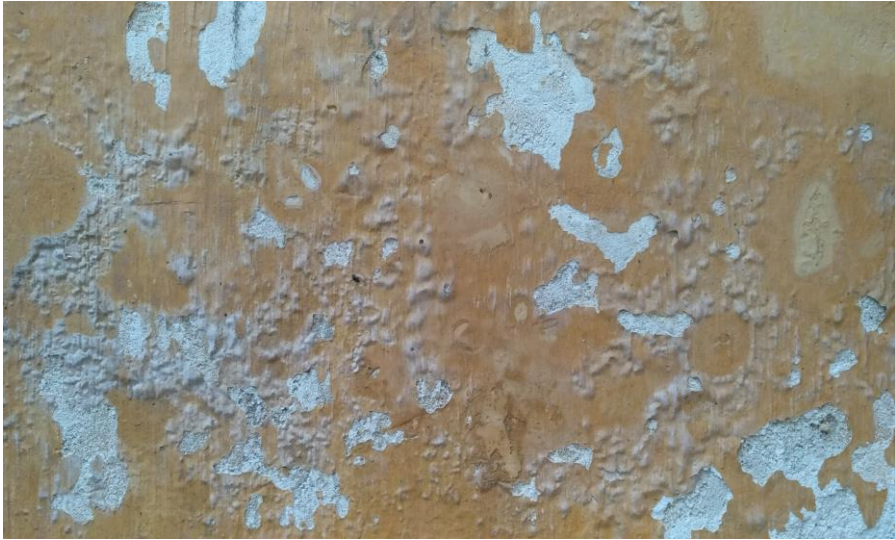
buildings in the Rua da Ribeira do Patane area. The appearance of the city is coordinated, but only the appearance is consistent with the original. The difference in materials has caused local damage to the building.

Fig. 2. Facade with blistering and falling off.

Macau belongs to the southern part of the Lingnan region. It has a subtropical maritime monsoon climate with hot summers and warm east, and there are still southern days throughout the year. It is relatively humid. The humidity in the air is high at ordinary times, and the building facade needs to be "ventilated". It can be seen from the on-site inspection of the facade of the pavilion that the wall has fallen off, and there are some bumps and blisters. This is because latex paint is not breathable, and when the building needs to "breath" and "breath", the "air" generated will push the latex paint out, causing it to fall off and foam.

The Patane Night Watch House is the only remaining building in Guangdong, Hong Kong and Macau, which embodies the architectural features of the traditional residences of Cantonese in Lingnan. However, due to improper use of materials in the restoration project, the facade of the building was obviously damaged. It is recommended that in the follow-up periodical repair process, the common “bottom-probing method” of cultural relic restoration should be used first, a small part of the excavation knows the material composition inside, and the repair should be carried out according to the method of “repair as old as old” using the ratio of raw materials. At the same time, the latex paint that damages the exterior wall of the building should be removed until the brick layer is seen, and then the grass or paper reinforcement ash should be added. Being good at adapting to local climate conditions and environment, and choosing building restoration materials can the building be preserved for a longer time.

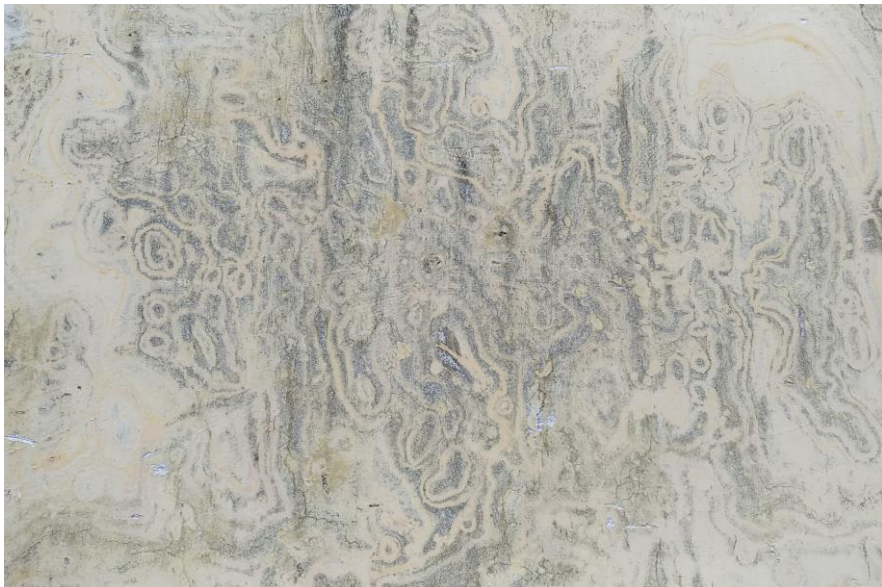
Fig. 3. Vortex traces on the windward side.

At the same time, the west façade of the pavilion belongs to the windward side, and the roof and side stone walls are all subjected to wind suction. The airflow swirls between the eaves on the windward side and the wall, and then forms a whirlpool after separation. The dust in the vortex and the whirlpool formed traces of different shades of black and gray on the wall, which were difficult to clean [6].
