Heat and power plant chimneys thermal inspection with an infrared camera

Katarzyna Stokowiec^{1*}, Dagmara Kotrys-Działak¹, Dominika Mochocka¹ and Marcin Sokołowski¹

¹Kielce University of Technology, Faculty of Environmental Engineering, Geomatics and Power Engineering, Kielce, Poland

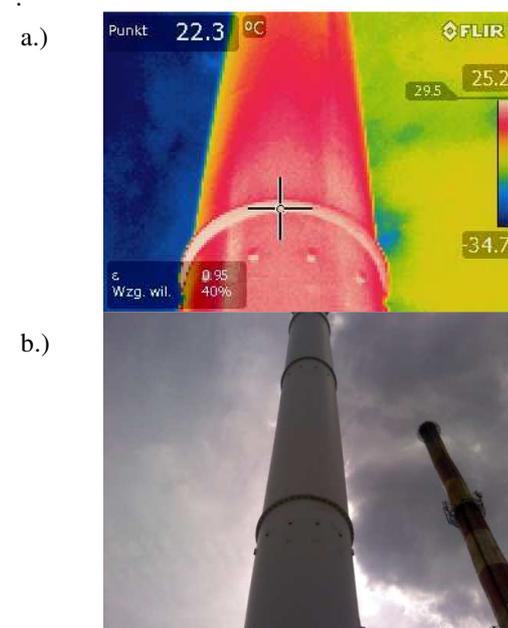
Fig. 2. Structural steel chimney picture – top of the facility (north side) a.) thermal image, b.) digital photo

As we can observe the thermograms for structural steel chimney are more homogenous, while the reinforced concrete image presents several spots shown as darker parts on image that may indicate some cracks or leakiness, since they present areas of higher temperature. Therefore, even the infrared pictures itself could be one of the easiest and the most efficient ways to conclude whether the construction has tight walls. The first assumptions may indicate the necessary

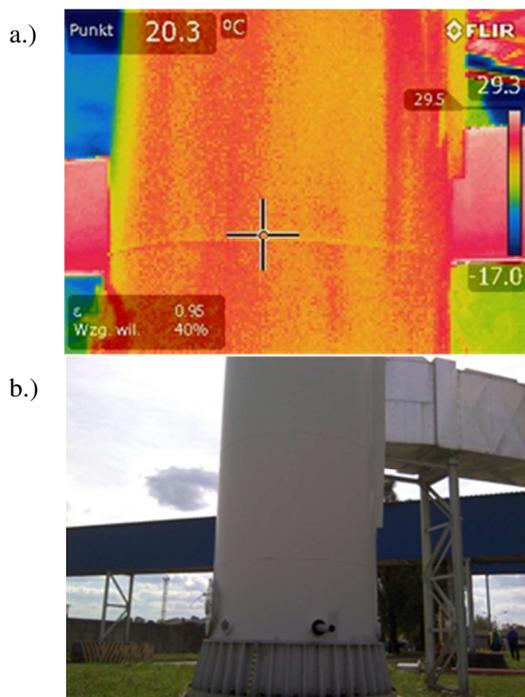
Fig. 3. Structural steel chimney picture – bottom of the facility (north side) a.) thermal image, b.) digital photo

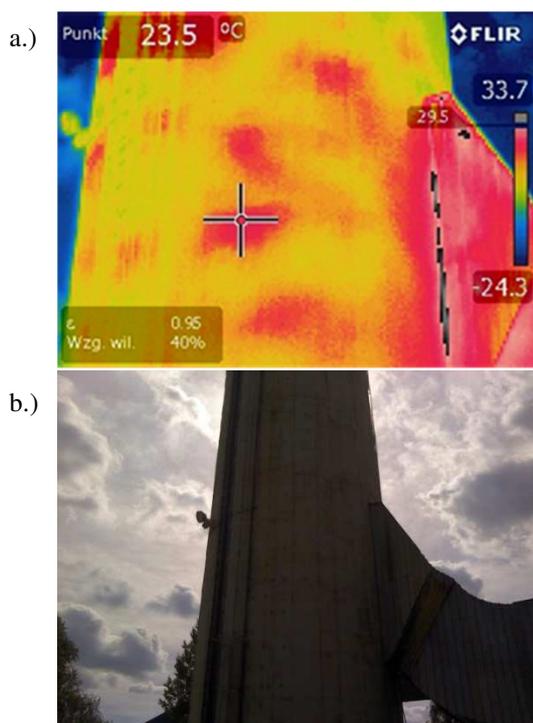
Fig. 4. Reinforced concrete chimney picture (north side) a.) thermal image, b.) digital photo

conservation works or on the other hand when the thermal image presents no possible damage the facility owner may avoid unnecessary heavy works.

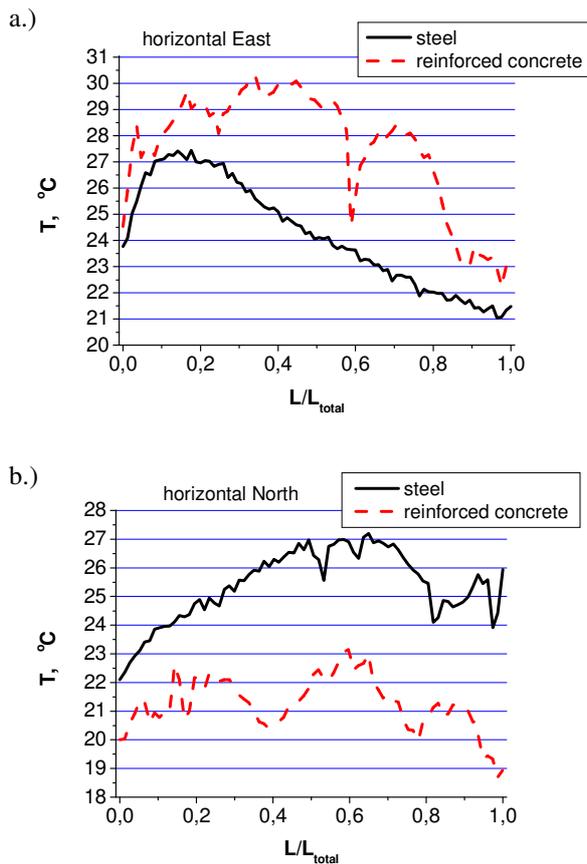
Fig. 5. Temperature distribution along the chimneys in horizontal direction oriented: a.) East, b.) North

Figure 5. presents the temperature distribution in the horizontal direction on both steel and reinforced concrete chimney. The analyses were selected for east and north orientation since the research was conducted in this orientation for both chimneys due to the conservation works and problems with taking thermal images of reinforced concrete chimney.

As it is shown in east direction the temperatures decline along each chimney whereas the diagrams for north orientation present the opposite tendency: the temperatures mostly increase. The temperature difference in each case is low (up to 6K). The differences in temperature in each direction are similar no matter the chimney material.

The east orientation presents higher temperatures along the line for both structural steel as well as reinforced concrete chimney than the north orientation. The outer surface temperature of the facilities increases faster due to the greater solar operation on the east side than on the north one.

The diagrams present many sudden temperature drops, which is more visible in case of the chimney made of reinforced concrete. The declines in temperature prove numerous discontinuities on the outer surface of the chimney.

What is more, we observe higher temperatures along the structure on the reinforced concrete chimney in east direction, whereas the opposite tendency is presented in north direction. From the curves it may be assumed that the reinforced concrete chimney preheats faster but the structural steel one conveys less heat to the ambient.

In Figure 5. and 6. we can also observe several sudden temperature drops which can be explained by means of several cracks and/or joints on the chimneys' surface.

Figure 5. presents temperature distribution along both chimneys in horizontal direction. The discrepancies in observed temperatures arise from the differences in the chimneys' structure: the material, its thermal conductivity, whether or not there is an isolation.

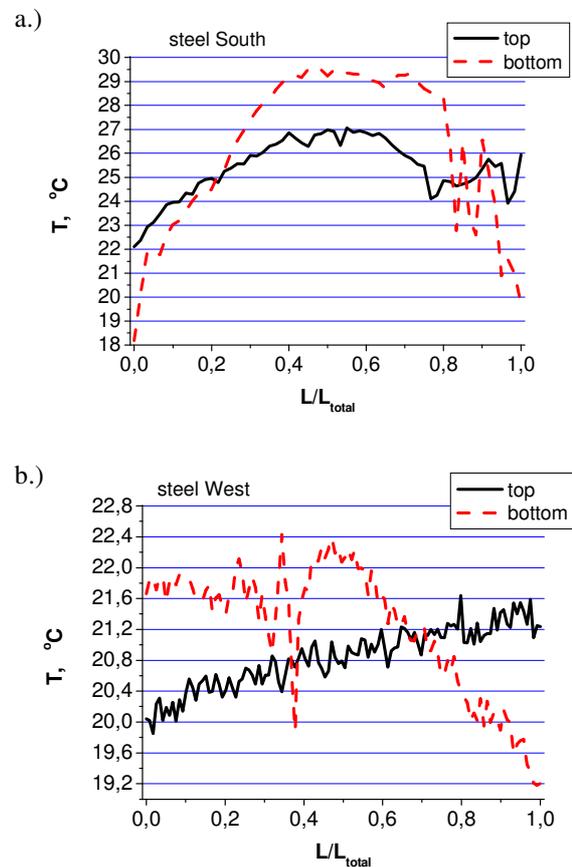
Fig. 6. Temperature distribution along the structural steel chimney at the bottom and top of it in horizontal direction oriented: a.) South, b.) West

Figure 6. pictures the temperature distribution only along the structural steel chimney in horizontal direction. The lines present the bottom (straight one) and the top (dashed one) of the chimney. The measurements were performed by means of thermal imaging camera taking two photos along this chimney in each orientation (N, S, E, W) but only south and west are samples shown in Figure 6.

The curves mainly present the lower temperatures at the bottom of the chimney. The combustion gases decrease their temperature during the flow to the chimney outlet. Moreover they are subject of the wind operation. Therefore the higher they reach, the temperature decline is more visible.

The south orientation presents higher temperatures values along the horizontal line for both bottom and top of the structural steel chimney than the west orientation. The reason for that phenomenon is the

sun's migration on the horizon during the day. Solar operation faster reaches the chimney walls on the south side than on the west one.

The diagrams for steel chimney (Figure 6) bottom and top thermal images prove the temperature differences between those two parts are negligible. Still the top of the chimney presents other temperatures due to the wind exposure. On the South side of the steel chimney (Figure 6a) we observe the temperature drop

at the edge of the chimney that can be explained by the radiation impact. The most reliable temperature results are in the middle of the chimney which has cylindrical shape.
