# The damage effect on the structural capacity of school building columns due to tsunami inundation in Banda Aceh city after 16 years

**Abstract.** The 2004 Indian Ocean earthquake and tsunami caused catastrophic damage to buildings and infrastructure in Banda Aceh. The impact and damage depended on several factors such as the distance of the area from the coast. It was reported that in Banda Aceh, the tsunami wave inundation reached the city center and affected over a third of the population. Due to priority reasons at the time, although the structure was submerged in tsunami inundation, numerous public facilities including school buildings still in use without any proper repair. This study aims to determine the effect of column damage due to the tsunami inundation on the strength of the building. The school building of SMPN 6 Banda Aceh is selected as the case study. Seven analysis cases were carried out to simulate the degradation of the column cross-section caused by tsunami inundation. The reduction of the column cross-section was determined from 5 to 25% with increments of 5%. The analysis results revealed that the decrease in strength has occurred from the case of 5% degrad

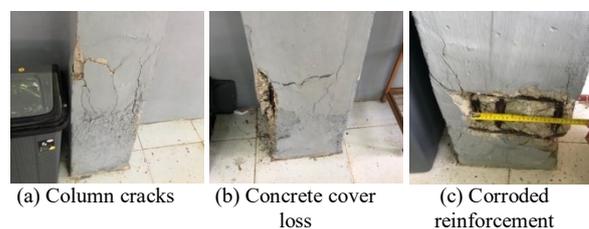
Direct observations at the SMPN 6 Banda Aceh building revealed that the concrete portion of the column which was submerged by the tsunami has cracked. Moreover, some of the concrete covers have peeled off and the exposed reinforcement was corroded. These conditions are shown in Fig. 1.

Fig 1. Column conditions

During the field survey and direct observation, it was found that most of the column on the first floor, which experienced 1.8 meter high of tsunami inundation, was degraded. Associating direct observation data and Finite Element (FE) analysis results, the columns of SMPN 6 Banda Aceh structure is classified as heavy damage.

As the structural mitigation efforts, it is recommended to evaluate the condition and the function of the school buildings, as well as other public facilities. Particularly, those submerged to the tsunami inundation and unrepaired yet, since similar damage might have occurred. The capacity of the existing structure should be enhanced by applying retrofitting methods.

One of retrofitting methods for flexural columns is by adding reinforcements. This method is effectively applied to vulnerable columns so that it can increase column capacity and reduce direct shear failure.

The other retrofitting method is column jacketing. Jacketing is a method of structural retrofitting and strengthening aims to increase or restore the structural capacity of existing structures by providing wrapping sheets of additional material around the existing member. This additional material can be of several types such as concrete, steel, FRP, and composites.

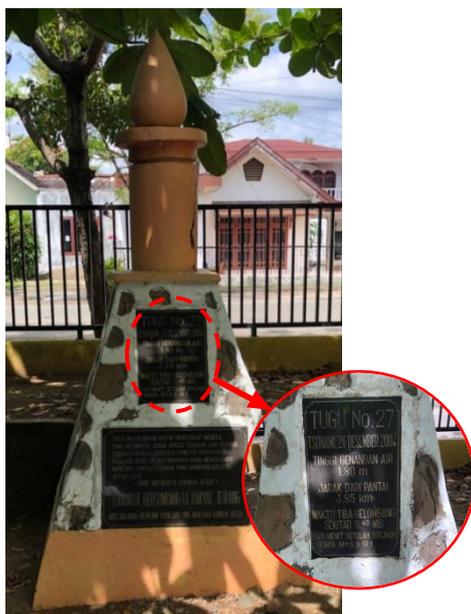
According to the research conducted by Iemura *et al* (2008) [9] in building the Tsunami Height Memorial Poles in Banda Aceh and Aceh Besar, the tsunami inundation at SMPN 6 Banda Aceh is 1.80 m high with a distance to the coast of about 3.85 Km. The tsunami memorial pole at SMPN 6 Banda Aceh is shown in Fig. 7.

Fig 7. Tsunami memorial pole in SMPN 6 Banda Aceh

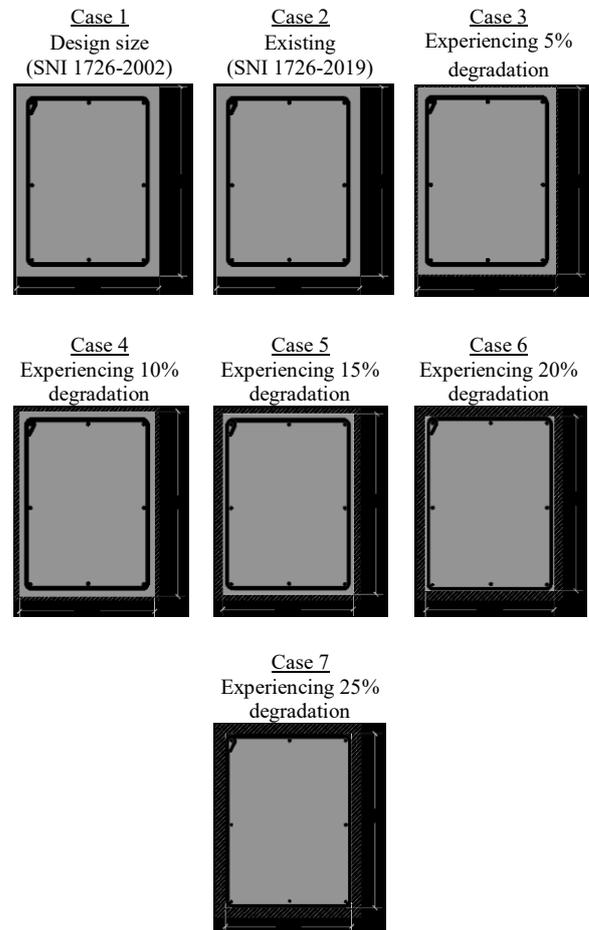
To simulate the effect of degradation of the column cross-section caused by tsunami inundation, seven scenario of analysis cases were carried out as illustrated in Fig. 8. The degradation of the column size was carried out sequentially to evaluate the capacity of the building structure. The reduction of the column cross-section was determined from 5 to 25% with increments of 5%. The degradation percentage of column cross-section were applied on each side of the width and depth.

Fig 8. Column degradation included in the analysis

Case 7 was carried out to simulate the above conditions. In this case, the column was experienced complete concrete cover loss and the reinforcement started to corrode. Thus, it was required to reduce the cross-sectional areas of the reinforcement in the analysis. The reduction in the reinforcement cross-section due to corrosion of 5.64  $\mu\text{m}/\text{yr}$  was used in the analysis referred to the research conducted by Al-Hadi (2016) [10].

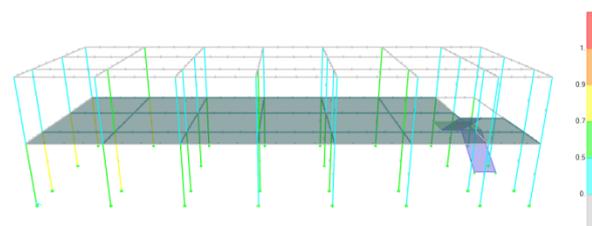
In Case 1, the analysis result shows that most of the columns are in a light blue color, indicating that the structure is safe. In Case 2, where the applied earthquake load was updated to the latest SNI, the analysis result shows more columns had turned green, indicating that the capacity of the column was decreased, in other words, the vulnerability level of the column was increased. However, the structure is still within the safe level. According to the results, it can be concluded that differences in structural capacity were observed by updating the earthquake loading standard.

**Fig 9.** Case 1 - Structural capacity check visualization

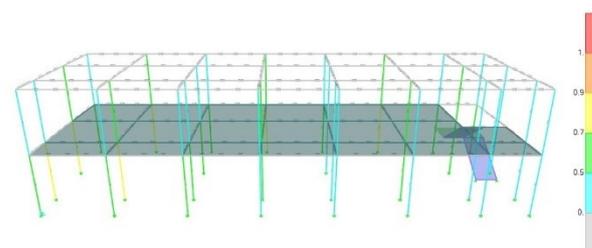
**Fig 10.** Case 2 - Structural capacity check visualization

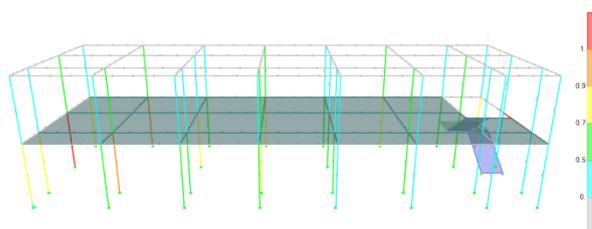
Start from Case 3, the red columns were observed. It indicates that the strength of the column was decreased and become incapable to bear the applied loads. According to the analysis results, when 10% of column cross-section has degraded, as in Case 4, it can be concluded that the risk of structural building collapse

**Fig 11.** Case 3 - Structural capacity check visualization

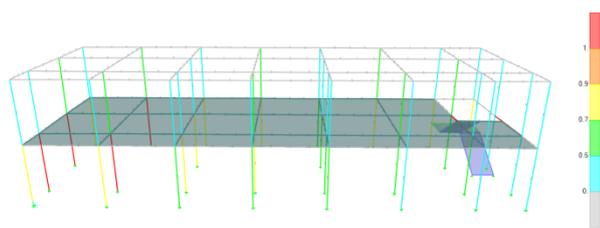
**Fig 12.** Case 4 - Structural capacity check visualization

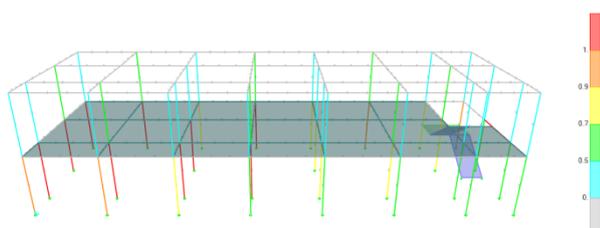
has increased. When the column cross-section has degraded for 15-25% as in Case 5-7, the structure is no longer safe and will fail because above 30% of main column of the structure is no longer able bearing the weight of the structure. Deteriorated column caused structural failure where the entire building will collapse because the column is main structural component that play important role bearing the weight of building.

**Fig 13.** Case 5 - Structural capacity check visualization

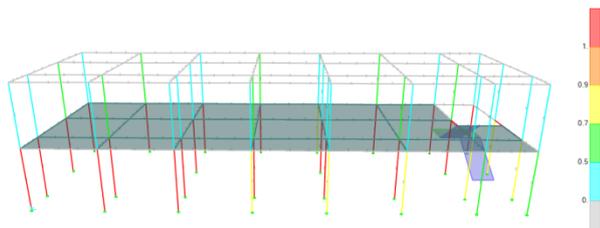
**Fig 14.** Case 6 - Structural capacity check visualization

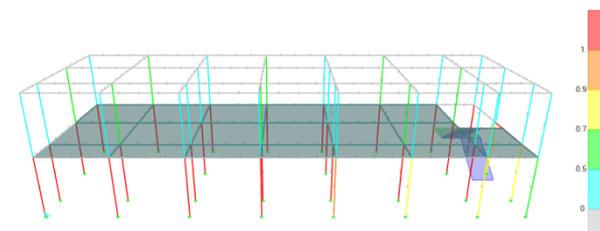
**Fig 15.** Case 7 - Structural capacity check visualization
