# Study of the sub-surface geological condition of the Sibalaya flow liquefaction using seismic refraction method

**Abstract.** Understanding the occurrence of flow liquefaction requires knowledge of the sub-surface condition controlling its occurrence. This paper presents the results of seismic refraction surveys conducted to evaluate the sub-surface geological condition in the Sibalaya flow liquefaction area. From the interpretation of the seismic refraction model, an inclined boundary presents between the near-surface sediment layers. Further examinations of the SRT images demonstrate the existence of localized basinal structures in the rock layer with the highest P-wave velocity. The basinal structure may be associated with a hidden normal fault system of horst-graben structures. Thus, this study indicates that such a complex sub-surface geological structure also contributed to the Sibalaya flow liquefaction occurrence.

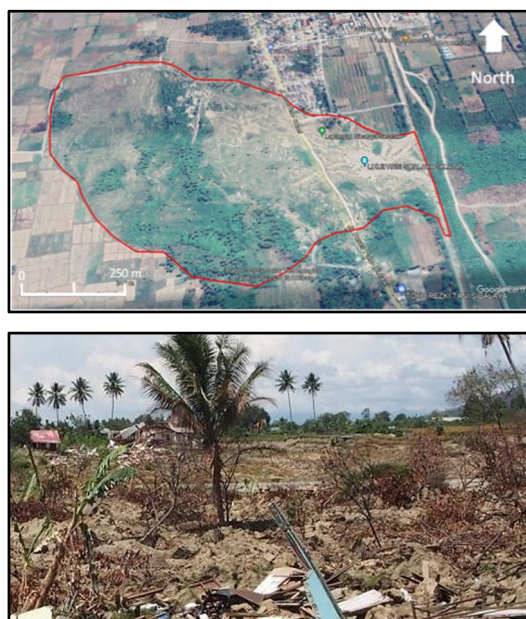
One flow liquefaction phenomenon occurred in the Sibalaya Village in Sigi Regency, about 35 km south of Palu City (Figure 1). The easternmost boundary of the Sibalaya liquefaction area is limited by an irrigation canal. The liquefaction destroyed about 150 houses and hundreds of hectares of rice fields and was probably caused by the breach of the irrigation canal [1].

**Fig. 1.** The areal photograph of the Sibalaya flow liquefaction (top) and destroyed houses (bottom).

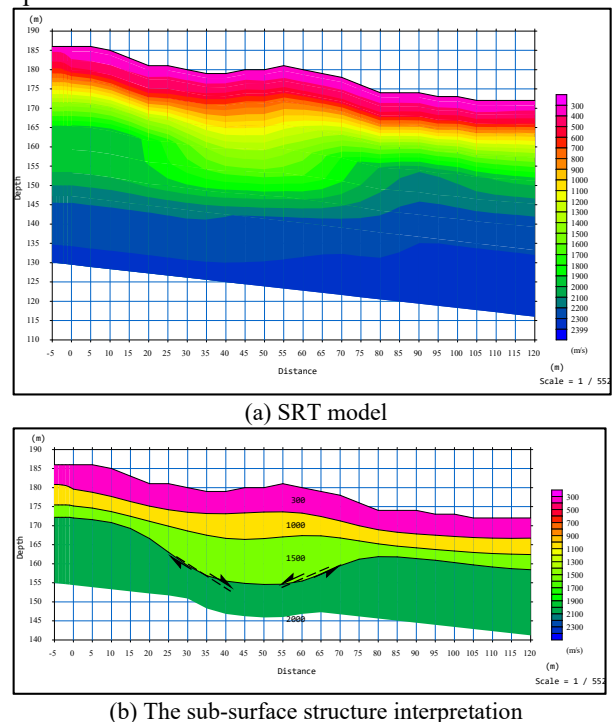
**Fig. 6.** SRT model and its interpretation of the sub-surface structure for Line S1.

A graben structure is seen in the middle section of Line-S1 shown in Figure 6(a), demonstrating that Line-S1 is contained within the zone affected by liquefaction. Figure 6(b) depicts the explanation of this seismic tomographic model, which shows the development of a horst and graben configuration in the fourth rock layer. This model, in particular, clearly elucidates the emergence of a pull-apart basin structure.

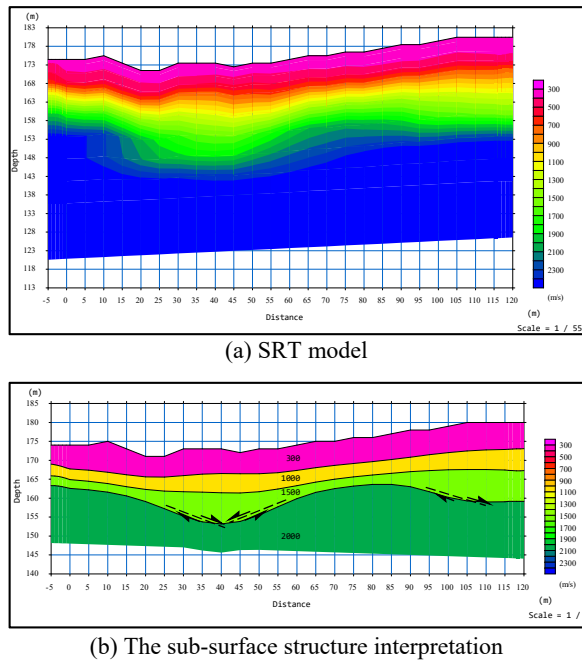
**Fig. 7.** SRT model and its interpretation of the sub-surface structure for Line S2.

According to Figure 7(a), the thickness of the third layer in Line S2 varies about 8 meters in the east, increases up to 15 meters in the middle of the profile, and then decreases up to 2.5 meters in the east. As a result, the seismic tomography model delineates the presence of a sub-surface basin shape under the liquefaction-affected region, which might be connected to a localized graben structure in the fourth rock layer. Figure 7(b) depicts the graben structure as an important component of a regionally constrained pull-apart basin phenomena.

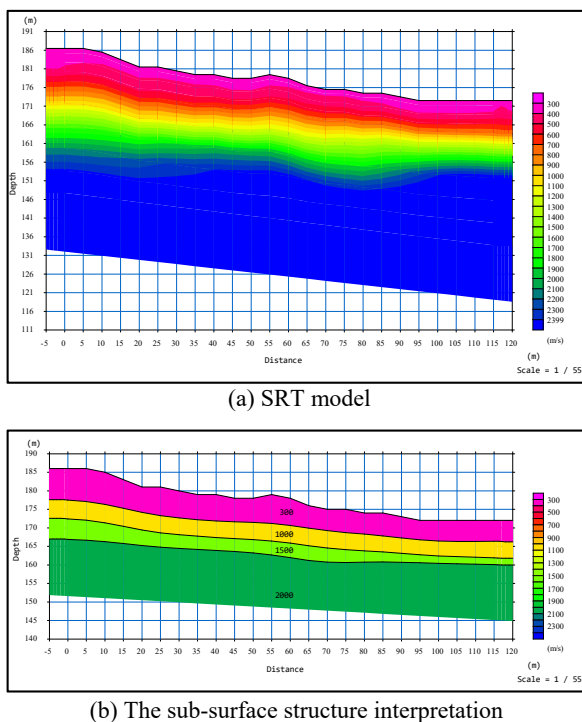
**Fig. 8.** SRT model and its interpretation of the sub-surface structure for Line S3.

Meanwhile, the SRT model for Line S3 is shown in Figure 8(a). The thickness of the first and second layers seems to be constant. Meanwhile, the third layer is relatively thicker in the north and becomes thinner towards the southern part, with thickness variation from 2.5 to 5 meters. Although the presence of horst and graben in the layered model is not visible in Figure 8(b), a shallow basin exists locally in the southern part of the survey line.
