# Study of technical reasons for fire-burning vehicles

**Abstract.** The article presents the authors' methodology for studying technical ignition causes of cars, with the establishment of the initial fire based on the signs and nature of temperature damage. What is more, subsequent development of the main scenario of fire occurrence is introduced. Modern control system is becoming larger and more complicated day by day and probability of system outage increases with it, so people urgently need to personalize the system of failure diagnostics to conduct real-time monitoring and malfunction diagnosis in production system and take necessary steps to improve its overall reliability and maintainability. According to the presented method of fire research, determination of the ignition causes is carried out by the method of successive elimination. Based on the functional features of the researchable object (a motor vehicle), established by expertise as an initial fire, the ignition of flammable liquid because of leakage from the fuel system, thermal development of the processes accompanying the emergency operation mode of the power grid could be possible ignition causes of the car. The

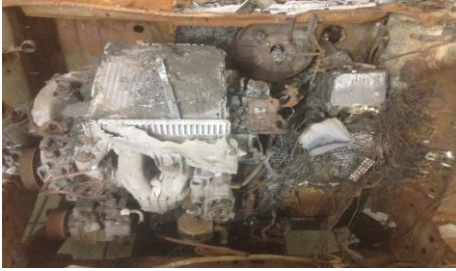
The materials of the independent expert review are presented below. Inspection of the engine room of the burnt-out car Mazda CX-7 allowed to establish that the supreme thermal

damages are on the left side of the engine (in the direction of the car). The fuse panel, car battery, rubber hoses and radiator were completely burnt out (see Fig.1).

**Fig. 1.** General view of the burnt engine compartment.

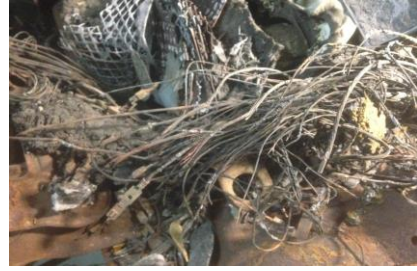
**Fig. 2.** Part of the electrical wiring of the motor harness.

When investigating the electrical wiring, it was found that there are no traces of a short circuit (see Fig. 2). There is no complete isolation. Metal of the conductors (copper) is brittle, fragile and dark red in color for a long distance. Some of the thin wires were burnt off in the middle part of the harness. Above mentioned characteristics are typical for copper wire that has been exposed to high temperatures for a long time. Most of the connecting devices at the ends of the conductors are in condition with a good crimp of the conductors and a push fit in the clips. Physiography of the surfaces of reflowings and adjoined sections of connectors is common to reflowings formed as a result of strong long-term heating. It should be emphasized that all these types of reflowings have some common features which are typical for copper conductors. They are: significant changes in the cross-section along the length; extended reflow zone; arbitrary forms of reflowings; fusion of individual wires in the vein among themselves. These characteristics are typical for copper conductors fused as a result of thermal influence rather than short-circuit currents [5]. There are also no traces of a short circuit on the control wiring that comes from the generator and car battery (see Fig.3, Fig. 4). The temperature of the gas environment in emplacement of a power cable significantly exceeds the melting temperature of the cable insulation (120°-140° centigrade) in the event of a fire in the engine room of a car.

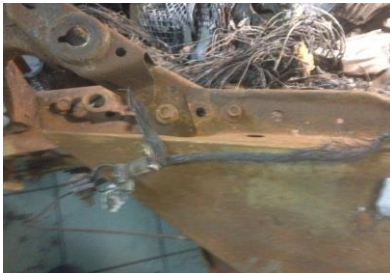
**Fig. 3.** A part of battery wiring on the side of the terminal post (+).

The second wire on the side of the terminal post (-) that comes from the car battery also has no traces of a short circuit. Color and brittleness of the copper wires of the veins in two zones are indicative of metal damage of the conductors as a result of long-term thermal influence. As the wires of the copper conductor core have slightly changed their properties in the partitioning area, and the cores themselves are not fused together, it can be affirmed

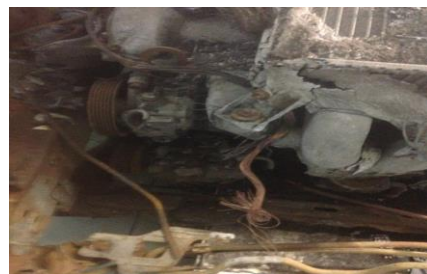
**Fig. 4.** A part of electrical wiring that comes from the generator.

that such heating could occur from external thermal influences. The generator has no external damage or traces of a short circuit. As the study showed, the generator at the time of the fire was in good order, there were no traces of a short circuit on the wiring harnesses which come from the generator. Therefore, high temperature of the fire in the engine room could be the only cause of such damage.
