# Monitoring of the technical condition of structures and building materials of an elevator silo housing

The object «Elevator building №. 2, Silo housing №. 3» is being investigated - technical passport №. 13624 is located at the address: Lipetsk region, Yelets, str. Krotevich, 30.

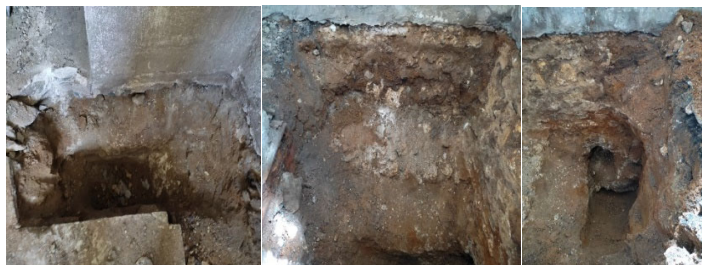
The object has a strip foundation made of rubble concrete [3, 4]. The photographs of the foundations excavated in the pits are shown in Figure 1.

**Fig. 1.** View of the state of the foundation in the pit № 1, 2, 3.

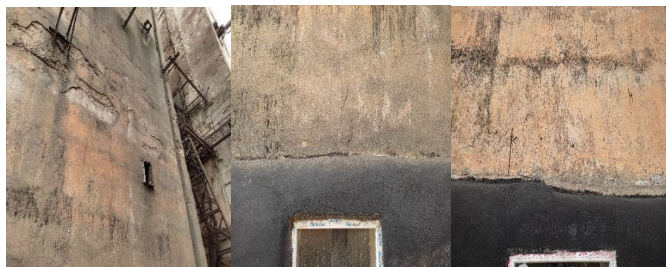
The surface of the walls is covered with a plaster layer with a thickness of 10 to 30 mm. A visual inspection of the monolithic walls revealed the following: at the level of the transition of the outer walls of the silo compartment to the outer walls of the silo compartment, there is a destruction of the plaster layer with areas of exposed reinforcement (Figure 2). Delamination of the plaster layer. When tapping, a deaf, bubbling sound of emptiness is heard, it easily lags behind or is disassembled by hand [5, 6]. On the surface of the walls there are masses of fallen off plaster. There are areas of cracking and spalling of the protective layer of concrete with an area of up to 1 m<sup>2</sup>, with exposure of large aggregates and rebar [7, 8].

**Fig. 2.** General view of the condition of the load-bearing walls of the building.

There are vertical, horizontal cracks opening up to 0.3 mm. At the level of +6.900 from the level of the blind area, there is a horizontal crack encircling the perimeter of the building. At the level of +7.900 there is a duplicate, horizontal crack encircling the perimeter of the building. In the area from +6.900 to +7.900, cracking and spalling of concrete, exposure of coarse aggregate and rebar are observed [9, 10]. Cracks along the reinforcing bars with an opening of up to 3 mm. In areas of painted concrete, corrosion of rebar is observed with a change in cross-section of up to 70%. The outer surface of the walls of the silo compartment is covered with a plaster layer along the grid. The plaster layer is covered with coating waterproofing [11, 12].

From the windows located in the walls of the silo room there are vertical cracks (opening width up to 0.2 mm) extending to the entire height of the walls of the silo room to the eaves slabs. On the surface there are traces of constant soaking by atmospheric precipitation [13, 14]. The cause of defects is the natural physical wear of the wall structure as a result of atmospheric action.

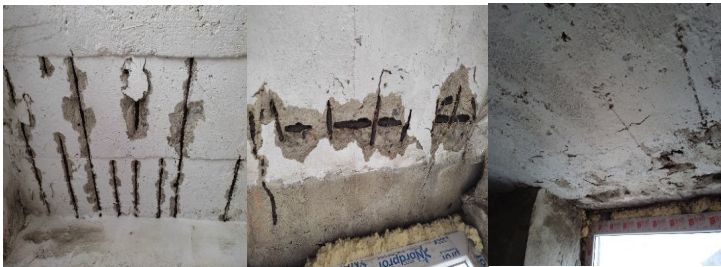
Part of the ceiling of the undersilo compartment is made in the form of a monolithic slab 200 mm thick (Figure 3). Reinforcement: longitudinal - metal rods Ø 10 mm. with a step of 100 mm; transverse - metal rods Ø 10 mm. with a step of 100 mm; reinforcement in the area of window blocks with longitudinal rods Ø20 with a pitch of 100 mm, for a width of 600 mm (5 pcs.).

**Fig. 3.** General view of the ceiling condition of the silo compartment.

Visual examination revealed: the protective layer of the lower reinforcement cage is  $5 \div 10$  mm; on the floor there are areas of delamination of the protective layer with bare reinforcement; bare reinforcement is subject to corrosive attack; deflections of sections of the slab, in the area of the premises located along the perimeter of the silo room, are up to 50 mm, on the lower surface of the slab there are longitudinal and transverse cracks with an opening thickness of up to 0.2 mm.

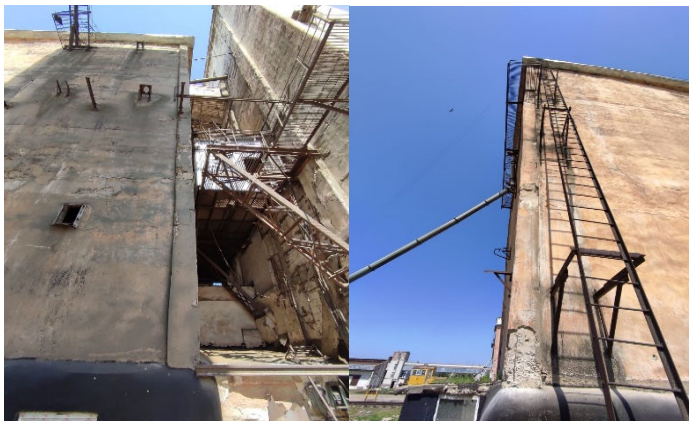
The structures of the columns are made of reinforced concrete, installed at the corners of the silo at the height of the silo (Figure 4). The size of the columns is 500x500 mm. Reinforcement is made with vertical steel.

**Fig. 4.** General view of the condition of the columns.

A visual inspection of the columns revealed the following defects: destruction of the plaster layer with areas of exposed reinforcement; peeling of the plaster layer. When tapping, a deaf, bubbling sound of emptiness is heard, it easily lags behind or is disassembled by hand. There are areas of cracking and spalling of the protective layer with exposure of coarse aggregate and rebar. There are vertical, horizontal cracks opening up to 0.3 mm. In areas of painted concrete, corrosion of vertical rods is observed with a change in cross section of up to 100%. Curvature of the column surface from the vertical plane according to external signs: deep cracks in the elements, reduction of the working section [19, 20, 21].

As a result of comparing the signs of physical wear with their normalized values, it was found that the actual value of the physical wear of the outer columns is 50%. According to the methodology, the established value of physical wear (50%) corresponds to an unsatisfactory technical condition.
