Functionalization of a 110 Wp Photovoltaic System for Computer Room Power Supply at SMK Muhammadiyah 2 Turi Sleman

Abstract. Sekolah Menengah Kejuruan Muhammadiyah 2 Turi Sleman has a photovoltaic system that powers the computer room. However, since 2022, the system has not been working correctly. This paper aims to restore the photovoltaic system's functionality. The activities include checking the condition of the system's components and taking corrective actions. During the inspection, it was found that the solar module was not installed outdoors, and the battery's performance had decreased, showing a voltage of only 11.95 V. The solar module had been installed outdoors correctly. Performance tests revealed that the system can produce electrical energy, with the solar module generating an average open circuit voltage of 23.32 V in sunny weather. The battery repair resulted in an average voltage of 12.23 V. The photovoltaic system now functions as a power supply for the computer room.

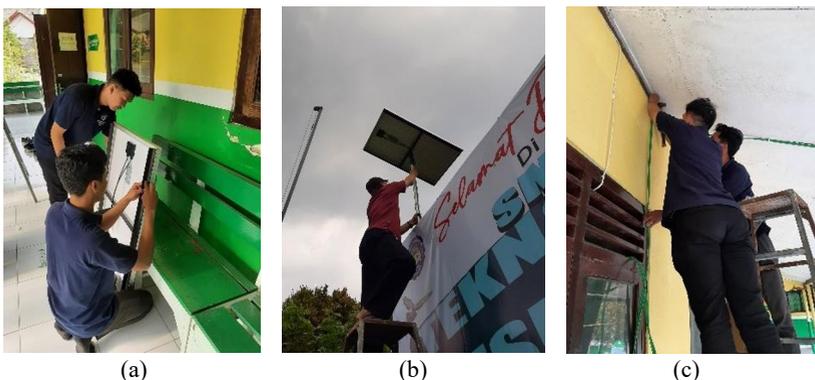
The initial step in installing solar modules outdoors involves securely fastening the cables to the junction box poles and ensuring the cover is tightly sealed to prevent water ingress. The pole installation was carried out at a location nearest to the computer room. With Mitra's consent, the solar module pole was positioned on the school billboard, 4 meters between the module pole and the computer room. This distance poses minimal risk of electrical loss and is considered safe. The location is accessible from shading by trees and buildings, which is crucial, as shading can significantly reduce the performance of the PV system [16]. The solar modules are oriented towards the north to maximize solar energy absorption [15]. Fig. 3 shows the solar modules installed outdoors.

Fig. 3. Installation of solar module: (a) module frame, (b) solar module, (c) module cable.

Installing solar modules outdoors necessitates a support frame and poles. The frame was constructed from galvanized angle iron, measuring 40 x 40 x 3 mm, and the poles are made of galvanized pipe with a 1.5-inch diameter. The frame is designed to accommodate the dimensions of the solar module, with a tilt angle of 20° to maximize solar exposure throughout the year [15]. The frame and solar module were secured with M8 bolts, and the solar module frame was attached to the pole using three M8 bolts.

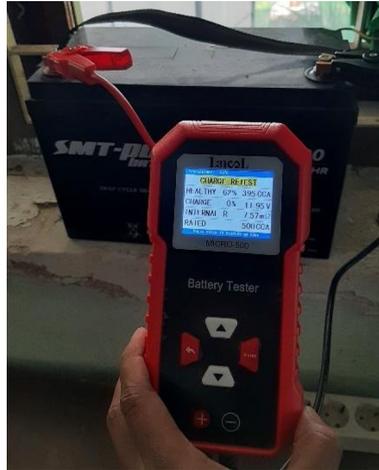
The battery used in the PV system is a deep cycle type. During the inspection, the battery voltage was 11.95 V, which indicates a weak battery since the operational voltage for a PV system should be above 12 V [17]. Low battery voltage can result from several factors, including the battery exceeding its typical lifespan, malfunctioning lead plates, or inadequate

electrical energy supply. In this case, the low battery voltage is primarily due to the lack of electrical energy supply, as the solar modules were not installed outdoors. This issue is clearly illustrated in Fig. 4, which shows a 0% charge condition.

Fig. 4. Existing battery conditions.

According to Fig. 4, the battery health is at 62%, indicating that the battery condition is relatively fair. The PV system can still use the battery, as it will receive electrical energy from the solar modules. An additional battery of the same type is added to ensure better battery performance. The two batteries are installed in parallel to maintain a PV system voltage of 12 V [18]. Using two batteries also increases the electrical energy storage capacity. Each battery has a capacity of 100 Ah, and the total capacity of two batteries is 200 Ah. Adding a second battery benefits the computer room, extending the duration of electrical energy availability. Fig. 5 shows the battery repair process.

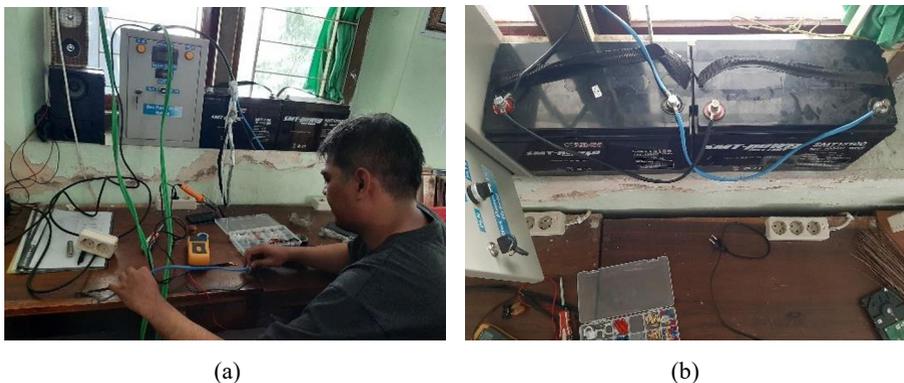
Fig. 5. Installation of battery: (a) wiring repair, (b) parallel connection

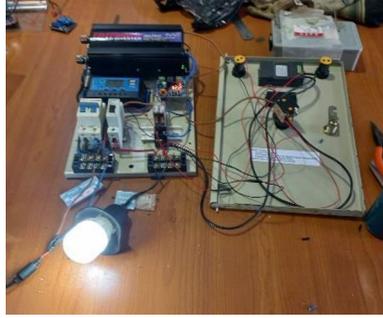
Function tests were performed on the PV system following the installation of the solar module, battery repairs, and wiring system corrections. The test uses a 10 W AC incandescent lamp connected to the output panel box. The functional test results confirm that the PV system effectively generates electrical energy to power the lights, as illustrated in Fig. 6.

Fig. 6. Function test of PV system.

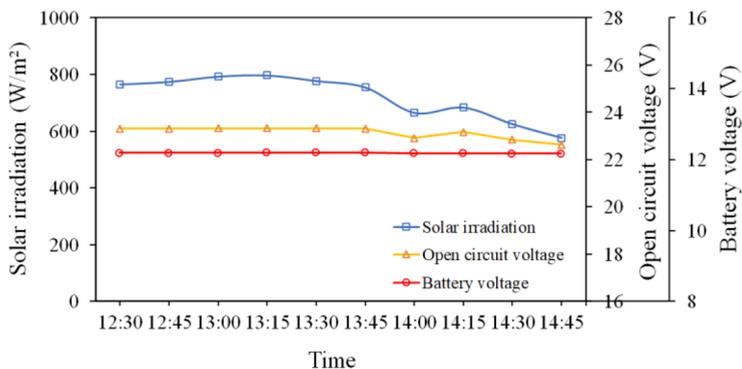
The solar radiation intensity was relatively high at the beginning of the performance test. However, from 13:45 onwards, the solar radiation decreased due to cloudy weather, which directly impacted the performance of the solar modules. The average open circuit voltage recorded from the start of the test until 13:45 was 23.32 V. After the appearance of clouds, this voltage decreased and fluctuated. An open circuit voltage of 23.32 V indicates that the solar module's performance is good, as it exceeds the factory nominal value of 23 V [19]. The average battery voltage during the performance test was 12.23 V, which indicates proper battery function, as it is above the nominal PV system voltage of 12 V.

Fig. 7. Performance test results.
