Comprehensive Analysis of Solar Photovoltaic System Defects and Inspection Techniques in Tropical Environments Using Thermal UAV: Study Case in Marang, Terengganu

Aisyah Marliza Muhmad Kamarulzaman^{1,2}, *Wan Shafrina* Wan Mohd Jaafar^{1,*}, *Nurul Asyiqin* Abu Bakar¹, *Kelvin* Chew², *Nazarul Ikram* Khairi Anuar², *Alif Izzuddin* Anuar², *Ahmad Fikrie* Mat Som², *Sofiah* Mohamad Zamri², *Muhammad Zahirul* Hafiz Zainorzuli²

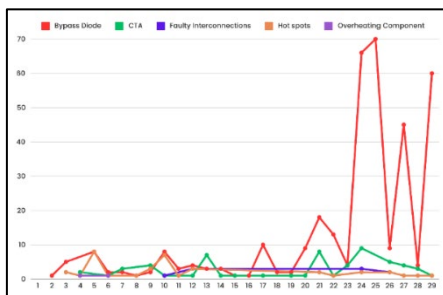
Fig. 5. Thermographic Defect Occurrences in Marang Area

The graph in Fig. 5 shows the findings of five distinct thermographic fault types as recorded by the 29 zone flights in the Marang Area. The graph provides a comprehensive analysis of different fault types in different zones, along with valuable quantitative data on their distribution patterns. Bypass diodes are the most common type of system error, with 352 incidences detected across all zones. There are eight or more occurrences in each of the following zones: 5, 10, 21, 22, 24, 25, and 27. There are a total of 59 panels of CTA (Clusters of Thermal Anomalies) faults, with Zones 24 and 29 being particularly notable, with 9 and 5 occurrences, respectively. Faulty interconnections, which have occurred a total of nine times, are rather uncommon. Among all the zones, Zone 24 has the highest number of incidents, with three occurrences. Zones 5, 10, and 24 contain the majority of the 40 hot spots. Each of these zones has eight or more instances of hot spots. In contrast, overheating component failures are relatively rare, with only two instances observed across all zones. Zone 24 consistently displays a high frequency of occurrences across several fault types, indicating that it may necessitate targeted maintenance or corrective actions. In contrast, some areas exhibit reduced frequencies or the complete absence of specific fault types, indicating greater resistance to those particular problems. This comprehensive quantitative analysis enables the identification of zones with higher risk levels, allowing resources to be prioritized for targeted interventions. As a result, it helps create more efficient fault management systems.

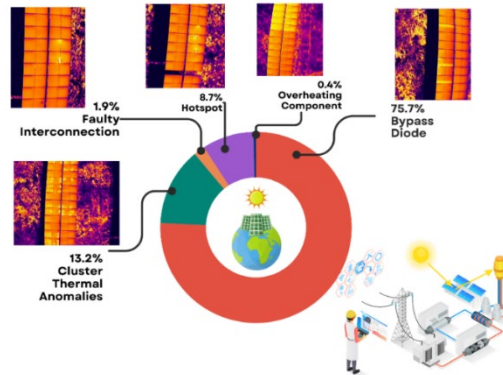
Fig. 6. Percentage of Thermographic Defect Occurrences

In addition to the panel values for the 29 zone flights, we can determine the percentages of the types of defects that have occurred in the solar farm located in Marang, Terengganu. Looking at the different types of faults in Fig. 6 can help you understand how they are spread out and how important they are in the 29 zone flights that were done in the Marang Area. Bypass diode difficulties, accounting for a significant majority at 75.70%, are the most common problems detected. The significant proportion underscores the potential widespread occurrence of bypass diode malfunctions in the examined area, underscoring a critical issue that necessitates investigation and remediation efforts. Clusters of Thermal Anomalies (CTA) defects occur less frequently, but they still account for a significant amount, 13.20%. These anomalies highlight specific places with typical temperature patterns, necessitating a thorough analysis to identify the problems. However, improper linkages account for only 1.90% of reported problems. Hot spots, with a percentage of 8.70% of defects, signal localized overheating concerns that require prompt attention to prevent equipment damage or safety hazards. Lastly, Overheating Component defects, though rare at

0.40%, indicate potential equipment malfunctions or inefficiencies, underscoring the need for proactive maintenance. By systematically analysing these defect types and their respective percentages, stakeholders can prioritize resources and interventions effectively to mitigate risks and optimize the operational reliability of the Marang Area infrastructure.
