The results of the study on the technical condition of hydraulic structures in reservoirs

Abstract. The article discusses the results of a study on the technical condition of operated hydraulic structures in reservoirs. During operation, various effects of long-term use, shortcomings in design, construction and operation of reservoirs as well as factors affecting the reliability of their hydraulic systems are manifested. The article also provides main criteria for ensuring reliable operation of reservoir systems.

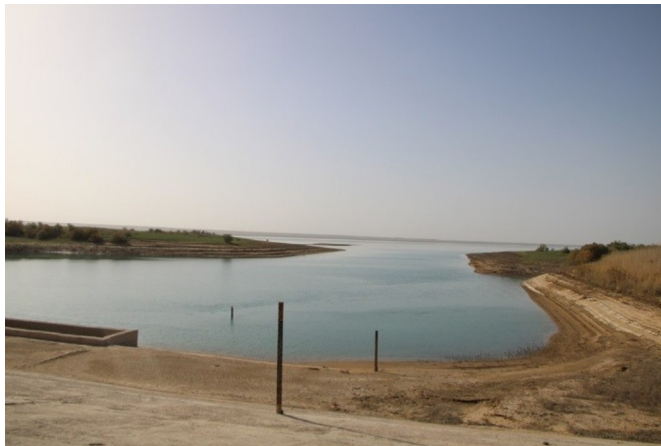
a

Fig. 1. Talimarjan water reservoir: a) reservoir bowl; b) upstream slope position.
