In situ ageing of a lime/cement-treated expansive clayey soil

Nicolas Chabrat^{1,2#}, Olivier Cuisinier¹, and Farimah Masrouri¹

ABSTRACT

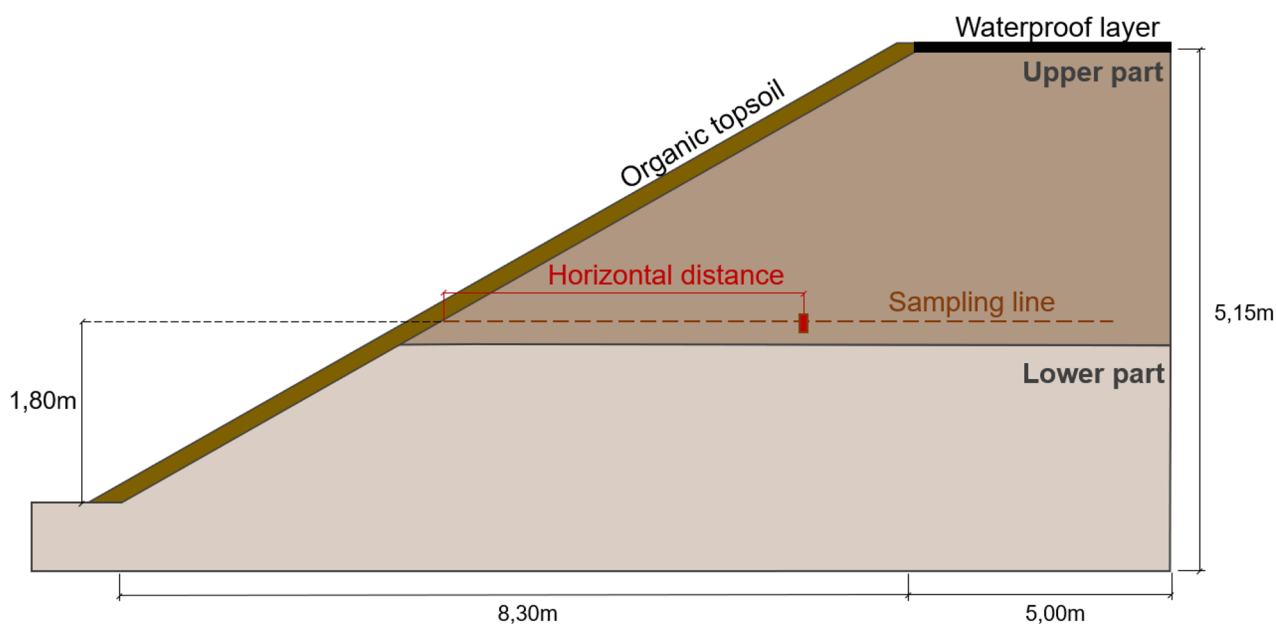
Figure 2. Core drilled zone in the upper and lower part of the embankment.

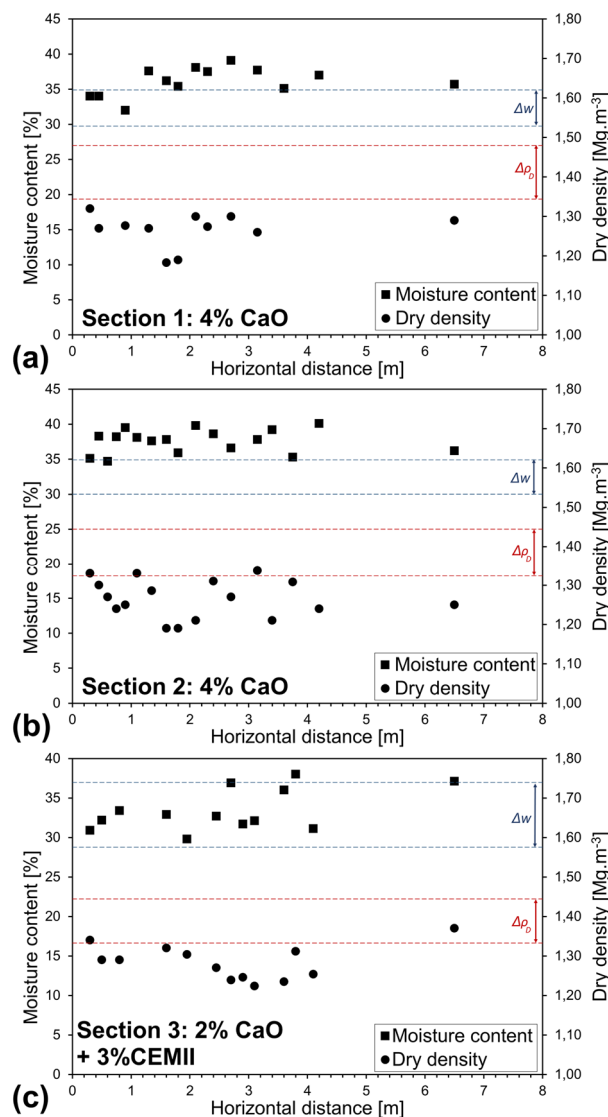
Figure 2. Moisture content and dry density evolution along the horizontal cores for section 1 treated with 4% lime (a), section 2 treated with 4% lime (b), and section 3 treated with 2% lime and 3% cement (c).

For section 1, the moisture content was comprised between 34% and 39% with a mean value of 36.1%. The lowest values of water content were found at low horizontal distances. The average dry density was found equal to 1.26 Mg.m⁻³. In section 2, the average dry density was also 1.26 Mg.m⁻³ while the average moisture content was 37.5%. Moisture contents and dry densities along the sampling line were also measured for the third section treated with 2% of lime and 3% of cement. The mean value of the moisture content was 33.4%, while the average dry density was found at 1.29 Mg.m⁻³. The density and moisture content found in section 3 were slightly different from the other sections, as the optimum moisture content depends on the treatment dosage.

Moisture content presented in Figure 2 can be compared to the one measured at construction time (Table 4). Moisture content values from all sections slightly increased since construction time: from 33.0% to 36.1% for section 1, from 35.0% to 37.5% for section 2

and from 32.8% to 33.4% for section 3. The edge of the backfill was however slightly drier than the inner part of the backfill (Figure 2). These results tend to indicate that the moisture content of the backfill has not significantly changed since the time of construction. Besides, moisture content values suggest that the soil was not impacted by the water used for drilling. These results are in line with the data collected by the in-situ sensors and presented by Bicalho et al. (2015). Continuous monitoring over a year indicated that the volumetric water content measured at 0.50 m of horizontal distance could vary from 0 to 1.5%. On the other hand, moisture sensors installed in the core of the embankment (at 4.50 m of horizontal distance) did not detect relevant variations of volumetric water content. Thus, the compaction parameters of the soil remained nearly unchanged over the years, except for the edge of the embankment where the soil is most exposed to atmosphere interactions. This confirms that the impact of climatic conditions on moisture content is limited to the first tens of centimeters of the embankment.

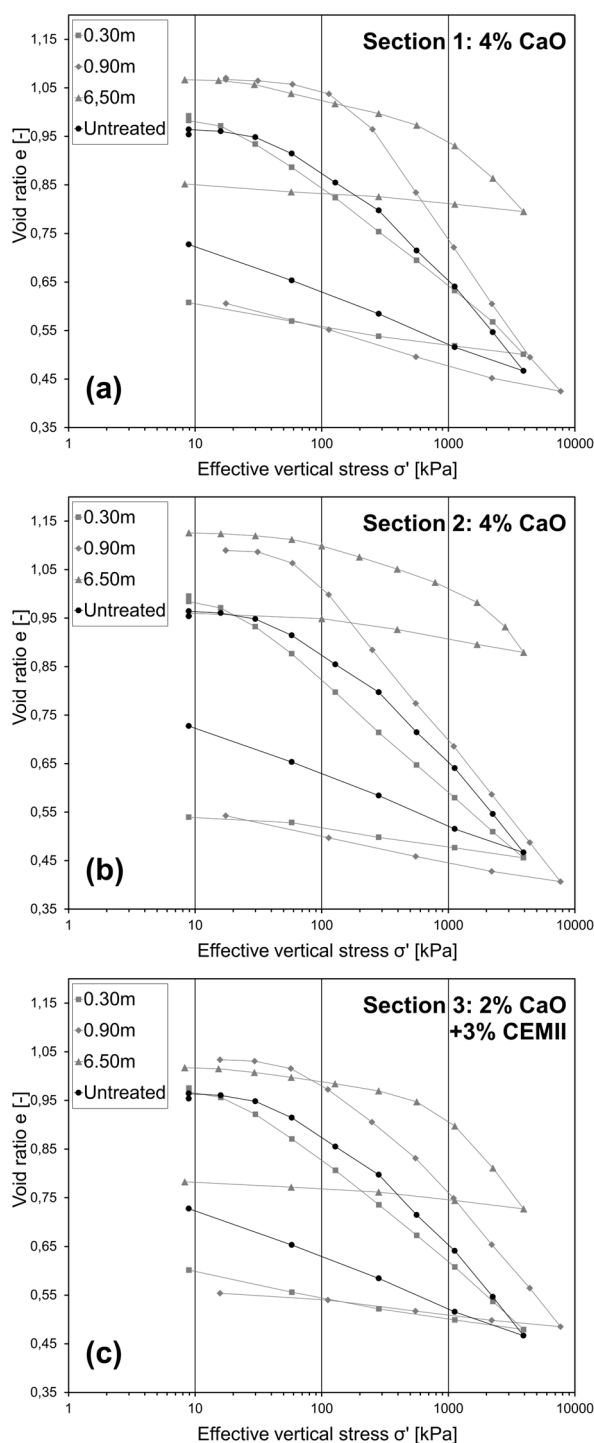
Up to 17 oedometer tests were performed in each section. Examples of the compressibility curves obtained from each section are plotted in Figure 3. The yield stresses determined in each oedometer test are shown in Figure 4. The results of these tests were compared to the curve obtained from the specimen taken from the untreated part of the backfill (lower part of section 1). The yield stress determined at the edge of the backfill in section 1 was equal to about 20 kPa. The compression curve of this specimen is very close to the one obtained with the untreated sample (Figure 3); the yield stress determined from both curves is of the same order of magnitude. The swelling index C_s of the two specimens were also very close. The results showed that the yield stress of the sample taken at the center of the backfill exhibited a yield stress of about 1000 kPa, significantly larger than the one determined on the sample taken at the edge. Figure 4a shows that there is a progressive increase of the yield stress from the surface up to about 2.70 m, the yield stress remaining stable between 2.70 m and the inner part of the backfill.

The analysis of the oedometer tests carried out in section 2, also treated with 4% lime, are plotted in Figure 3b and Figure 4b. At 0.30 m from the surface, the yield stress was slightly lower than the yield stress of the untreated specimen compacted at the optimum moisture content. This might be related to the initial void ratio of the treated sample that was lower than the one of the untreated sample. The yield stress progressively increased up to about 1200 kPa at 2.40 m from the surface. Between 2.40 and 6.50 m from the surface, the yield stress remained almost constant and higher than 1000 kPa.

A similar trend was observed in section 3. On the edge, the yield stress of the specimen was equivalent to the one of the untreated soil and equal to 20 kPa (Figure 3c). The yield stress gradually increased until a distance of 2.00 m from the surface. After that, it remained significantly higher than the yield stress of the untreated soil, even if the scattering of the data is greater compared to the results obtained in the first two sections.

Figure 3. Compression curves of specimens taken from various horizontal distances for section 1 treated with 4% lime (a), section 2 treated with 4% lime (b), and section 3 treated with 2% lime and 3% cement (c).

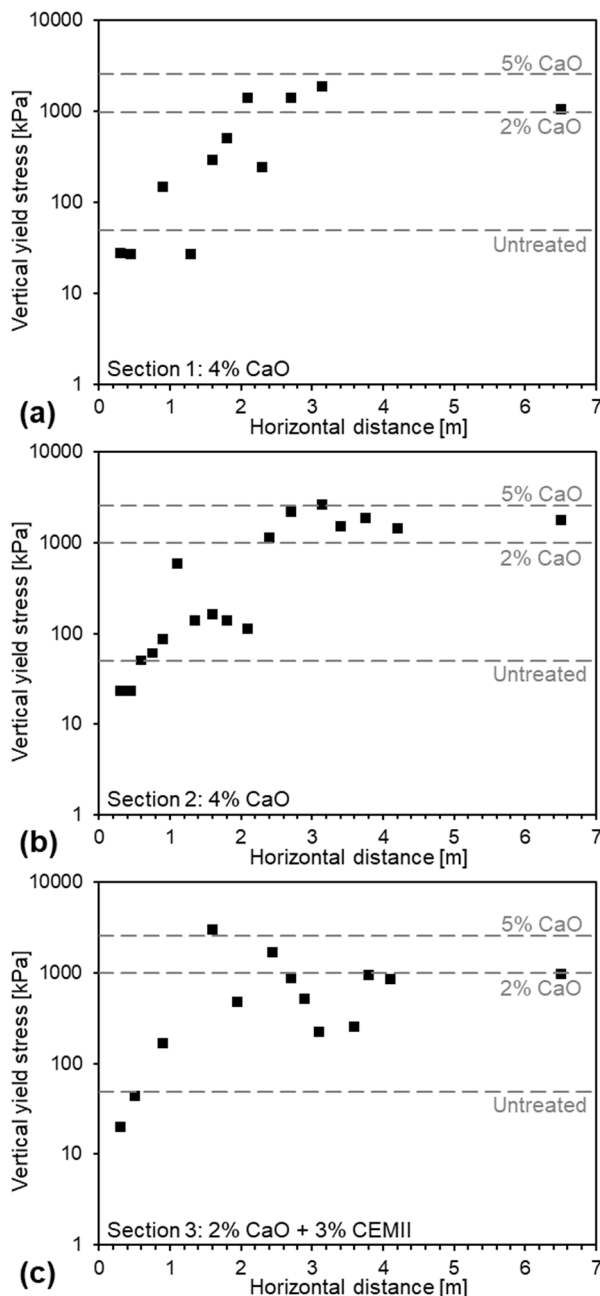
In all sections, the three series of oedometer tests showed a progressive increase of the yield stress from the surface until about 2.50 m towards the inner part of the backfill. Beyond 2.50 m, the performance of the soil remained stable with values of yield stress higher than 1000 kPa. On the edge, the behaviour of the specimens is very close to the behaviour of the untreated soil. This indicates that the treatment is no longer impacting significantly the yield stress of the soil. Results obtained in section 1 and section 2, both treated with 4% lime, led to the same degradation of the edge of the embankment. This tends to confirm the repeatability of the tests performed. The yield stress of the soil treated with quicklime after 360 days of curing (at constant moisture content) was determined by Stoltz et al. (2014). It was equal to 3500 kPa with 5 % of quicklime and equal to 1200 kPa with 2 % of quicklime. These results demonstrate that both the yield stress of specimens from the inner part and the yield stress from treated specimens prepared and cured in laboratory have the same order of magnitude. It can be thus concluded that the treated soil was altered on the first two meters of the backfill, while the inner part performance is comparable to what has been observed after curing at constant moisture content in the laboratory.

The degradation that is observed on the outer part of the backfill can be partly explained by moisture content variations that are known to alter the behaviour of stabilised soils (Guney et al., 2007; Consoli et al., 2017; Liu et al., 2019). Indeed, the monitoring of the backfill showed that the moisture content variation was limited to the first tens of centimeters from the edge of the backfill (Bicalho et al., 2015). Freezing/thawing cycles over the years could have explained the degradation of the performances (Dempsey and Thompson, 1967; Consoli et al., 2017; Lu et al., 2020). However, *in situ* thermal sensors installed at 0.25 m from the surface did not evidence any temperature below 0°C (Bicalho et al., 2015). Other hydro-chemical processes like carbonation, temperature or water leaching could also have led to the degradations observed here, but complementary analyses are required to confirm their potential contribution.

Figure 4. Yield stress of specimens taken from various horizontal distances of the three different sections and compared to the yield stress of the untreated clayey soil, and to the yield stress of specimens treated in laboratory at 2% and 5% lime.
